DAMAGE MECHANISM OF PVC DRAINAGE PIPE CONNECTED TO HOUSE WITH HIGH SEISMIC PERFORMANCE

Abstract

Keywords: Shaking table test; wood house; functionality; PVC drainage pipe

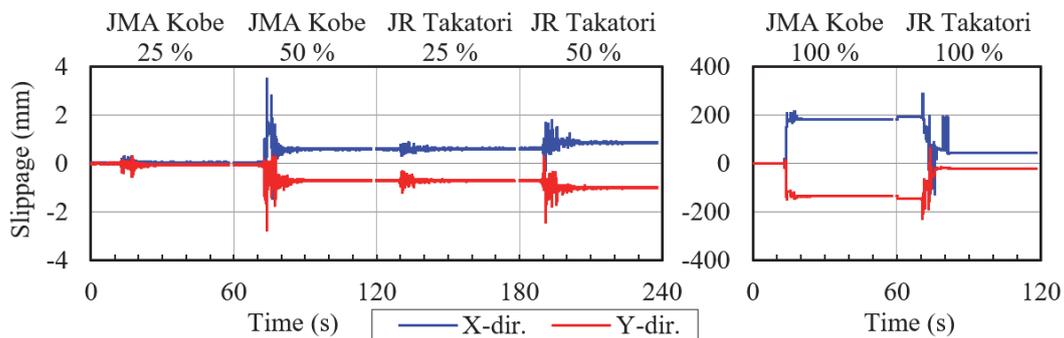
Fig. 7 – Time histories of house slippage

Time histories of foundation slippage are plotted in Fig. 7. The slippage herein is an average displacement measured by laser displacement transducers at the four corners of the house in both of the X- and Y-directions. At input of JMA Kobe 100 % and JR Takatori 100%, some of the transducers could not record the displacement in the large input motions. Also, the displacement time histories showed considerable rotation around Z-axis and rocking behavior of the house, but it is assumed that these behaviors gave minor influence to the behaviors of the pipes herein for qualitative discussion. It is noted that the motion of JR Takatori 100 % was input in horizontally reversed directions to avoid excessive accumulation of the house slippage in both of the X- and Y-directions. This figure indicates that residual slippage was less than 1 mm after the first 4 input motions, and the house significantly slipped in JMA Kobe 100% and JR Takatori 100 %.

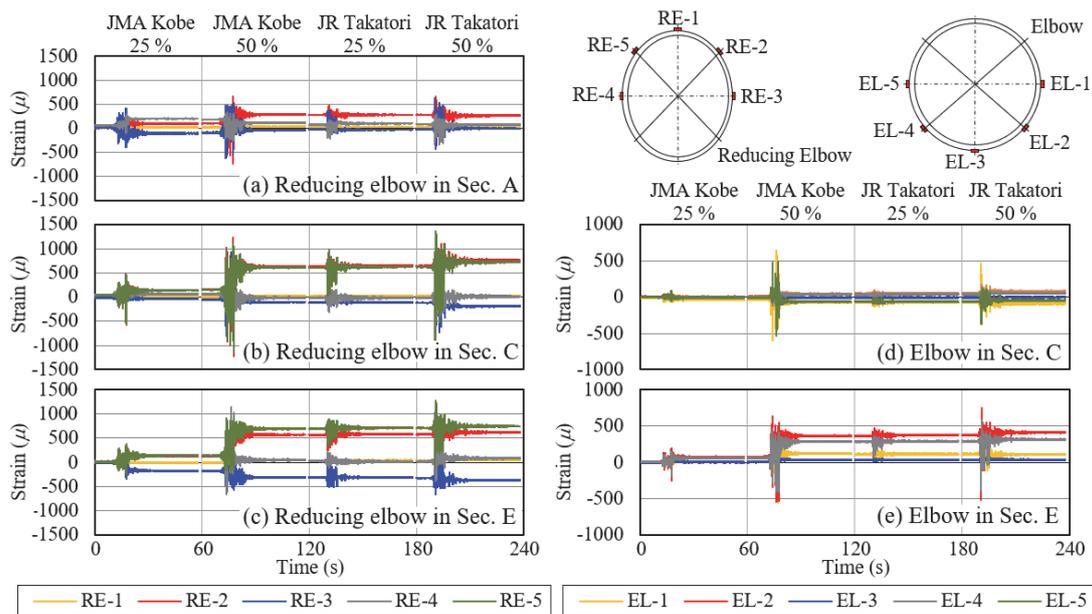
Fig. 9 – Time histories of axial strain around elbows at input of JMA Kobe 25 % to JR Takatori 50 %

Based on records obtained in the shaking table test, deformation development and failure mechanisms are discussed herein. Figs. 9a, 9b and 9c show time histories of axial strain around the reducing elbows in the first four input in Sections A, C and E, and Figs. 9d and 9e show ones around the lower elbows in Sections C and E. Strain time histories in Sections B and D showed similar tendency to ones in Sections C and E, respectively. According to these figures, the follows are drawn: 1) Axial strain in Section A was smaller than ones in the other sections. It implies that the flexible pipe and expansion joint could reduce strain around the reducing elbow, 2) Even though the house slippage was less than 1 mm, approximately 750 micro axial strain was remained in the reducing elbows in Sections C and E. In addition, insignificant axial strain appeared in the lower elbow in Section C, but about 400 micro axial strain was remained in the elbow in Section E. It implies strain along PVC drainage pipes is accumulated even in small level earthquake motions.

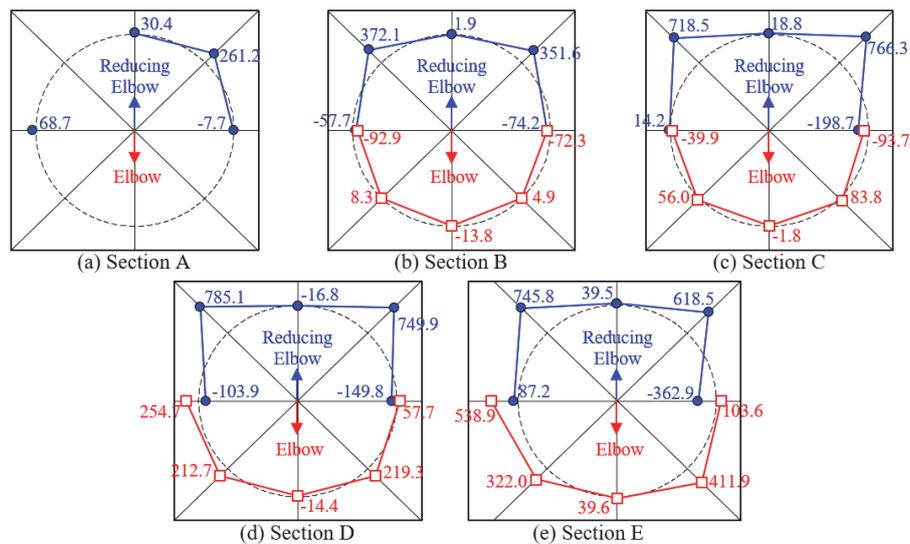
Fig. 10 – Distribution of residual axial strain around elbow portions after input of JR Takatori 50 %

Distributions of residual axial strain around the reducing elbows and the lower elbows after input of JR Takatori 50 % are plotted in Fig. 10. In this figure, the top half is distribution in the reducing elbows, and the bottom half is one in the lower elbows. It is noted that slightly larger displacement was applied to Sections D and E than to Sections A to C because of rotational component of the house slippage. The distributions indicate the follows: 1) Axial strain in Section A was considerably smaller than in the other sections. 2) In all the sections, insignificant strain appeared at the top of the reducing elbows, RE-1. On the other hand, RE-2 and RE-5 showed considerable tensile strain. 3) In all the sections with the lower elbows, EL-3 gages recorded insignificant strain. 4) Most of axial strain concentratedly appeared in the reducing elbows in Sections B and C. However, considerable axial strain was observed at EL-2 and EL-3 in the lower elbows as well as in the reducing elbows in Sections D and E. It may result from different confining pressure from the surrounding soil; that is, Sections D and E with smaller depth of embedment had smaller confinement from the soil, the lower elbows in these sections could deform more flexibly than Sections B and C. It implies the soil characteristics considerably influence to the pipe deformation and failure.

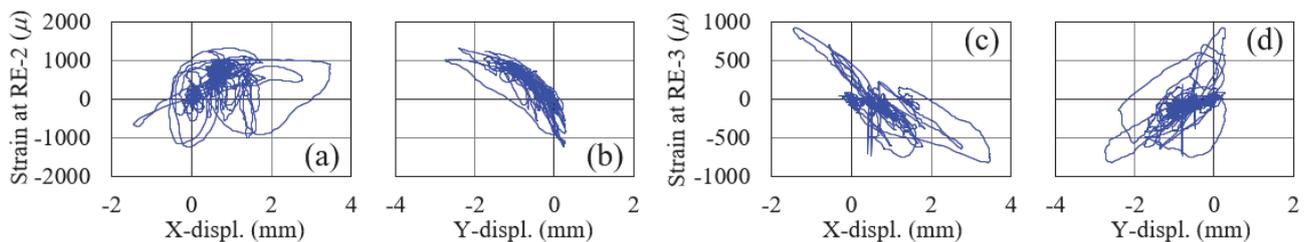
Fig. 11 – Relationship between axial strain and house slippage in Section C in the first 4 input

Fig. 11 shows relationships between axial strains at RE-2 (Figs. 11a and 11b) and RE-3 (Figs. 11c and 11d) in Section C and the house slippage in X- and Y-directions in the first four input motions. Based on this figure, the follows are drawn: 1) Axial strain at RE-2 tends to be propotional to the house slippage in Y-direction. It is noticable that tensile and compressive strain appeared in the negative and positive Y-directional slippage, respectively. 2) Axial strain at RE-3 is propotional to the slippage in X-direction. Because strain at RE-4 shows almost out-of-phase time histories with RE-3, it indicates that strain at RE-3 was induced by bending due to the house slippage in X-direction.

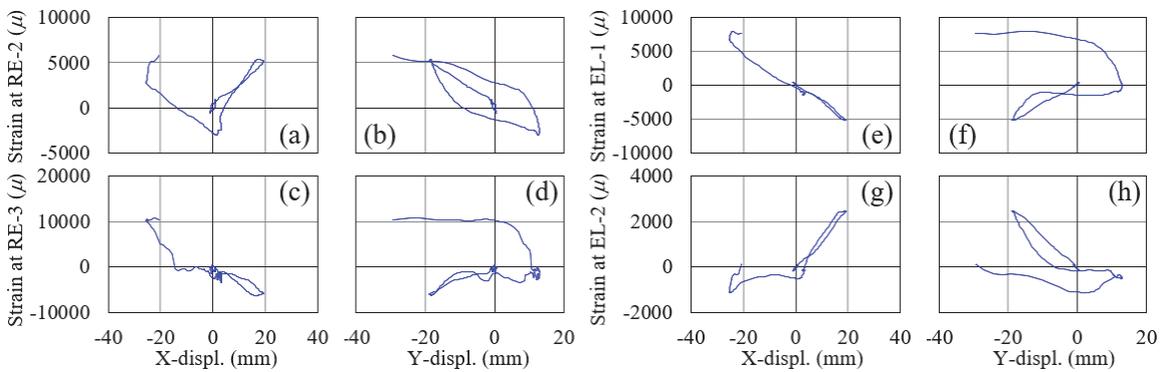
Fig. 14 – Relationship between axial strain and house slippage in Section C in JMA Kobe 100 % up to 13.8 s

Relationships between axial strain at RE-2, RE-3, EL-1 and EL2 and the house slippage in X- and Y-directions are shown in Fig. 14. All the strains tend to be highly dependent on the house slippage in X-direction. It implies deformation at gage locations was correlated to bending around the vertical axis, but it is noted that the fatal failure of the elbows was not happen in the instrumented portions as mentioned above.

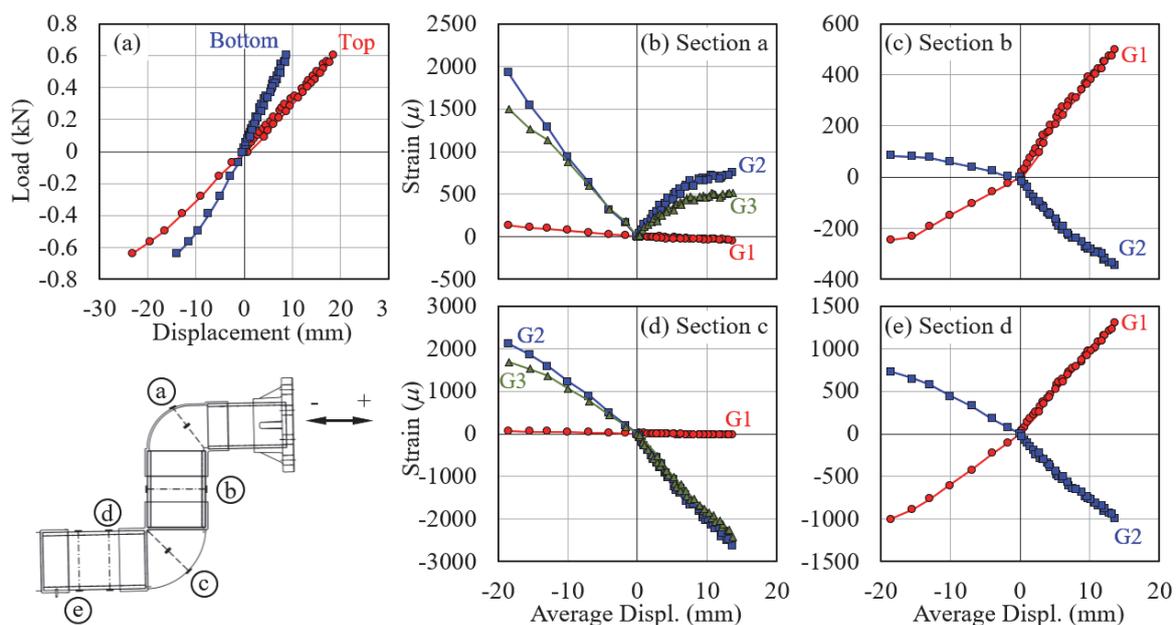
Fig. 19 – Behaviors of specimen at static loading in axial direction

Load-displacement curves at top and bottom loading points are plotted in Fig. 19a. The displacement at the top was always larger than at the bottom, and it indicates that the specimen at the loaded end were rotated. Figs. 19b to 19e show relationship between axial strain and input displacement averaged the displacements at

the top and the bottom string pots in Sections a to d. Strains in Section e showed identical tendency strains with in Section d. Based on the figure, the follows are drawn: 1) G1 gages along both of the elbow portions recorded insignificant axial strain. This tendency is similar to the results in the shaking table test. 2) The specimen was slightly less flexible at loading in pushing direction than in pulling direction as shown in Fig. 19c. It is probably because of its crank-shaped geometry of the PVC drainage. 3) Both sides of the reducing elbow are always in tension (G2 and G3 in Fig. 19b). These gages corresponded to RE-3 and RE-4 in the shaking table test and these gages also recorded compressive strain (refer to Fig. 9). It may result from bending due to the house slippage in X-direction in the shaking table test. In addition, the boundary condition at the house foundation may be another possible reason on the compressive strain.

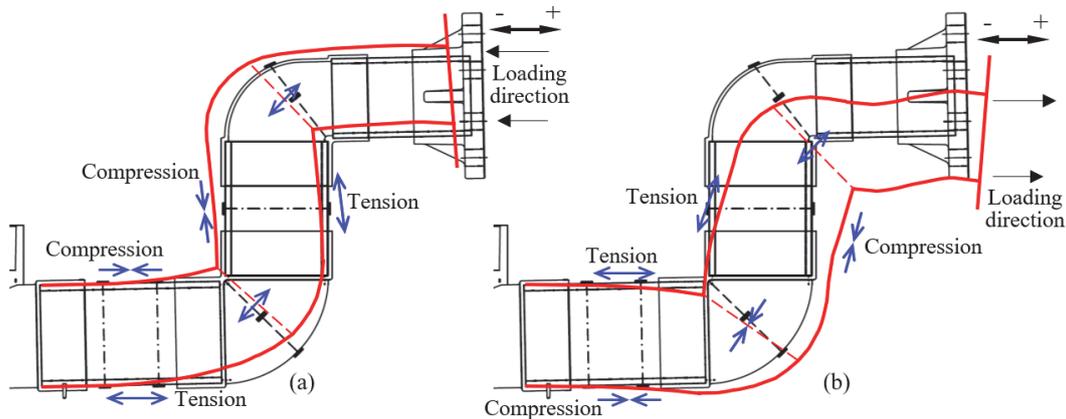
Fig. 20 – Deformation of PVC drainage at static loading in axial direction

Fig. 20 illustrates deformation shape of the PVC drainage specimen in the static loading test. Because actual PVC drainage pipes are usually embedded in the soil, they are less flexible due to confinement from the surrounding soil. Intensity of the confinement is related to the surrounding soil, and therefore, it should be noted that the most critical portion of the PVC drainage may be dependent on characteristics of the soil.
