NONLINEAR DYNAMIC ANALYSIS OF AN INFILLED RC FRAME BUILDING DURING THE 2016, MUISNE, ECUADOR EARTHQUAKE

Abstract

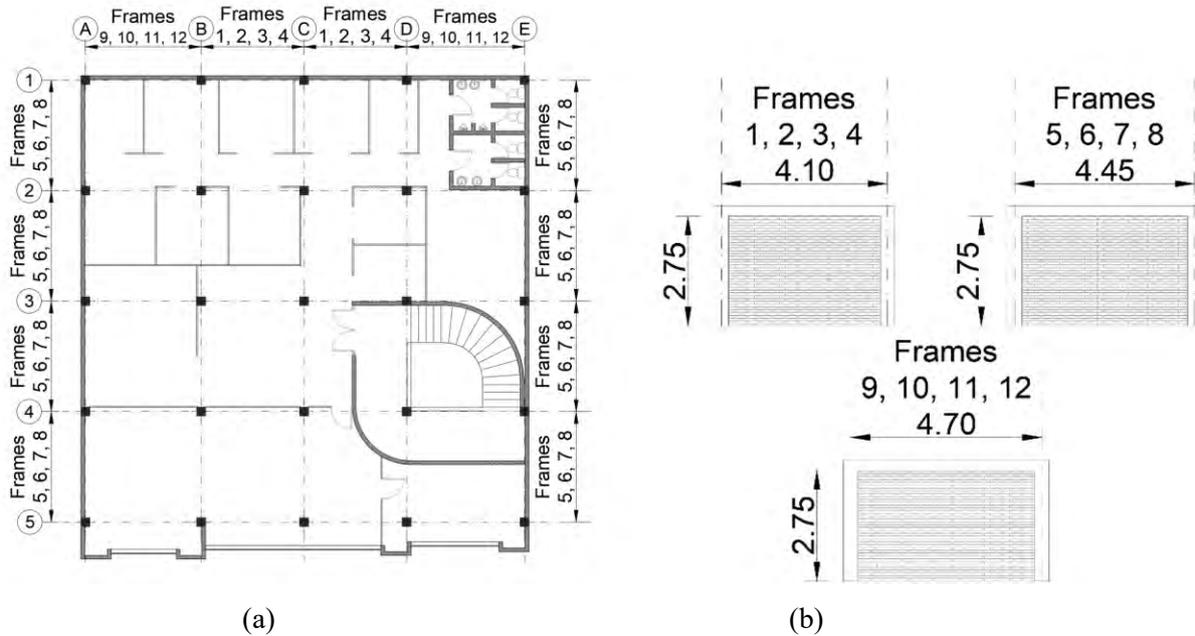
lower levels. That is, several single-bay, single-story models were built. Frames 1, 5, and 9 correspond to the fourth story. Frames 2, 6 and 10 correspond to the third story. Frames 3, 7 and 11 correspond to the second story. Frames 4, 8 and 12 correspond to the first floor. The classification of the different infilled frames is explained further in Figure 3. The estimated force-displacement curves for each frame are shown in Figure 4.

Fig. 3 – (a) Classification of infilled frame, plan view (b) Infilled frame types

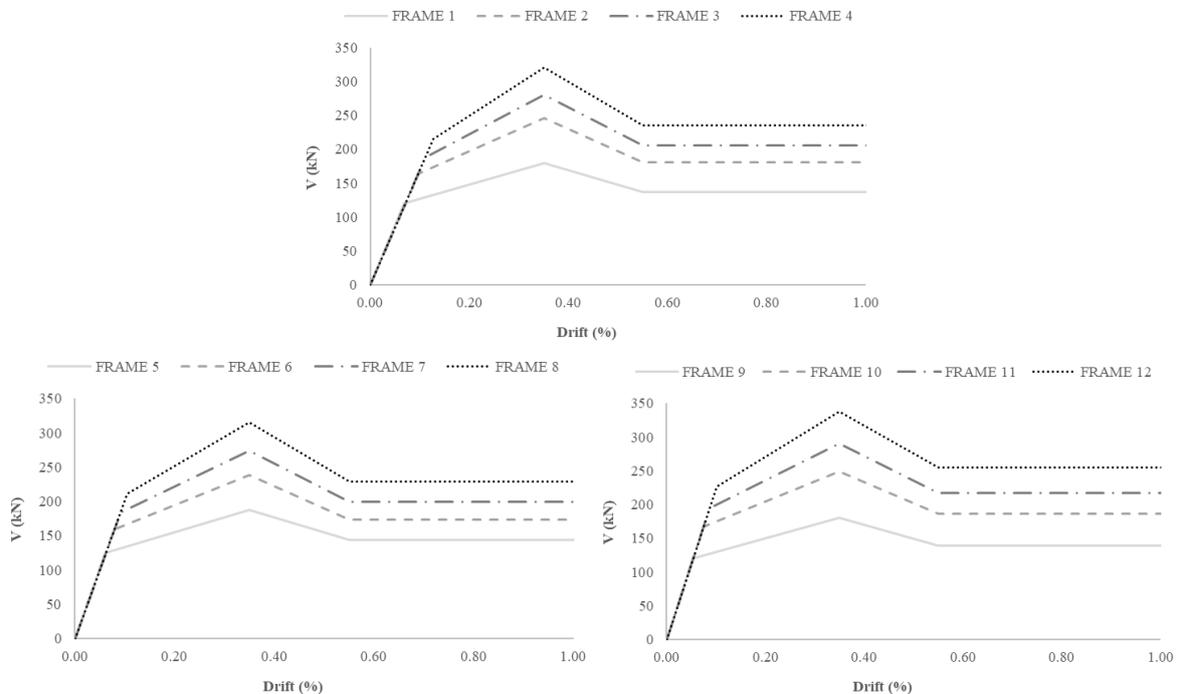
Fig. 4 – Lateral force-vs.-drift curves for the different infilled frame types

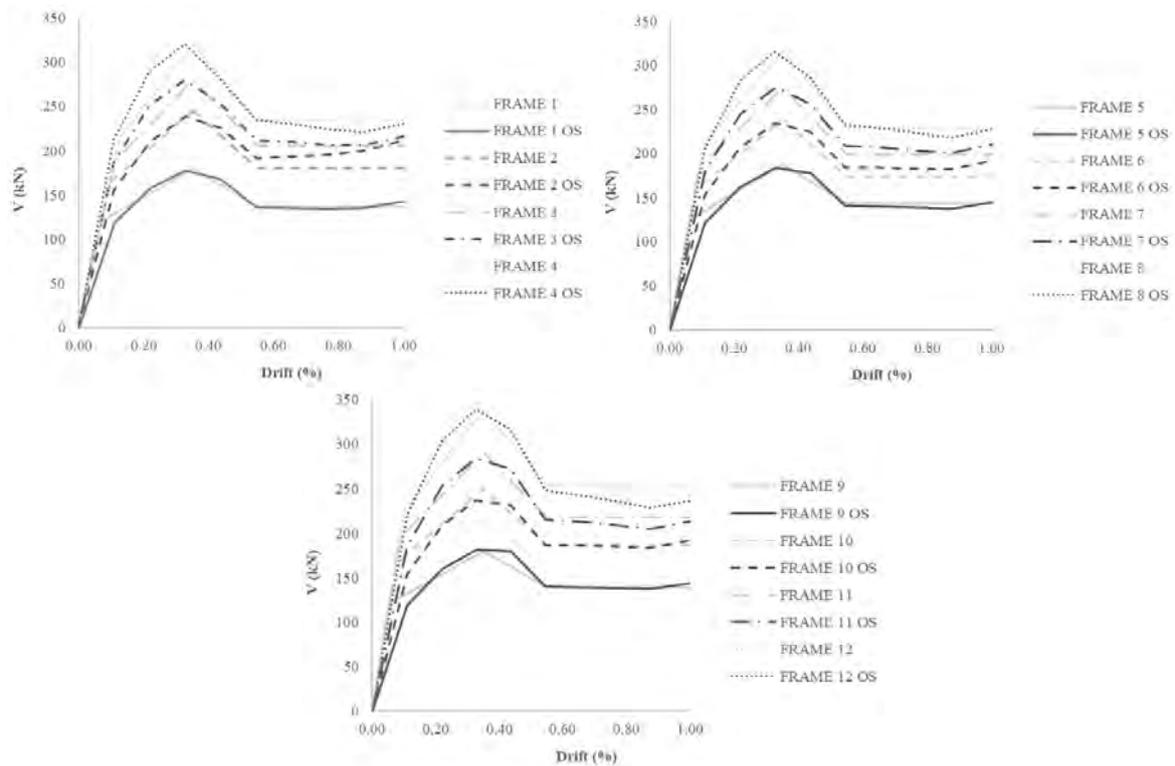
One model for each single-bay, single-story infilled frame shown in Figure 3.b is built using OpenSees [14]. The masonry is represented by a diagonal strut, modeled by a truss element. The width of the strut was the same as the thickness of the wall. The height of the strut was calibrated to best approximate the backbone curves of Figure 4. Columns and beams were modeled as displacement-based inelastic beam-column elements. Both, the frame and infill, are modeled using distributed-plasticity fiber sections and Concrete02 material. Rebar is modeled using Steel02 material. Table 4 and 5 presents the material properties used for the analysis. Figure 5 compares the curves obtained following ASCE 41 and the curves calibrated using OpenSees .

Fig. 5 – Calibrated lateral force-vs.-drift curves for the different infilled frame types

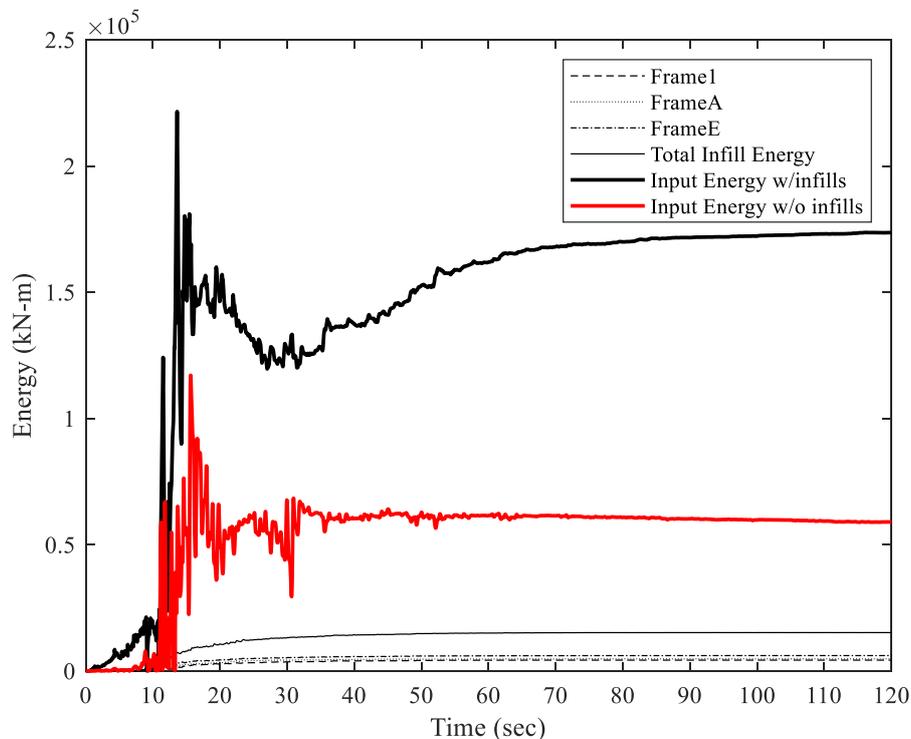
Finally, the input energy time histories of the model with and without the infills is presented in Figure 10. The contribution from each infilled frame and the total contribution from the infills is also shown.

Fig. 10 – Energy Time-Histories

The amplification in the input energy for the infilled-frames model responds to the resonance effect that arose due to the similarity in the period of the soil, 0.65 sec, the period of the building, 0.67 sec, and the
