Experimental Seismic Test of Drywall Partition Walls with Improved Detailing for Damage Reduction

R. Ryan⁽¹⁾, H. Hasani⁽²⁾

Abstract

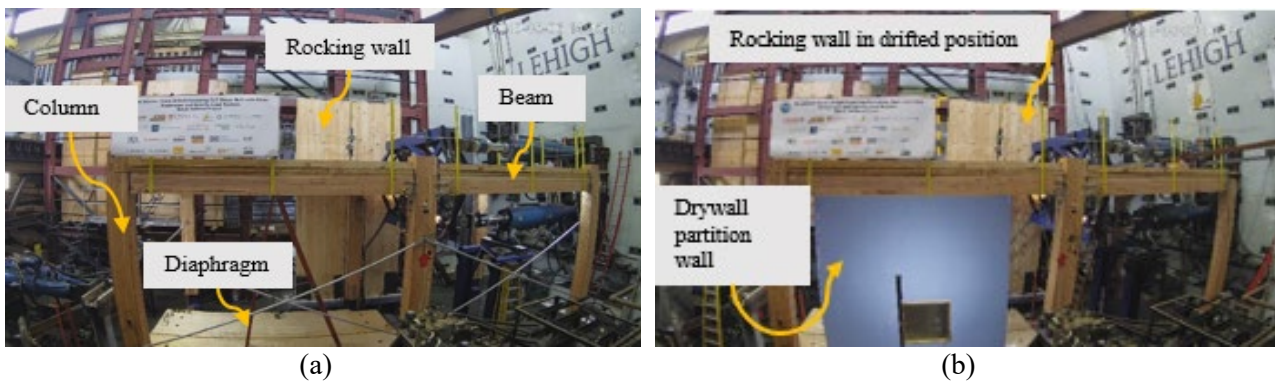
Fig. 1: (a) Testbed structure; (b) testbed structure with drywall partition walls subjected to 5% drift

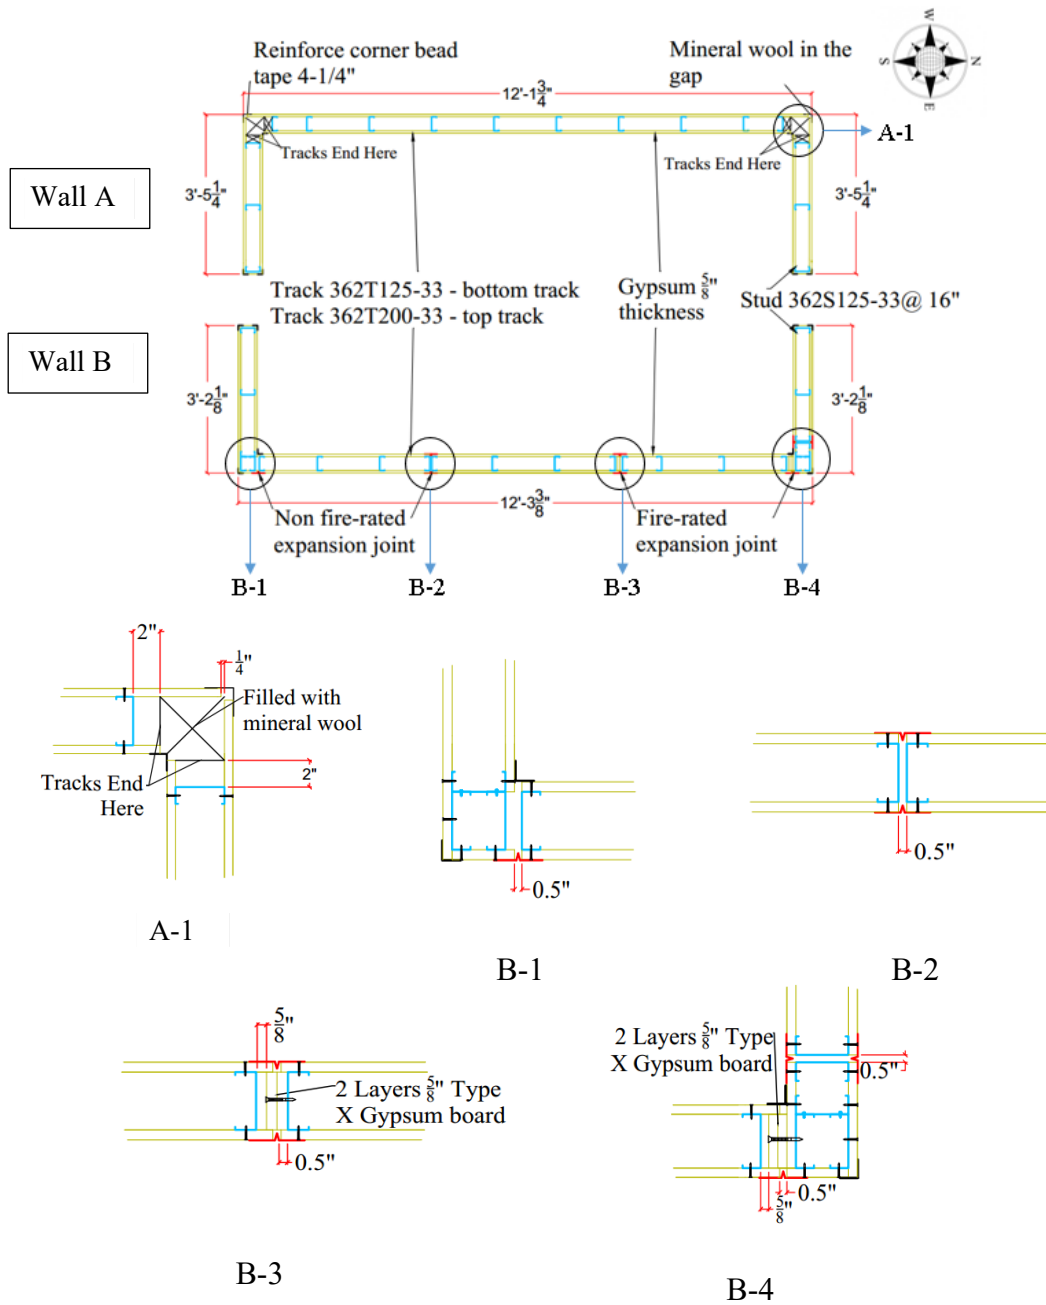
Fig. 4: Drywall partition walls with different detailing: Wall A = corner gap and Wall B = distributed gap; (A-1) corner gap detail; (B-1) wall intersection non-fire rated expansion joint; (B-2) interior non-fire-rated expansion joint; (B-3) interior fire-rated expansion joint; (B-4) wall intersection fire-rated expansion joint.

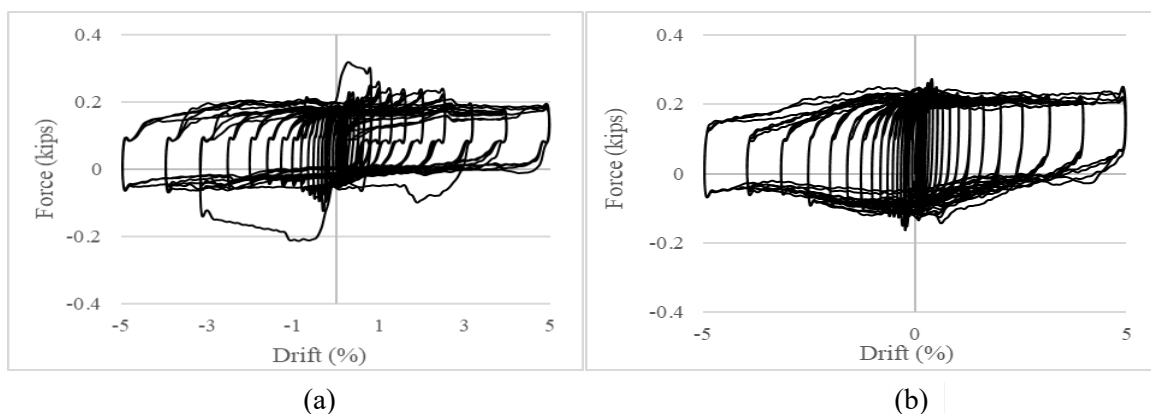
The force vs. displacement hysteresis loops of the partition walls are used to validate the damage observations and evaluate ductility capacity. Fig. 13 shows the hysteresis loops of the Phase 1 walls; the wall with slip-track detailing in Fig. 13a and telescoping detailing in Fig. 13b. The hysteresis loops show that both walls developed approximately similar forces because both walls have slip behavior at the top. Moreover, the hysteresis loops suggest that the out-of-plane drift of the drywall partition does not affect the in-plane force of the wall considerably. The slip track wall hysteresis loops exhibited a few sudden increases in the force, which coincided with the occurrence of damage to the framing of this wall mentioned earlier.

Fig. 13: Phase 1 force vs. displacement hysteresis of drywall partition walls: (a) slip track detailing; (b) telescoping detailing

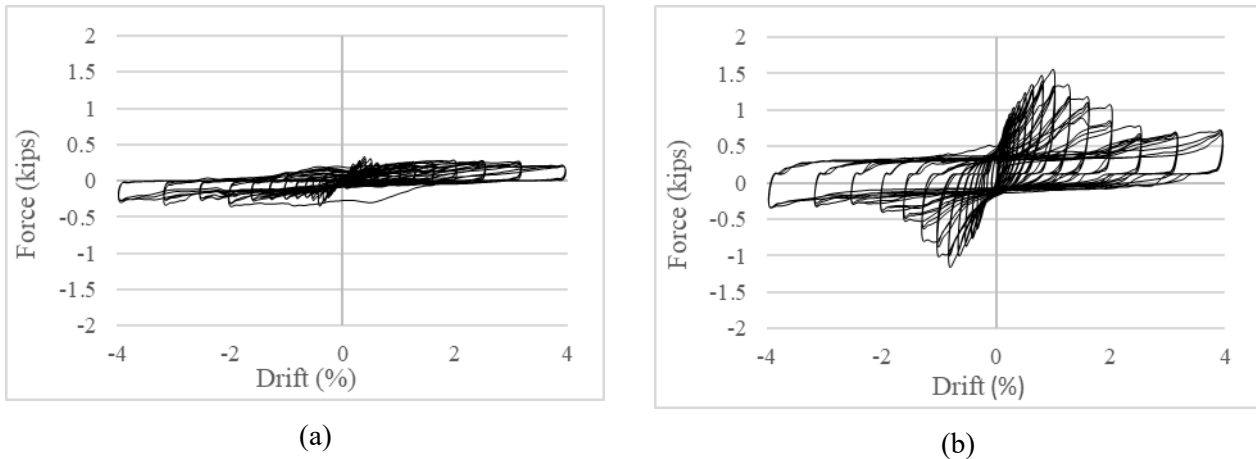
Fig. 14 shows the hysteresis loops of the corner gap wall (Fig. 14a) and the distributed gap wall (Fig. 14b). Based on these hysteresis plots, the forces that developed in the corner gap wall were much lower than in the distributed gap wall because the distributed gap detailing behaved like an ordinary wall intersection after the expansion joints closed. As shown in Fig. 14b, the forces dropped substantially in the distributed gap wall after about 1% drift.

Fig. 14: Phase 2 hysteresis of drywall partition walls: (a) corner gap; (b) distributed gap

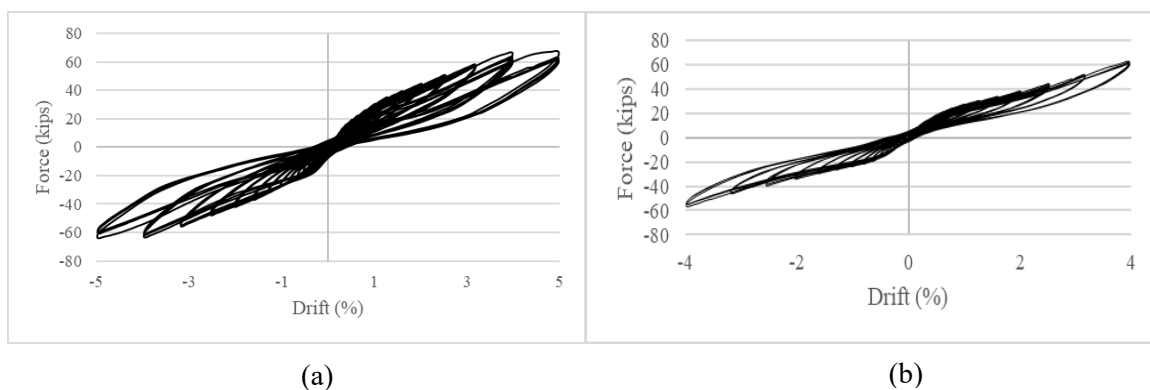
The hysteresis loops of the entire subassembly (CLT rocking walls and partition walls) for both phases are shown in Fig. 15. In Phase 1, the partition walls contributed less than 1% to the whole subassembly force (Fig. 15a). In Phase 2, the partition walls contributed less than 3% to the total force (Fig. 15b). The resistance in Phase 2 increased due to the impeding effect of the return walls but was still insignificant compared to the CLT rocking walls. Furthermore, in both phases, the rocking walls were damaged from the previous phases, which would effectively lower their resistance and increase the relative resistance of the partition walls. Thus, in a large earthquake with an initially undamaged lateral system, the resistance of the partition walls is practically negligible, and need not be accounted for in the design of the lateral system.

Fig. 15: Hysteresis loops of building in the in-plane direction: (a) Phase 1, (b) Phase 2
