REHABILITATION AND ADAPTIVE REUSE OF THE HISTORIC 1940s HOWARD HUGHES WOODEN AIRCRAFT HANGAR

P. Noll⁽¹⁾, S. Rees⁽²⁾, R. Pallmann⁽³⁾ and A. Jiras⁽⁴⁾

Keywords: Adaptive Reuse; Rehabilitation; Seismic Retrofit; Glulam; Historic Building;

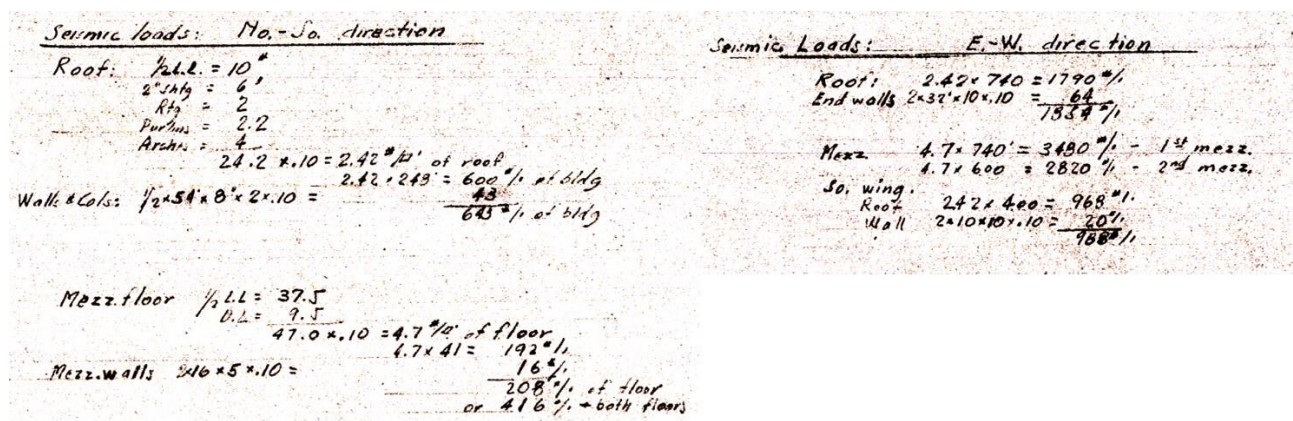
The existing building, designed in early 1940s, was designed for a lateral load equal to 10% of the self-weight of the structure ($0.1g$, see Fig. 2).

Fig. 2 - Extract from the 1940s calculations, showing the seismic load of $0.1g$

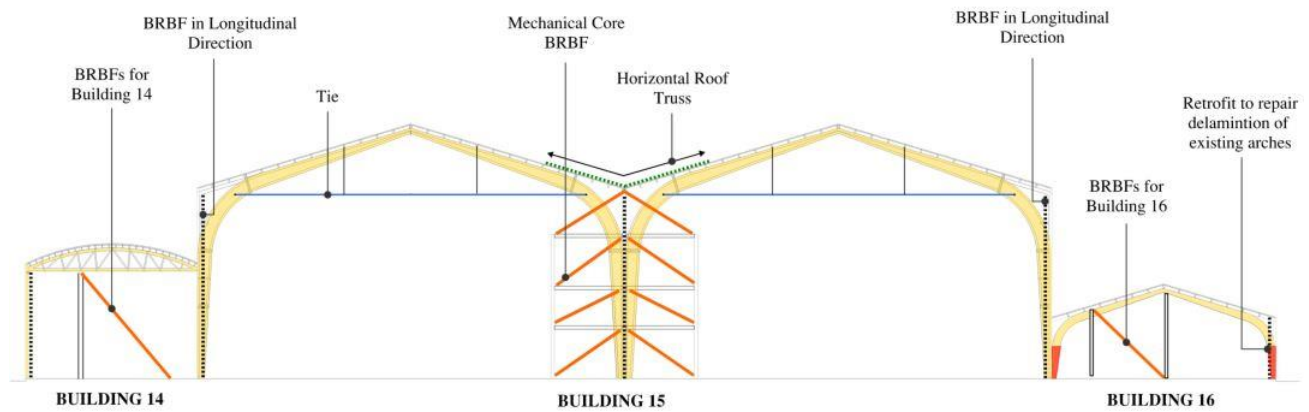
Fig. 4 - Building Cross section with Retrofit scheme

The cross section (Fig. 4) and isometric (Fig. 5) summarizes the retrofit scheme for Hangers B14, B15 and B16 and show the BRBF locations for the new SFRS of the existing structure. The new structure within the building is not shown in figures for clarity.

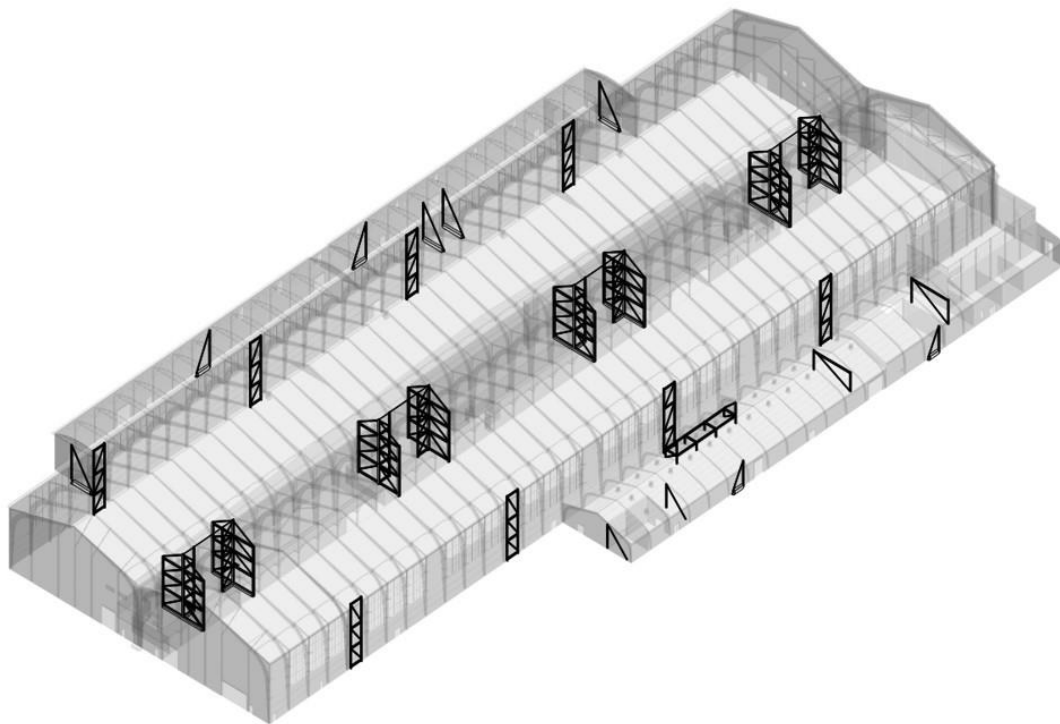
Fig. 5 - Building Isometric with layout of Retrofit BRBF locations

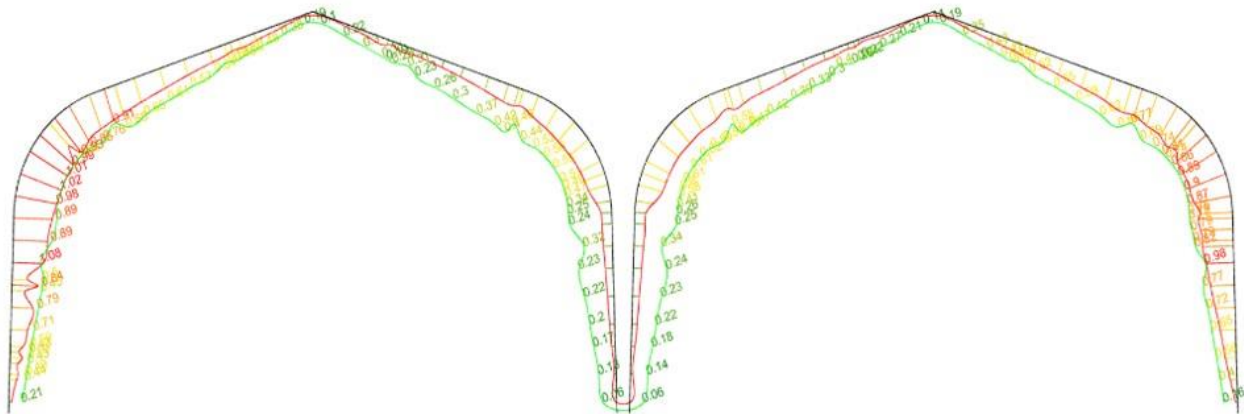
Visualization templates were used to present the analysis and design results, facilitating and accelerating the design process and permit process. Analysis results from the ETABS[®] model of the entire existing structure were post-processed in Grasshopper and Rhino to create a stress distribution envelope of the glue laminated arches over the 38 gridlines. The final representation was one cross section (Fig. 6), allowing for simple verification that all stresses were below the capacity limit.

Fig. 6 - DCR envelope of all Glulam arches at all Gridlines

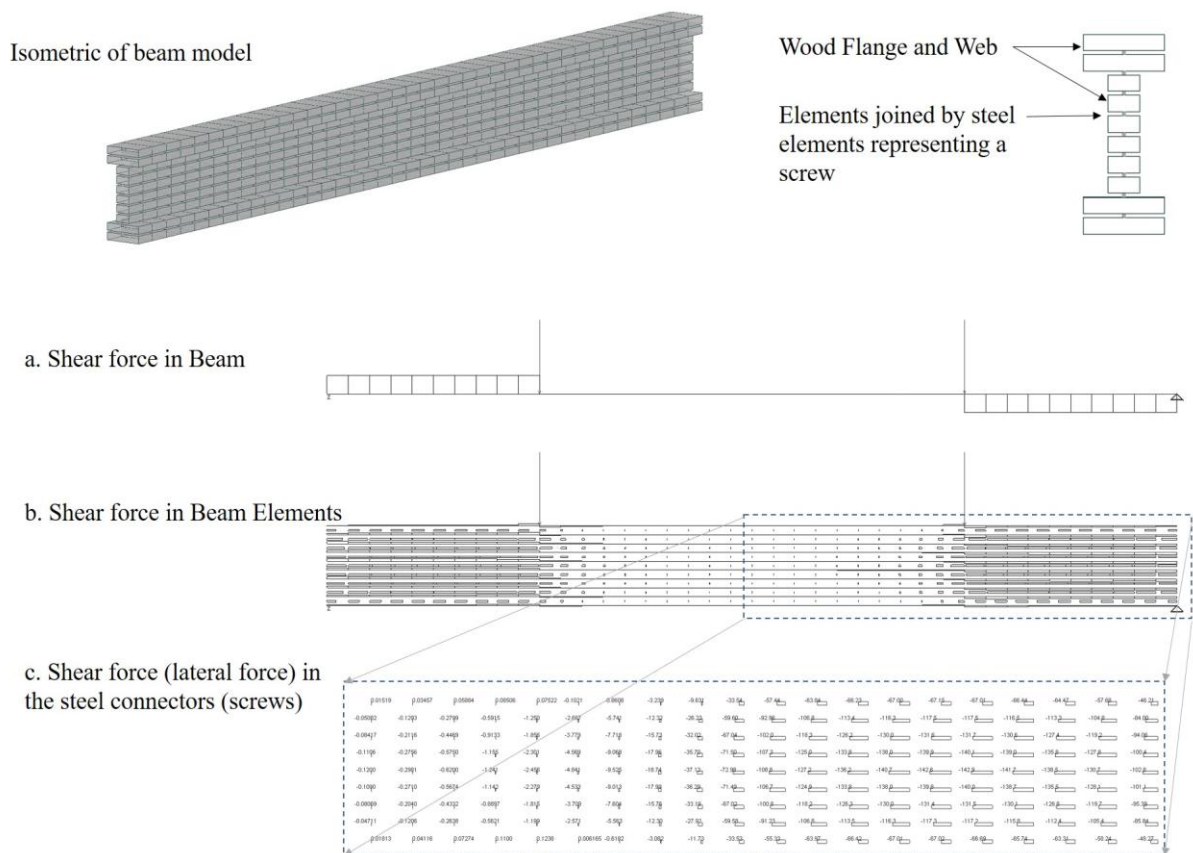
Fig. 8 - Simplified Beam model for group action factor clarification

Arup prepared detailed study models to show that the group action factor C_g applicable to a typical tension connection does not apply to the repair of glulam delamination. The analysis shows that in a repair situation (bending in the beam) the connectors are subject to very similar forces and there is no amplification of the force in the outermost connectors, which would require the reduction. These findings are in line with the findings about shear keys in mechanically laminated beams by Miller et al [9]. Fig. 8 shows the shear distribution in a beam and the shear connectors of a beam subject to bending, which is also the expected stress distribution for a repair of the glulam beam delamination.
