# INVESTIGATION AND ANALYSIS OF LIQUEFACTION-INDUCED DEBRIS FLOWS IN PALU, INDONESIA FOLLOWING THE 28<sup>TH</sup> SEPTEMBER 2018 CENTRAL SULAWESI EARTHQUAKE

R. Lagesse<sup>(1)</sup>, A. Brennan<sup>(2)</sup>, I. Rusydy<sup>(3)</sup>

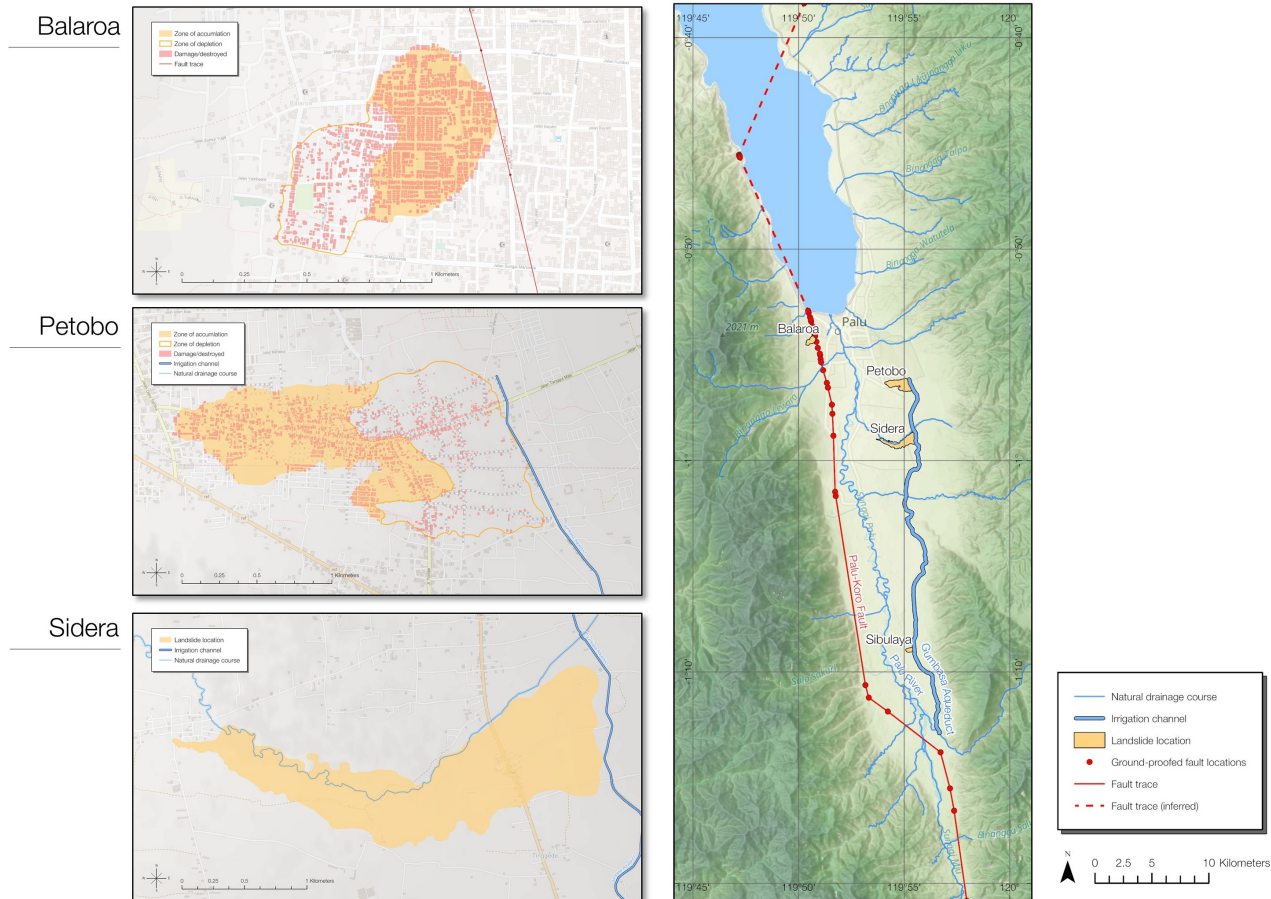
occurring to the south of the epicentre. The field investigation conducted detailed mapping of the fault rupture (Fig. 1) and confirmed that the rupture runs along the western side of Palu Valley, where displacements were at their largest. In addition to the large displacements caused by the fault rupture, significant ground shaking occurred in the valley where peak ground accelerations (PGA) are estimated to have reached 0.5 to 0.6 g during the main shock [2] [3].

Fig. 1 – Location map of Palu Valley showing Palu-Koro Fault, landslide locations, natural watercourses and the Gumbasa Aqueduct (*right*). Insets for each landslide (*left*).

It is notable that both the Petobo and Sidera landslides, as well as a much smaller (but still significant) failure in the town of Sibulaya to the south, all initiated along the irrigation channel (Fig. 1). Eyewitnesses remarked that prior to the earthquake the irrigation channel was full of water and rapidly emptied during the
