THE SURA POST-EARTHQUAKE ASSESSMENT METHODOLOGY. CASE STUDY: M7.1 MEXICO EARTHQUAKE, 2017

M.J. Barrera⁽¹⁾, V. Gonzalez⁽²⁾, E. Cardona⁽³⁾, G.M. Estrada⁽⁴⁾, J.D. Rendon⁽⁵⁾

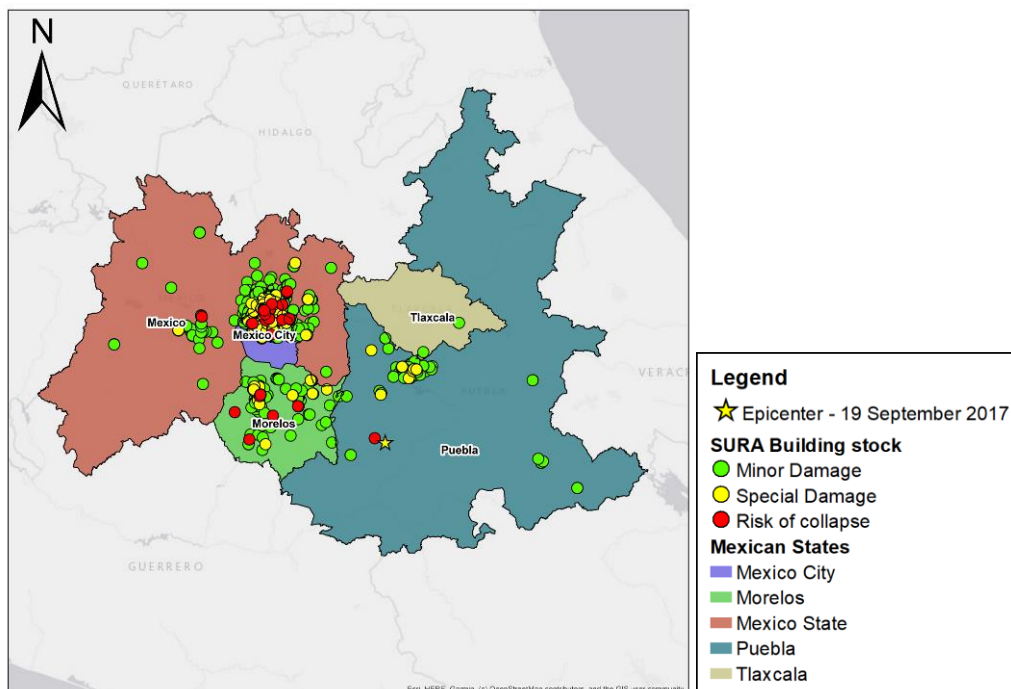
2114 structures were assessed during the implementation of the SURA Post-Event Structural Assessment Methodology in Mexico. Most of these structures were located in Mexico City, while a smaller portion were located in the states of Mexico, Morelos, Puebla and Tlaxcala. Fig. 1 presents the geographic distribution of the assessed structures.

Fig. 1 – Location of structures assessed by SURA according to damage classification
