SEISMIC EVALUATION OF NON-DUCTILE REINFORCED CONCRETE SMALL HOUSES

P. Rojas⁽¹⁾, F. Grau⁽¹⁾, J. Taylor⁽²⁾, E. Reuter⁽³⁾, J. Gonzalez⁽¹⁾, W. Loja⁽¹⁾

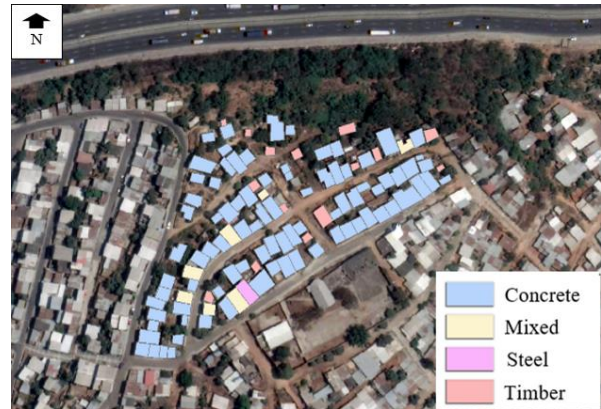
(b) Close-up view of the selected study area [5]

Bastión Popular was selected from other alternatives due to its steep slopes, presence of natural terrain that facilitates soil borings, and prior landslides. At noon of March 13, 2019, a covacha was buried with two people inside due to a landslide caused by the heavy rain that fell in Guayaquil on the night of Tuesday the 12th [6]. The landslide occurred in Block # 11 of the Floor de Bastion area very close to the selected zone. Bastión Popular area selected for the study has 5 blocks, and a total of 109 houses. Fig. 3(a) shows the aerial view, while Fig. 3(b) shows a close-up view of the common houses found on inspection.

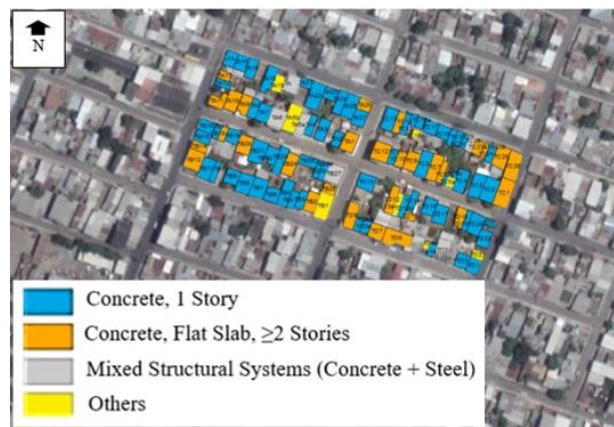
(b) Close-up view of the selected study area [5]

Trinitaria was selected due to the presence of soft soil and proximity to the estuary. This area has 4 blocks, and a total of 111 houses. Fig. 4(a) shows the aerial view, while Fig. 4(b) shows a close-up view of the common houses found on inspection.

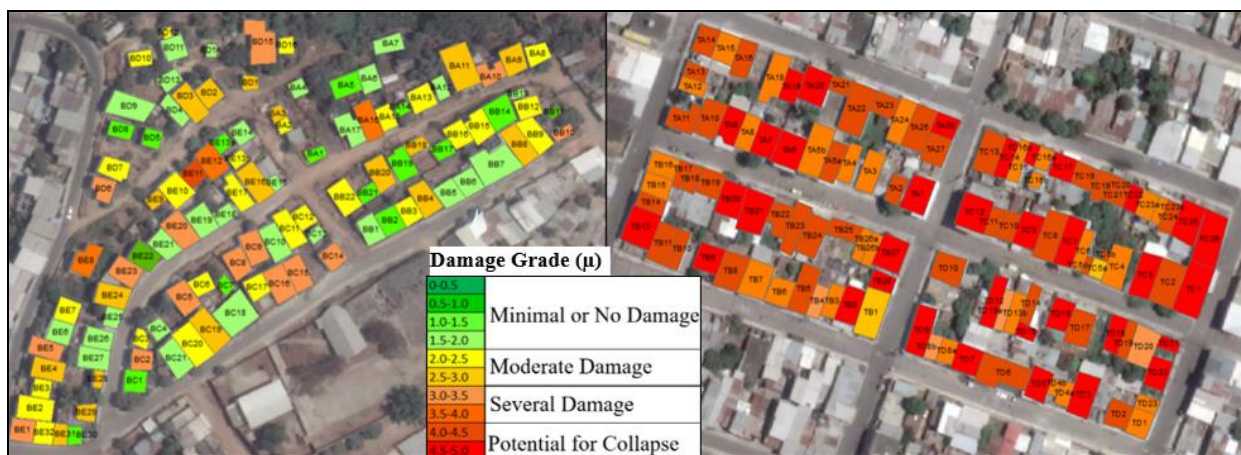
Fig. 12 – Damage Based on RADIUS Design Earthquake

Fig. 12(a) shows the Bastión level of damage for a VII seismic intensity. 1% and 17% of the houses may experience potential for collapse and severe damage, respectively. 42% and 40% of the houses may experience moderate or minimal (or no) damage, respectively. Fig. 12(b) shows the Trinitaria level of damage for a VIII seismic intensity. 70% and 28% of the houses may experience potential for collapse and severe damage, respectively. 2% of the houses may experience moderate damage. Therefore, it can be concluded that for the RADIUS design earthquake, the Trinitaria area is more likely to experience significant damage compared to the Bastión area.

a) Bastión Popular: Intensity VII

b) Trinitaria: Intensity VIII
