STUDY ON THE DISASTER INVESTIGATION OF RC BUILDING UTILIZING UAV

The investigated building is the RC government office building that was damaged by the 2016 Kumamoto earthquake. It is a three-story RC structure built in 1974. The longitudinal direction is a moment resisting frame structure, and the short direction is a frame with shear walls. In 2010, seismic reinforcement was performed by installing a steel braces with frames. Due to the 2016 Kumamoto earthquake, in the longitudinal direction, it was confirmed that the column was slightly cracked, and the painting of steel braces with frames were partly peeled off. In the short direction, shear failure of the shear wall and shear failure of the short beams were confirmed.

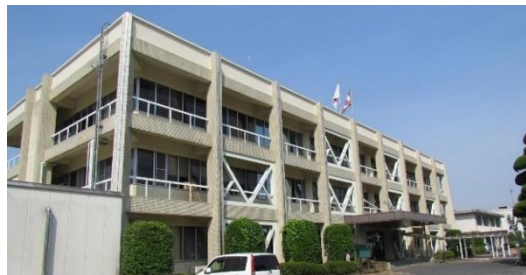
Fig. 1 shows the exterior of the objective building of investigation. The objective building was a government building located in Kamimashiki-gun, Kumamoto Prefecture, which was damaged by the 2016 Kumamoto Earthquake in April 2016. It is a RC building constructed in 1974 with three floors above ground, one underground, and one floor of a tower. It has a 9-span moment resisting frame structure in the longitudinal direction, and a 3-span frame structure with shear walls in the short direction. In 2010, seismic reinforcement was performed by installing a steel braces with frames..

Fig. 1 – Exterior of the objective building
