PHOTO-INTERPRETATION OF BUILDING DAMAGE DUE TO EARTHQUAKES USING AERIAL PHOTOGRAPHS

Naoki OGAWA¹ and Fumio YAMAZAKI²

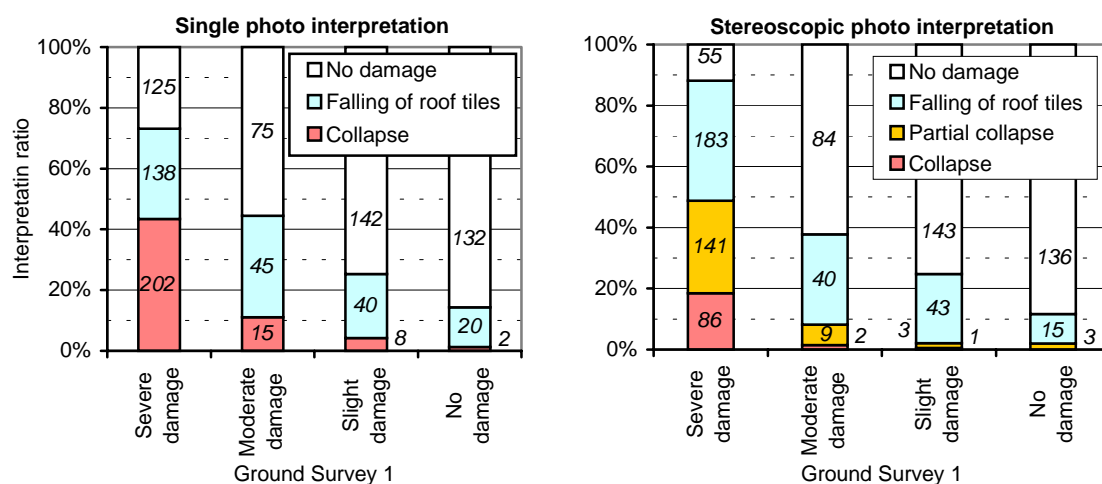
Figure 2: Relationship between the results of Ground Survey 1 and aerial photo-interpretations

Building damage was found in 472 (50%) of 946 buildings by single photo-interpretation. Among these, “collapse” applied to 227 buildings (24%) and “falling of roof tiles” to 244 buildings (26%). Building damage was detected in 528 (56%) of 946 buildings by stereoscopic photo-interpretation. Among these, “collapse” applied to 89 buildings (9%), “partial collapse” to 157 buildings (17%) and “falling of roof tiles” to 281 buildings (29%). The relationship between Ground Survey 1 and the aerial photo-interpretation is shown in Figure 2. Comparing the result of photo-interpretations with that of Ground Survey 1, single photo-interpretation and stereoscopic photo-interpretation showed almost the same tendency.

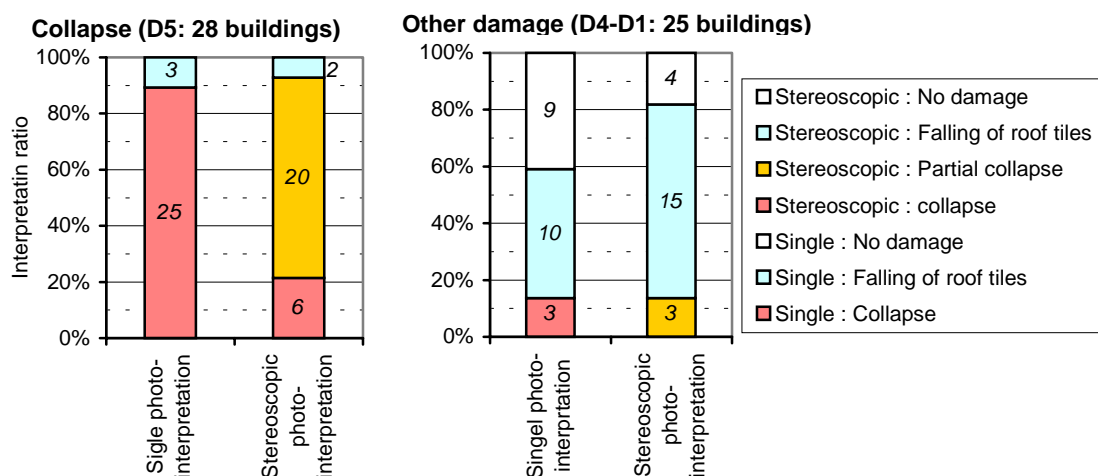
Figure 3: Comparison of the result of ground photo-interpretation, divided into “collapse (D5)” and the other damage levels (D4-D1), with that of aerial photo-interpretation

In order to evaluate the results of aerial photo-interpretation for collapsed buildings, a comparison with the ground photographs was conducted. The relationship between the results of interpretations from ground photographs and aerial photographs is shown in Table 3. The results of the ground photo-interpretation, divided into “collapse (D5)” and the other damage levels (D4-D1), were compared with the results of aerial photo-interpretations, as shown in Figure 3. For “collapse (D5)” by the ground photographs, “collapse” by single photo-interpretation and “collapse” and “partial collapse” by stereoscopic photo-interpretation are almost the same number. The rates of determination of “collapse (D5)” in both single and stereoscopic photo-interpretations are high at about 90%. For other damage levels (D4-D1), although about 10% of damage were mistaken as “collapse” for both single and stereoscopic photo-interpretations, most of the damage was identified as “falling of roof tiles”. In summary, collapsed buildings could be correctly identified but less severely damaged buildings could not by aerial photo-interpretation.

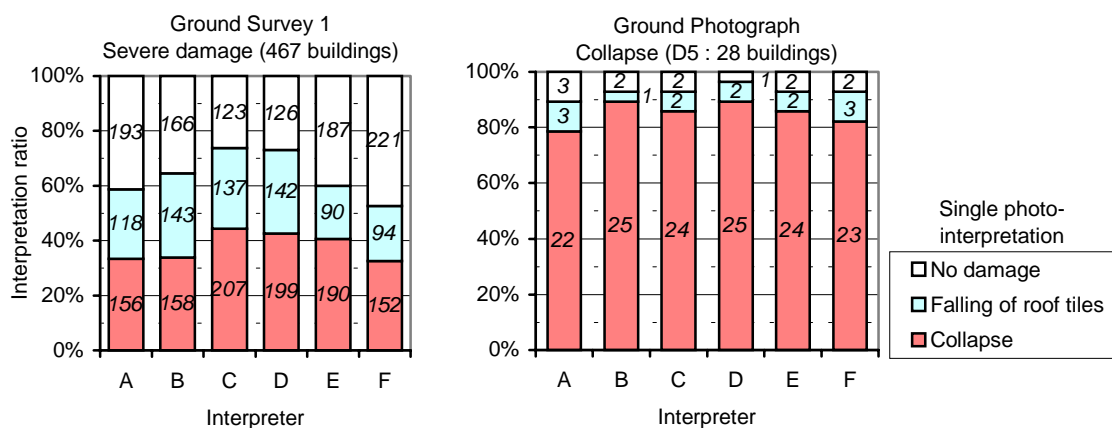
Figure 4: The results of building damage interpreted by six people were compared with those of Ground Survey 1 and ground photographs

Similarly, the results of building damage interpreted by six people were compared with those of Ground Survey 1 and ground photographs as shown in Figure 4. In this figure, the comparison of the six interpreters for “severe damage” in Ground Survey 1 and “collapse (D5)” of the ground photographs are shown. These interpreters are civil/structural engineers having experience of more than a few years. Damage at least to same extent was detected from 50 to 70% of the buildings for “severe damage” in Ground Survey 1. However, for “collapse (D5)” buildings in the ground photographs, about 80-90% buildings were detected correctly by the six interpreters and little variation was seen in their results. Although not shown in this figure, for the other damage (D4-D1) categories in the ground photographs, the rate of damage detection was 40 to 70% and a large individual variation was observed.

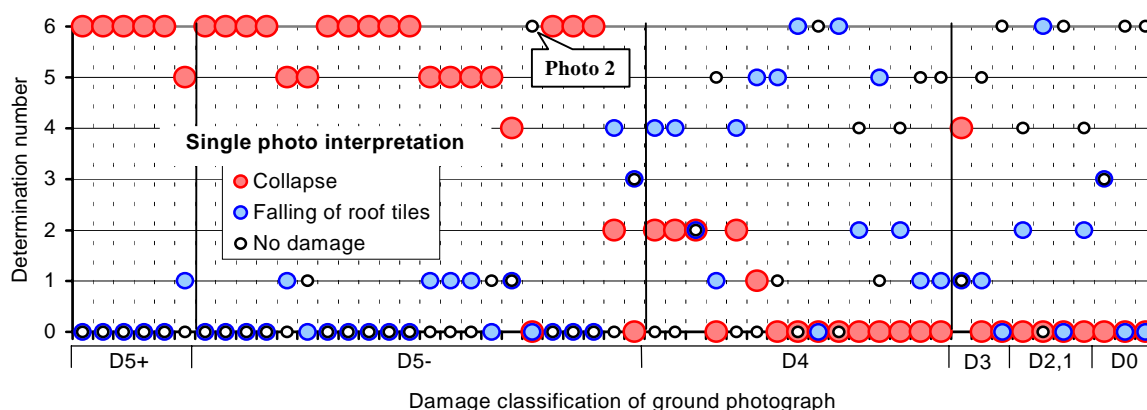
Figure 5: Damage classification and number of persons who determined that damage class

Next, the damage classification and the number of persons who determined that damage class are shown in Figure 5 for the 53 buildings with ground photographs. For “collapse (D5)”, most buildings (25 out of 28) were correctly identified by 5-6 people, indicating that the identification of “collapse” does not vary much. For “collapse (D5)”, only one building was interpreted as “no damage” by all the interpreters. For this building, it is clear in Photo 2 that the second story had almost no deformation while the first story was completely crushed. Since the side view of the building was not clearly visible in the aerial photograph, the building looked undamaged. This result demonstrates the limitation of building damage interpretation from aerial photographs. For the similar reason, the results of the aerial photo-interpretation also varied for other damage levels (D4-D1).

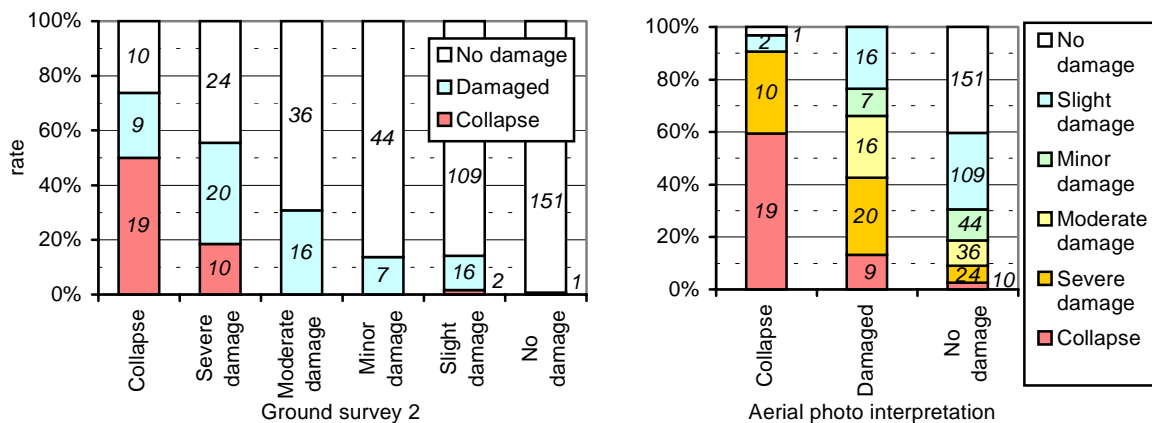
Figure 6: Relationship between the results of Ground Survey 2 and single photo-interpretation

Building damage was found in 100 (21%) out of 474 buildings by single photo-interpretation. Among those, “collapse” applied to 32 buildings (7%) and “damaged” to 68 buildings (14%). The relationship between the results of Ground Survey 2 and the aerial photo-interpretation is shown in Figure 6. In Ground Survey 2, although the rate of damage detection for “collapse” was comparatively highly as 74%, “severe damage” was 56% and damage classifications smaller than these were 40% or less. Most of “collapse” buildings interpreted from the aerial photographs were “collapse” and “severe damage” in Ground Survey 2. Those ratios of correct interpretation were low compared with those for “collapse” buildings in the wooden building area. Damage patterns differ significantly between non-wooden buildings and wooden buildings. For non-wooden buildings, complete collapse as seen in wooden buildings is rare while the collapse of a middle story and destruction of the lowest story are often observed for non-wooden buildings. In damage determination of non-wooden buildings, the side views of the buildings were important. Thus aerial photographs of a scale larger than that used for the damage interpretation of the wooden building area was used. However, information on the sides of buildings may not be obtained, depending on the position of buildings in photographs, the density of buildings, and the height of buildings. Hence, the rate of determination of damage was lower than that for wooden buildings.
