## A STUDY ON DAMAGE TO STEEL PIPE PILE FOUNDATION ON RECLAIMED LAND DURING HYOGO-KEN-NANBU EARTHQUAKE

Damage investigation was conducted on steel pipe pile foundations damaged during the 1995 Hyogoken-Nambu earthquake. The investigation site was located about 100m from both north and west quay walls. According to the damage investigation, piles were deformed at two levels. One-dimensional effective stress analysis and soil-pile-structure interaction analysis by a simple spring-mass model considering liquefaction were performed to examine the behavior of the ground and structure during the earthquake. The analytical model was set in detail based on the results of soil investigations, laboratory test and design documents of the structure. According to the one-dimensional effective stress analysis, it is considered that reclaimed decomposed granite soil, "Masado," below the ground water level liquefied. In soil-pile-structure interaction analysis, large bending moments over the full plastic moment appeared around G.L.-6m near the boundary of shear wave velocity in reclaimed layer, and around G.L.-15m, the lower boundary of Masado layer, during the main phases of the earthquake. The

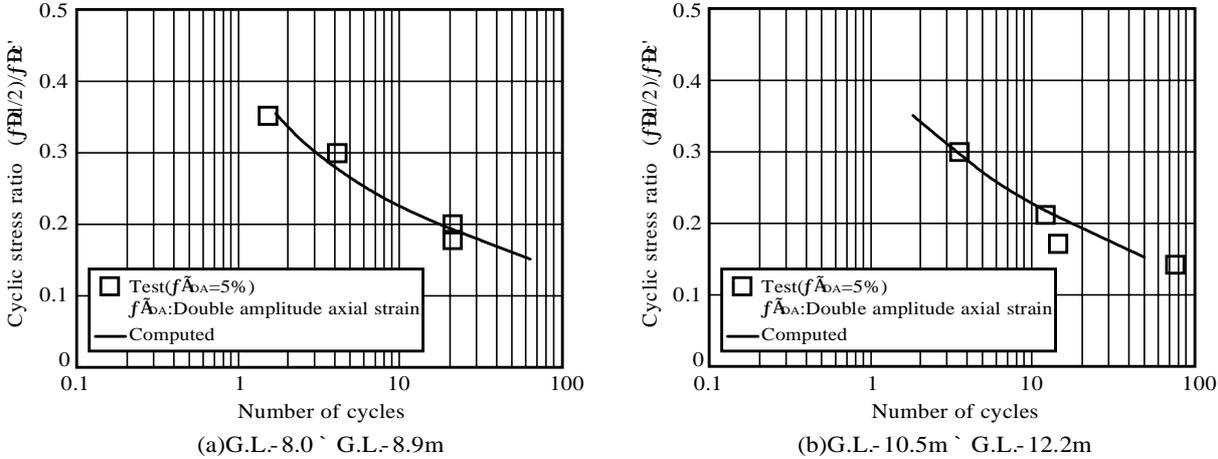
**Figure 4: Cyclic triaxial test results of *Masado* and computed liquefaction resistance curve**

The liquefaction strength of the soil was obtained by cyclic triaxial tests on undisturbed samples taken by triple-tube sampling from between G.L.-8.0 m and G.L.-8.9 m (sample A) and between G.L.-10.5 m and G.L.-12.2 m (sample B). Figure 4 shows the liquefaction strength. The cyclic stress ratios, required to cause 5% double amplitude axial strain in 20 cycles, obtained by the tests are about 0.2. The cyclic stress ratios are similar to past test results of undisturbed samples of *Masado* using triple-tube sampling taken from nearby reclaimed lands [Mizutori et al., 1998].

The liquefaction strengths of sample A and B were applied to the *Masado* layer at G.L.-3.8 to -9.5 m and G.L.-9.5 to -14.8 m, respectively. The parameters of liquefaction strength of soil were determined to fit the liquefaction strength obtained by the elemental simulation analysis of simple shear test using “*FLIP*” to that of soil obtained by laboratory tests. The liquefaction resistance curve calculated from simulation analysis is superimposed on Figure 4. The liquefaction resistance curve well fitted to the liquefaction strength obtained by the cyclic triaxial tests, considering the validity of the parameter setting.

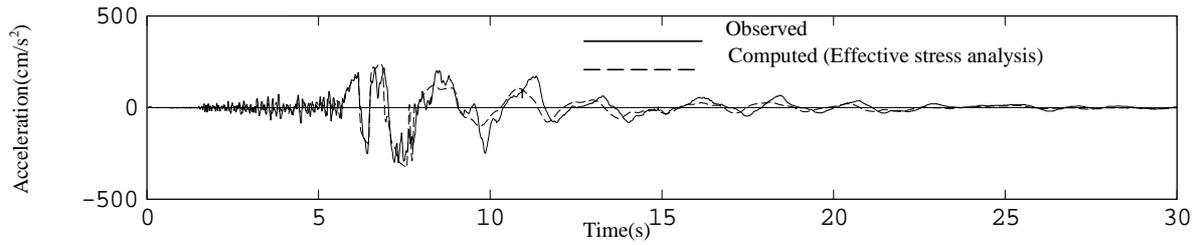
**Figure 6: Comparison between observed and computed acceleration time history at the surface**

Figure 6 shows the time history of acceleration at the surface calculated from the effective stress analysis. The waveform observed at G.L.-1.5 m in the Higashi Kobe Bridge Station, rotated similarly to the input motion, is also shown for comparison. The computed motion reproduced the features of the observed motion, such as the predominant period was extended and amplitude was reduced after the main phases.

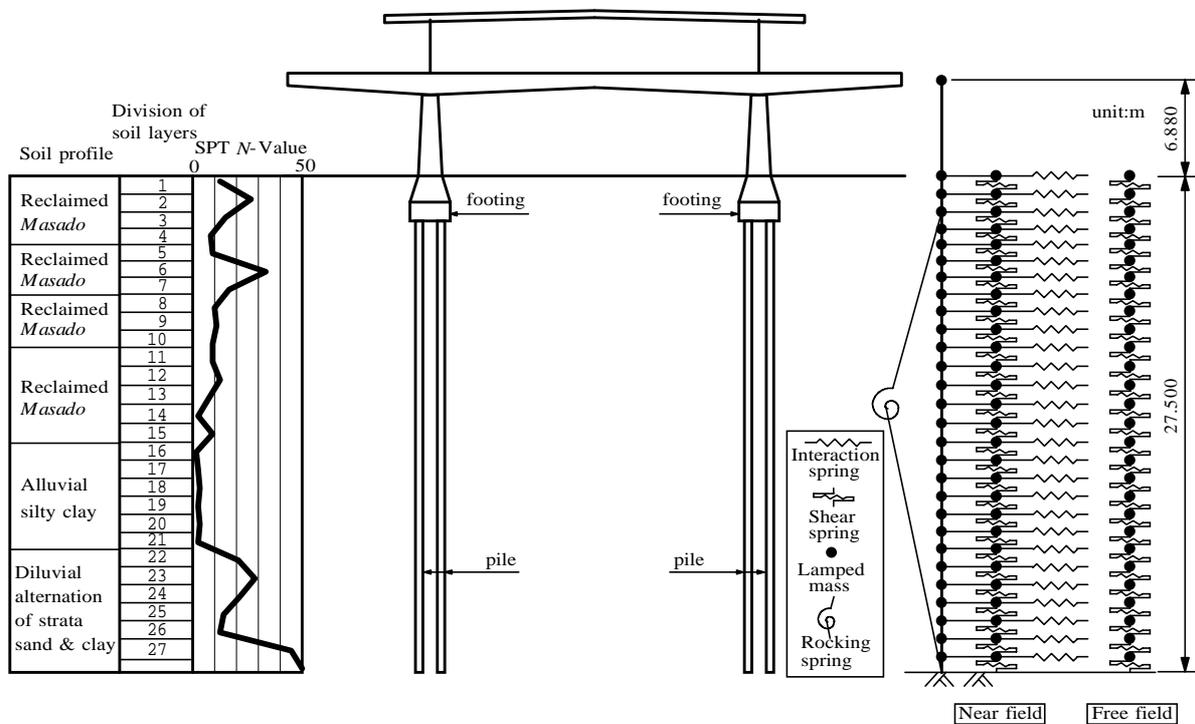
**Figure 8: Analytical model of soil-pile-structure interaction**

A seismic response analysis of soil-pile-structure interaction was conducted using a multi-lumped mass model considering liquefaction proposed by Mori et al. [Mori et al., 1992] to evaluate the behavior of the piles and building during the earthquake as well as the causes and the processes of damage. One frame of span direction was modeled for the analysis. The analytical model, that is an improved model of so-called modified Penzien type model, is shown in Figure 8.
