STUDY OF REINFORCED CONCRETE BUILDINGS DAMAGED DUE TO THE MIYAGIKEN-OKI, JAPAN, EARTHQUAKE OF JUNE 12, 1978

Shizuo Hayashi*1, Yoichi Morishima*2, Akira Wada*3 and Seiji Kokusho*4

SYNOPSIS

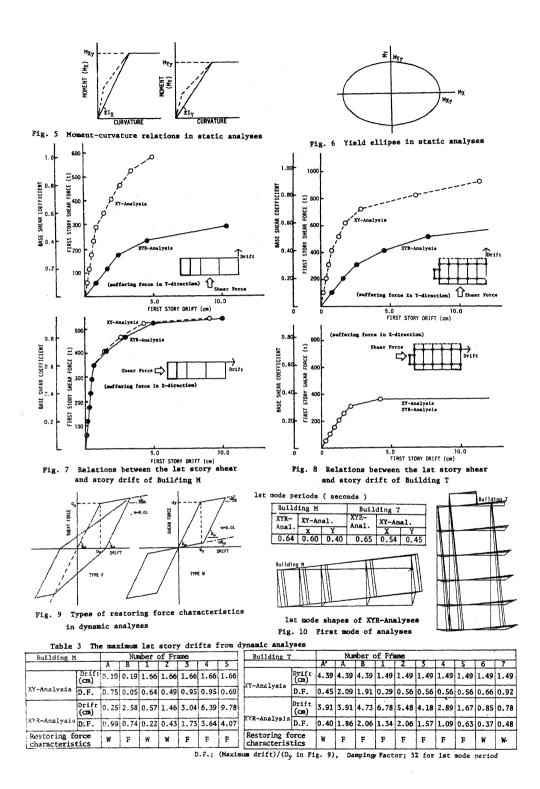
Fig. 3 The 1st floor and foundation plans of Building T

Building T: This was built in 1964. The plan, section and columns on the 1st story are shown in Fig. 3, 4 and Table 2. Floor slabs projected over from the column line A or B in E-W direction, and there was no foundation at the tips of the cantilever beams. Shear walls were located only arround a staircase of the north side.

The building was inclined toward southeast due to shear failure of columns on the lst story.

It is found that the building causes large drift and rotation from the analyses taking into consideration of the torsional rotation. On the aseismic design, it is very important that shear walls should be located so well balanced that the centroids of shear force and rigidity coincide.
