# DESIGN SEISMIC COEFFICIENT IN SEISMIC COEFFICIENT METHOD AND ACTUAL EARTHQUAKE DAMAGE

Shunzo Okamoto<sup>I</sup>, Choshiro Tamura<sup>II</sup> and Katsuyuki Kato<sup>III</sup>

This paper mainly takes up the Miyagi-ken-oki Earthquake of 1978 which caused much damage to facilities and structures designed based on earthquake-resistant design methods, and describes the relations of damage, earthquake motions and design seismic coefficients in regard to bridges and dams.

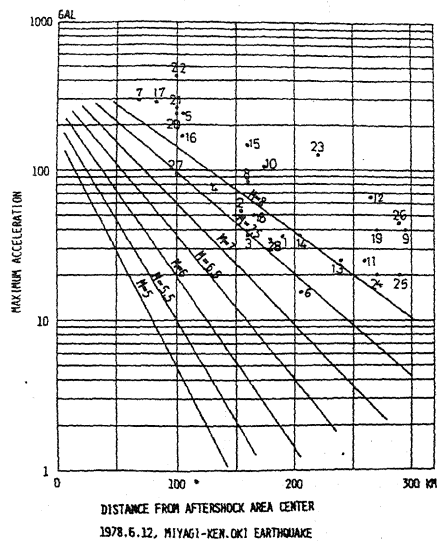
Fig. 1 shows the relations between maximum accelerations in the horizontal direction at bedrock, base rock, ground surface and underground obtained during the Miyagi-ken-oki Earthquake and the distances from the center of the aftershock area. The particulars of this earthquake are the following:

In Fig. 1, numerals with  $\bullet$  marks are numbers of measuring points, 1 to 5 being at bedrock, 6 at weathered bedrock, 27 at foundation ground, and 29 at bedrock 67.2 m underground. Among these measuring points, the maximum acceleration at 5 was 240 gal, whereas the second highest was approximately 130 gal, and only the maximum value is especially predominant. This trend is seen at 22 also, where the second highest value is 250 gal. The straight lines are the relations between the maximum accelerations and epicentral distances obtained in earthquake observations being carried out by the authors at an underground location in bedrock approximately 120 km north of Tokyo expressed with magnitude as the parameter. According to Fig. 1, with 5 being an exception, the values at bedrock or foundation ground are seen to indicate the lower-limit values of maximum accelerations corresponding to the distances from the aftershock area center. The numbers 20 and 21 in Fig. 1 are measuring points at the ground floor and the second basement of a building on a diluvial table in the city of Sendai with 240 gal and 253 gal, respectively. The number 7 is for a measuring point at the ground surface in a case of hard rock existing 2 to 3 m underground. It is estimated that on diluvial ground around Sendai approximately 100 km from the aftershock area center, maximum accelerations of about 250 to 300 gal were reached. During the earthquake of  $M = 6.7$  which occurred on February 20, 1978 several tens of kilometers north of this earthquake, it was seen that the lower limits of maximum accelerations were similarly expressed by straight lines.

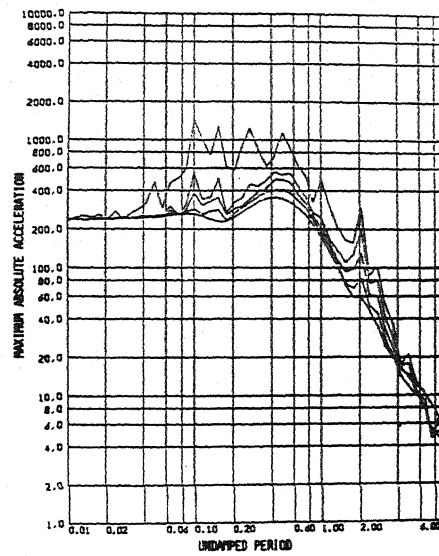
Fig. 2 shows response acceleration spectra (according to the Public Works Research Institute, Ministry of Construction) calculated from acceleration records (Tarumizu Dam) obtained at measuring point 5. In case of damping coefficients of 0.1 to 0.2, taking into consideration high-order vibrations also, it may be seen that the maximum accelerations will reach roughly 350 to 500 gal at the surfaces of surface layers having predominant vibration periods of 0.4 to 1.0 sec.
