ENGINEERING IMPLICATIONS OF THE BUCHAREST COMPUTING CENTER COLLAPSE

Glen V. Berg (I)

SUMMARY

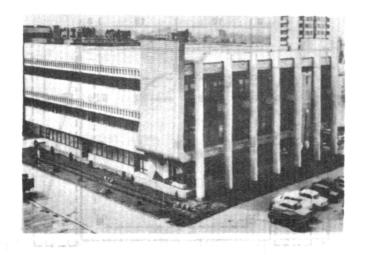
Fig. 1. The computing center

The computing center was a three-story reinforced concrete structure of striking architectural design. Fig. 1 shows the building before the earthquake. It was a flat plate building with service towers at either end housing the stairwells, elevators, etc., and a main building in between. The central building was structurally separated from the service towers. The service towers remained intact, but the central building collapsed, as shown in Fig. 2.

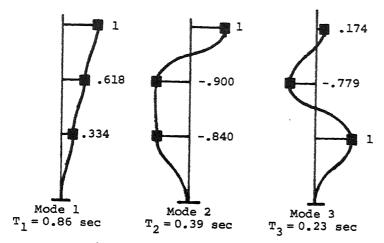
Fig. 5. Modes of vibration.

Dynamically, this was a nice clean building, uncomplicated by any added stiffness due to shear walls or nonstructural components. The main building was essentially a three degree of freedom system having only the columns to provide lateral stiffness. The three modes and their associated periods are shown in Fig. 5. These are the modes computed on the idealized condition of fully fixed column bases and completely rigid floors. Any flexibility in either the footings or the floors would lengthen the computed periods.

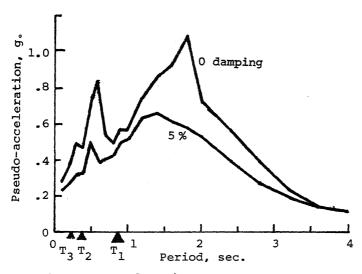
Fig. 6. Acceleration response spectrum.

The ground motion was not recorded at the building site, but it was recorded at INCERC, the Building Research Institute, just a few kilometers away. A spectrum of the N-S component of that motion is shown in Fig. 6. It is not what we think of as the usual spectrum, for the pronounced peak out in the 1.5 to 2 second period range is not what we are accustomed to seeing. However, there is no question that the recorded motion did occur in Bucharest, and the regional geology gives cause to believe that this may be a prevalent characteristic of Bucharest ground motion. The spectral values are large. For comparison, the Housner spectrum intensity for 5% of critical damping is 247 cm. for the Bucharest ground motion, and 135 cm. for El Centro 1940.
