# DAMAGE TO PORT STRUCTURES BY THE 1978 MIYAGI-KEN-OKI EARTHQUAKE

Setsuo NODA<sup>I</sup> and Satoshi HAYASHI<sup>II</sup>

## SUMMARY

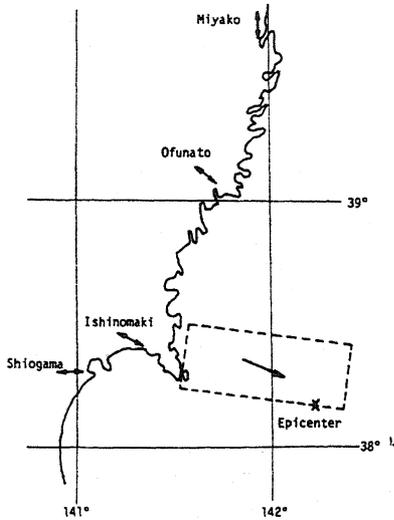
F-16 Predominant Direction of Ground Motion

The predominant direction did not clearly appeared from the orbit by the two horizontal components of acceleration records. However, orbits by the displacement records showed evidently the predominant direction of the ground movement. Orbits which were calculated by the simulation of the source model agreed well with those by the observed records. The predominant directions by the observed records in each port and the fault plane of the earthquake are shown in Fig. 16.

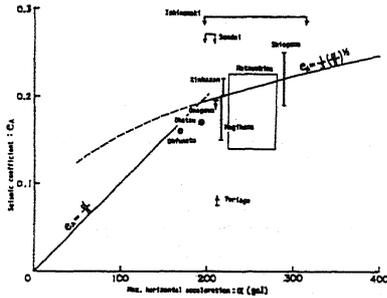
F-18 Seismic Coefficient and Maximum Ground Acceleration (Gravity Structure)

The relationship between the maximum ground accelerations and the seismic coefficients for 36 quaywalls at 10 ports were estimated as shown in Fig. 18. In the figure the curved line indicates the proposed relationship which was derived from 129 quaywalls in 12 earthquakes, and the straight line indicates the relationship for the rigid body on the firm foundation. Even though the range of the estimated values in Shiogama, Matsushima and Hagiwara ports are wide to some extent, the results of the present estimation show the similar characteristics to the proposed curve. In case of the ground acceleration smaller than 200 Gals the straight line may indicate more suitable relationship than the curved line. As arrows indicate downward in Sendai and Ishinomaki ports, the expected seismic coefficients in these ports do not always contradict with the curved line. Consequently it is concluded that the relationship between the maximum ground acceleration and the seismic coefficient for gravity type quaywalls in this earthquake is also expressed by that derived from the past earthquakes.
