THE FEBRUARY 4, 1976 EARTHQUAKE IN GUATEMALA CITY AND
VICINITY: ENGINEERING FIELD REPORT

RAUL HUSID^I

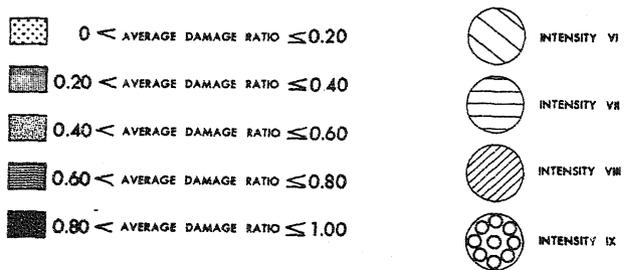
FIGURE 3
 DETAILED AVERAGE DAMAGE RATIO MAP & INTENSITY DISTRIBUTION
 FOR ZONES 1 THROUGH 6 FOR GUATEMALA CITY

for six zones in Guatemala City. Fig. 3 gives the same information superimposed on the MMI map.

Differences between the damage estimated from D.R.'s and the MMI's are obvious from Fig. 3. The Intensity map appears to be rather generalized in its representation of damage and is, in some cases, in conflict with the D.R. map. As an example, Zone 1 was assigned predominantly intensity VII; and Zone 2, predominantly intensity VIII. The D.R. data yield a larger number of adobe buildings with D.R.'s > 0.80 in Zone 1 than in Zone 2.
