DAMAGE OF REINFORCED PRECAST CONCRETE PILES
DURING THE MIYAGIKEN-OKI EARTHQUAKE OF JUNE 12, 1978

Hideaki KISHIDA^I
Toshikazu HANAZATO^{II}
Shoichi NAKAI^{III}

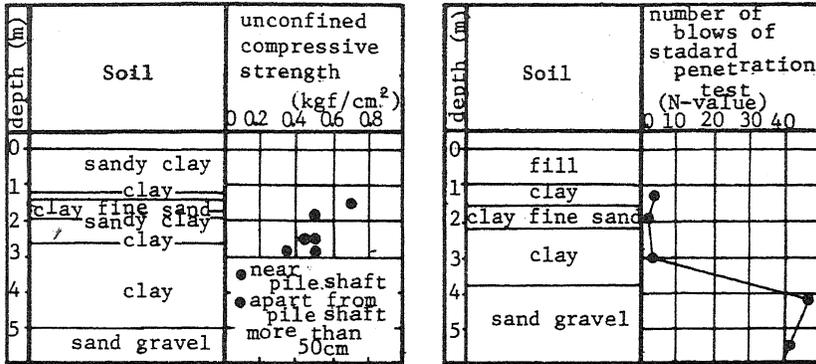
Fig. 11 Soil profiles of Oroshi-machi, Sendai City

The block samples of the undisturbed soil were taken at the site of the Maruyoshi building during the investigation, and the soil profiles are given in Fig. 11. The standard penetration test results obtained at other site apart about 200 m from the Maruyoshi site are also shown in Fig. 11. The data used for computation of horizontal resistance of piles at the Maruyoshi building is given in Table 1.
