PROGRESS REPORT OF RESEARCH WORKS IN BRIDGE EARTHQUAKE ENGINEERING
AT THE PUBLIC WORKS RESEARCH INSTITUTE, JAPAN

Eiichi KURIBAYASHI^I and Toshio IWASAKI^{II}

SUMMARY

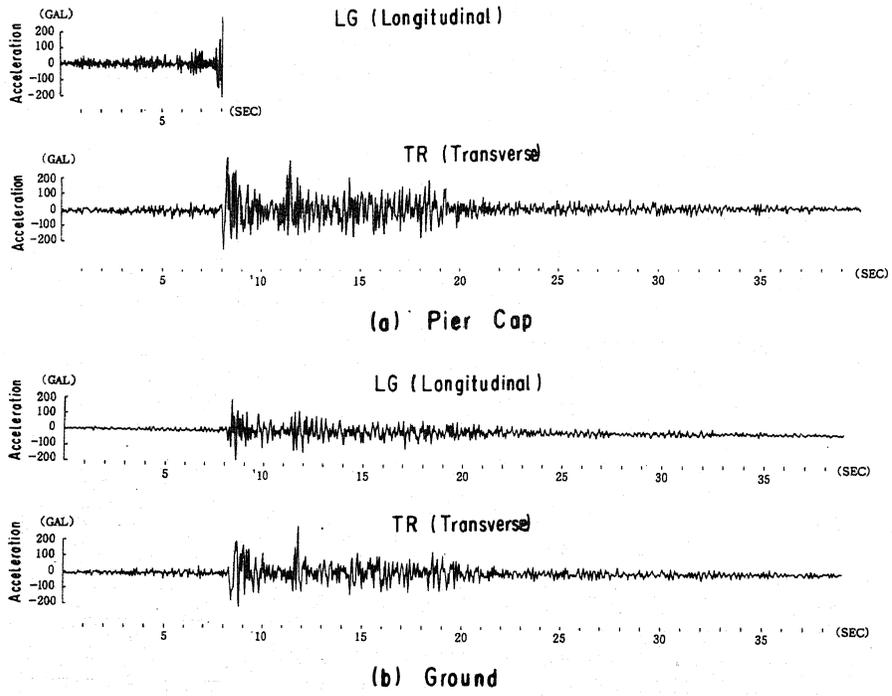
Fig. 3 Strong-Motion Records at Kaihoku Bridge Pier and Ground Nearby

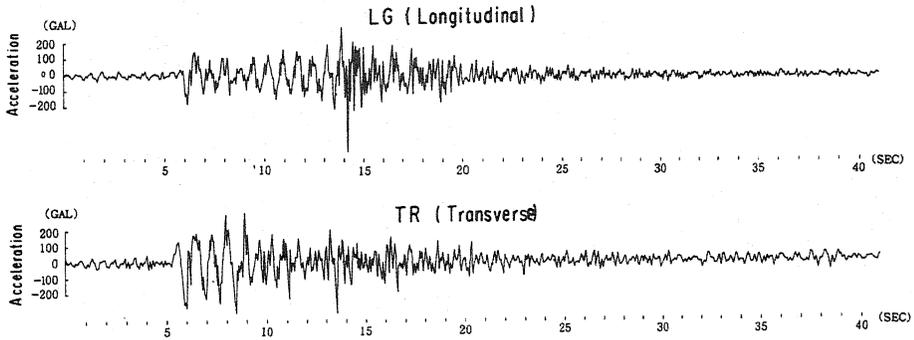
Next, Fig. 4 shows a record at a pier cap of Date Bridge located near Fukushima City (epicentral distance of 160 km). The maximum accelerations on the pier cap were 480 gals in the longitudinal direction, and 320 gals in the transverse direction. This bridge suffered moderate damages to bearing supports and a truss member above the fixed bearing.

Due to the June Earthquake a lower chord member buckled just at the fixed bearing on Pier 2 (see Fig. 14). Several pins at the fixed bearing and one of the movable bearings were sheared off and came out of the shoes. The substructures did not sustain any damage. A strong-motion accelerograph is set up on the cap of Pier 2, and triggered a complete time history of the acceleration at the pier cap (see Fig. 4).

Fig. 4 Strong-Motion Record at Cap of Pier 2, Date Bridge

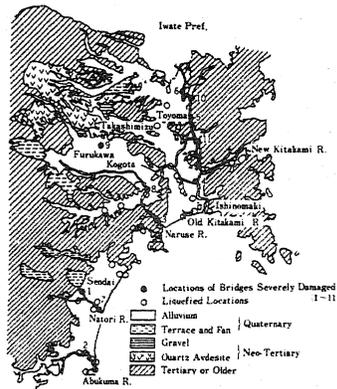
Features of Bridge Damage³⁾ — Fig. 5 shows locations of severely damaged highway bridges (black circles), places where liquefaction was observed (white circles), and geological conditions in Miyagi Prefecture. It is seen from Fig. 5 that most of major bridge damages and liquefaction took place in alluvial lands along large rivers such as Kitakami, Naruse, Yoshida, Natori, and Abukuma.

Fig. 5 Geological Features and Locations of Major Bridge Damages and Liquefaction Sites
