EXCAVATION AND RESPONSE ANALYSIS
OF A DAMAGED RC PILES BY LIQUEFACTION

T. Nishizawa (I)
S. Tajiri (II)
S. Kawamura (III)

SUMMARY

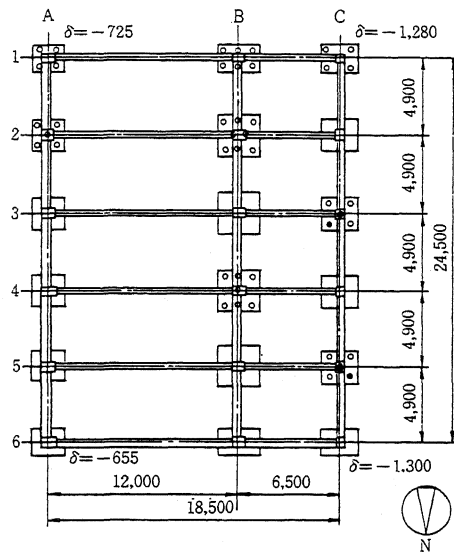
Fig.1 Plan of the Building

In 1964 Niigata earthquake the building was settled and inclined as shown in Fig.2 due to the damages of the piles caused by the liquefaction of subsoil. The maximum settlement was 1.3m. Underground pipings and the like were also damaged, though the upper structure itself was slightly damaged. After the earthquake the building was jacked up and supported by the H-shaped steel piles newly driven. It was used till recently.

● Excavated Piles δ : Settlement (mm)

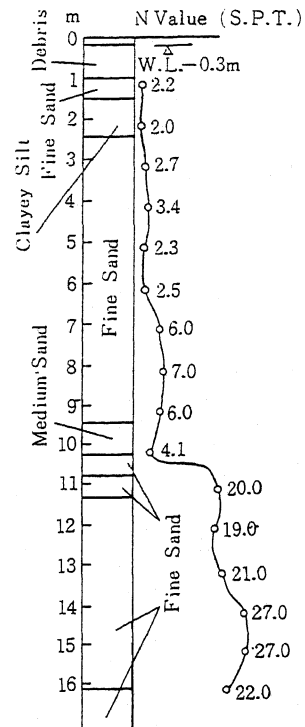
Fig.3 Geological Formation

In the Niigata earthquake liquefaction occurred and many buildings were settled and tilted around the site. The geological formation of this site is shown in Fig.3. It mainly consists of sand with partial silty layer near the ground surface. The N values of standard penetration tests are 2~7 down to GL-10.5m, and more than 20 below it. The water table lies at GL-0.3m and almost all layers up to GL are saturated. The pile tips were at GL-12m and penetrated the fine sand layer of N value more than 20 by 1.5m.

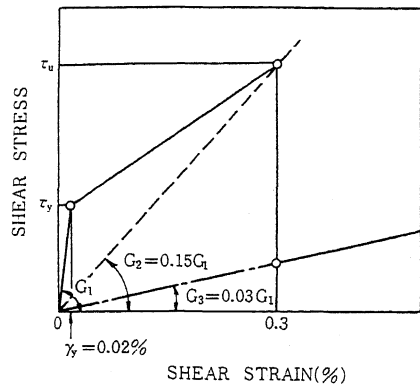
Fig. 7 Liquefaction Model

Nonlinear response analysis was done considering the liquefaction of soil as well as the linear one. The liquefaction model was composed based on the results of dynamic torsion tests as shown in Fig.6. The model exaggerated the result and is shown in Fig.7. The stiffness is reduced to 15% of the first value at the shear strain $\gamma=0.02\%$, and the strength suddenly falls at $\gamma=0.3\%$. Also in this model the cyclic degradation of stiffness is taken into account in the following form.

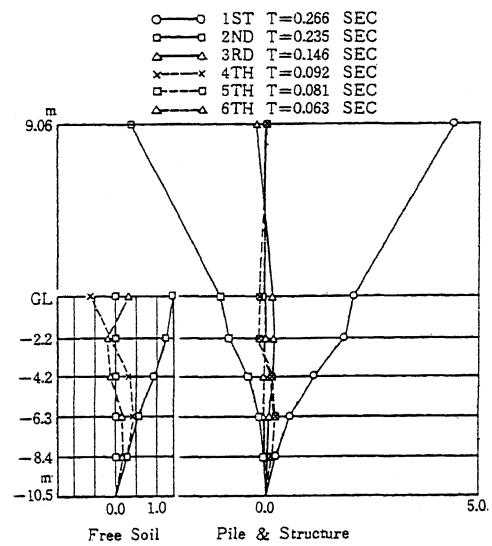
Fig. 8 Natural Period and Participation Function

in Fig.8. First and second mode is stimulated to large amount. In the first mode only the structure moves, when the free soil stands still. In the second mode the free soil moves in the shape of its first mode and the structure is in the opposite phase.

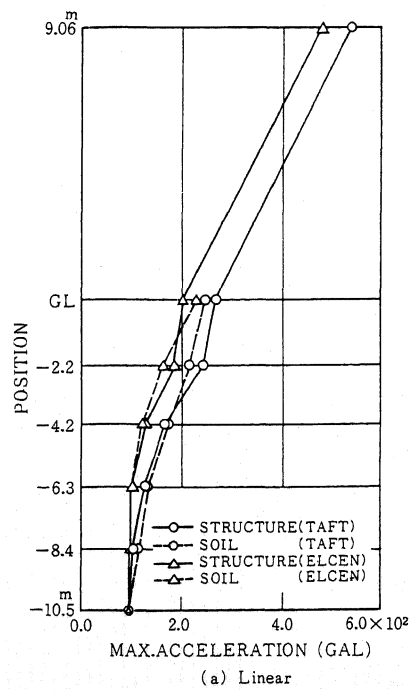
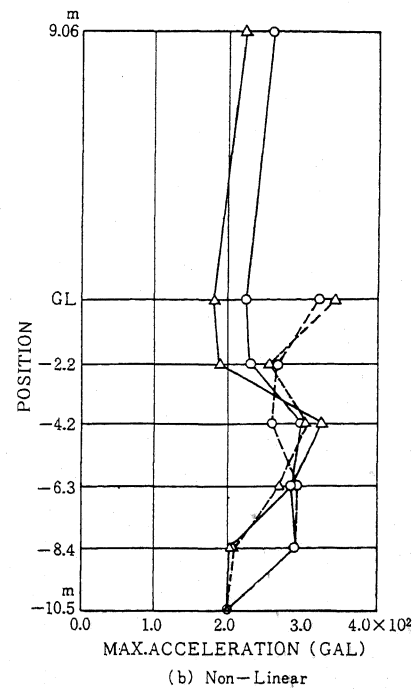
Fig. 9 Maximum Response Acceleration

Linear and nonlinear maximum response accelerations are shown in Fig. 9. In the nonlinear response the amplification ratio is less than that of the linear response, and the mode is also varied from the linear one. The hystereses of the shear spring of the free soil at the third layer from the bottom are shown in Fig.10, where cyclic degradation of stiffness and strength is clearly noticed. The bending moment of a pile is shown in Fig. 11. The value for TAFT exceeded the crack moment to a large extent, which corresponds to the actual damage.
