Seismic Assessment and Retrofitting of a Container Wharf and Container Yard following the 27 February 2010 Chile Earthquake

J. P. Smith-Pardo
Seattle University, USA

J. C. Bardi, C. E. Ospina
BergerAbam Inc., USA

SUMMARY:

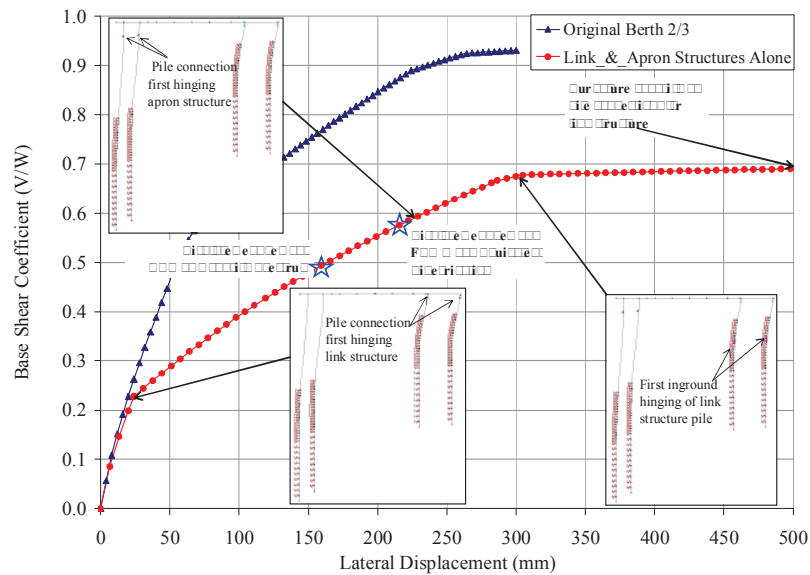
Figure 11. Lateral load response of original Berth 2/3 and new apron/link structure

As observed from Fig. 11, the combined new apron and link structure provides a system with comparable elastic lateral stiffness and base shear capacity, and significantly more ductile (by more than 60%) than the original structure. An improved performance under an event as extreme as the 2010 ground motion may be expected with the relatively simple repair scheme proposed.

The elastic base shear demand for a period of about 0.6 seconds for the record obtained near to SVTI (Concepción EW) (Fig. 4) is around 1.0W. Such base shear demand exceeds the elastic limit in Fig. 11, which is consistent with the nonlinear response and structural damage evidenced after the February 27, 2010 Chile ground motion at SVTI. The upgraded structure would also experience damage under such extreme event; however, its ability to deform and dissipate energy would be greater than the original structure even when neglecting the contribution of the pre-earthquake structure.

Nonlinear displacement demands of the retrofitted Berth 2/3 structure were estimated (neglecting the contribution of the existing damaged structure to the overall lateral load resistance of the system) under the design acceleration spectrum (Sch2369, 2003). The lateral displacement demand was calculated to be 160mm based on the Capacity Spectrum procedure described in ATC 40 and 220mm based on the equivalent linearization procedure in FEMA 440 (2005). As can be observed from Fig. 11, the lateral displacement capacity of the combined apron/link structure –including the mass of the entire structure- is more than twice the demand obtained by either procedure and thus suggesting that the proposed retrofitting scheme provides seismic performance levels well in excess of what would be implicitly required by the current Chilean design code.
