Post Earthquake Field Investigation of the M_w 9.0 Tōhoku Earthquake of 11th March 2011

A reconnaissance was conducted by the UK-based Earthquake Engineering Field Investigation Team (EEFIT) to study the effects of the recent M_w 9.0 Tōhoku earthquake. The purpose of the mission was to assess the damage on buildings and infrastructure caused by the earthquake and tsunami. The consequent effects of the catastrophe on the local community were also one of the mission's key interests. This paper presents a wide coverage of the earthquake event, comprising the damage observed on residential, commercial and industrial buildings and facilities, geotechnical failures such as ground settlement, liquefaction and landslides, the effectiveness of coastal defences, vertical evacuation facilities and the use of geospatial tools after experiencing the nation's largest earthquake event since the beginning of instrumental seismology circa 1900. The observations on ground motion and shaking damage are discussed in the accompanying paper.

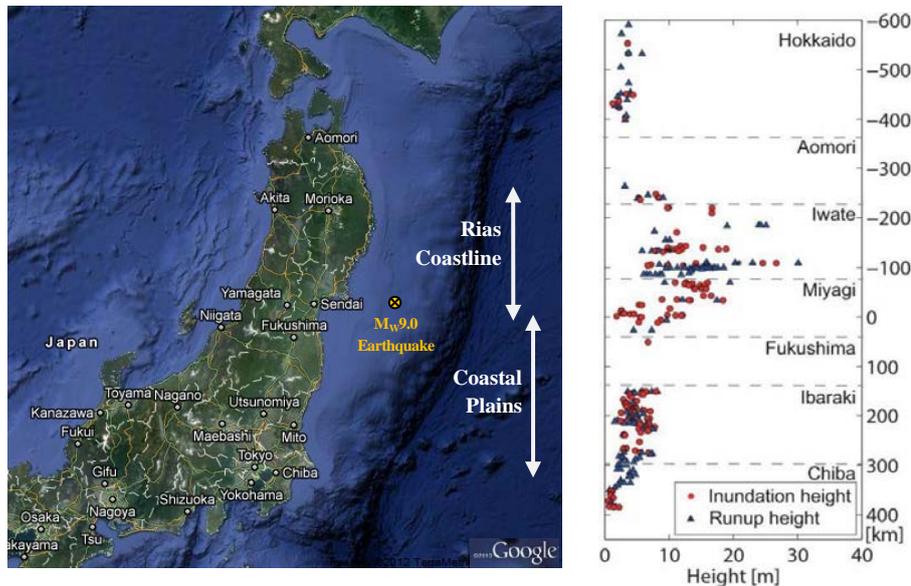
Figure 13. Types of topography with tsunami inundation and run-up heights data from JSCE (2011)

Two coastline types exist along the coast of Tōhoku, the rias in the north and the plains in the south of Sendai as shown in Figure 13. These different topographies have significant effects on an incoming tsunami. The shape of the river valleys in the rias coastline constraints the incoming waves and amplifies the tsunami's run-up height, but restricts the inland inundation of the waves. In contrast, the coastal plains offer lower resistance to the incoming waves which limit run-up height but allow further inland inundation of the tsunami than the rias.
