Damage of Road Bridges by 2011 Great East Japan (Tohoku) Earthquake

K. Kawashima

Tokyo Institute of Technology

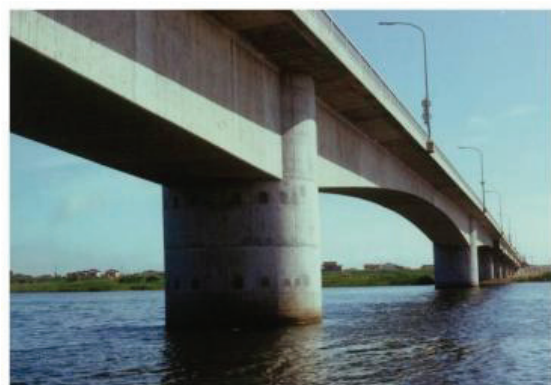
Photo 2. Yuriage Bridge

Yuriage Bridge (refer to Photo 2) suffered extensive damage at reinforced concrete hollow and solid columns, an end of prestressed concrete girders, and steel pin and roller bearings during the 1978 Miyagi-ken-oki earthquake as shown in Photo 3(a). Since the damaged columns were repaired and retrofitted by reinforced concrete jacketing, they did not suffer damage during the 2011 Great East Japan earthquake. However steel pin and roller bearings suffered extensive damage again in the similar mode as shown in Photo 3 (b). It is obvious that steel pin and roller bearings are vulnerable to seismic action, because the stress builds up to failure by allowing no relative displacements at pin bearings and relative displacements accommodated by roller bearings are insufficient to real relative displacement under a strong excitation. Furthermore, exactly the same end of a prestressed concrete girder which suffered damage during the 1978 Miyagi-ken-oki earthquake suffered damage.

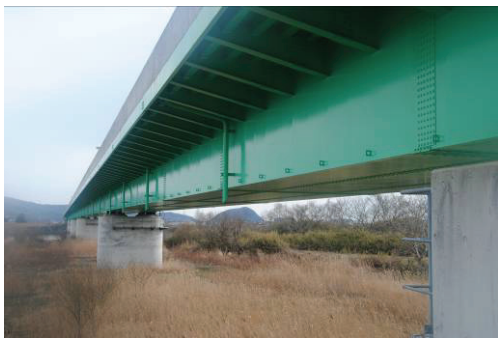
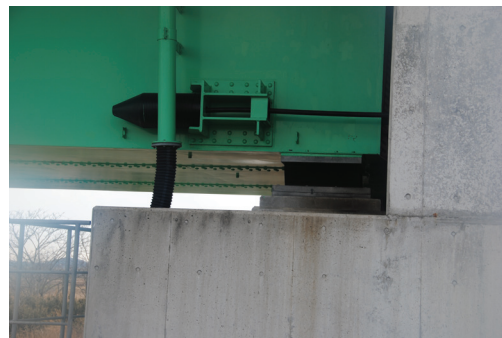
Photo 6. Shin-Tenno Bridge, National Road 45

(a) Bridge after Great East Japan Earthquake

(b) Elastomeric bearing and cable restrainer without damage

during the Great East Japan earthquake. For example, Photo 6 shows Shin-Tenno Bridge that was constructed in 2002. This bridge suffered no damage. Elastomeric bearings and new cable restrainers which satisfied the requirements of the post-1990 design code were set. The bridge was located only 200m upstream of Tenno Bridge which suffered extensive damage during the Great East Japan earthquake.
