SEISMIC PERFORMANCE ASSESSMENT OF EXPANSION JOINTS FOR WATER LIFELINES

SUMMARY:

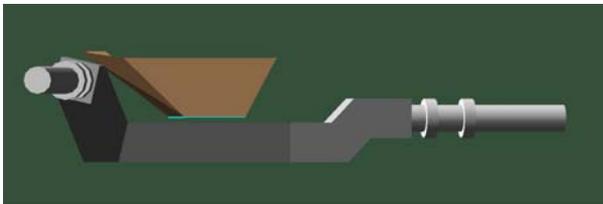
Figure 3.2. Three-dimensional illustration of under-crossing concrete encased structure

According to site observations, there were no ground changes triggering liquefaction, ground slippage or uneven settlement. As shown in Figure 3.2., this under-crossing concrete encased structure has an unstable configuration and is not symmetrical even in the two-dimensional plan view.

- (1) Asymmetrical shape of a structure can produce unstable responses. Actually, in this example, rotational motion caused simultaneous destruction of the expansion joints. Special attention should be paid to the seismic design of asymmetrical structures.

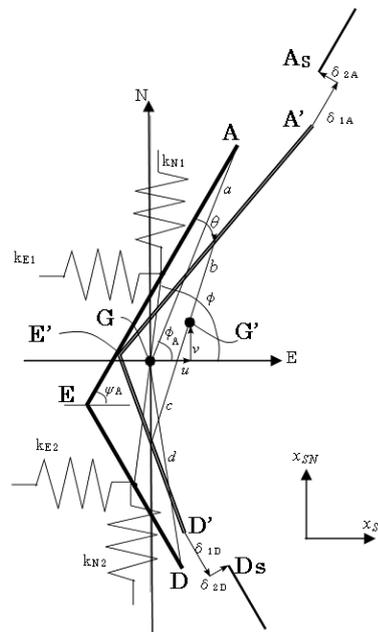
Figure 3.3. Two-dimensional simplified analytical model of under-crossing concrete encased structure

In order to investigate the failure mechanism of the two expansion joints, a configuration describing a two-dimensional simplified model of the under-crossing concrete encased structure is introduced, as shown in Figure 3.3. The gravity point of the structural model is the origin of this figure, and the

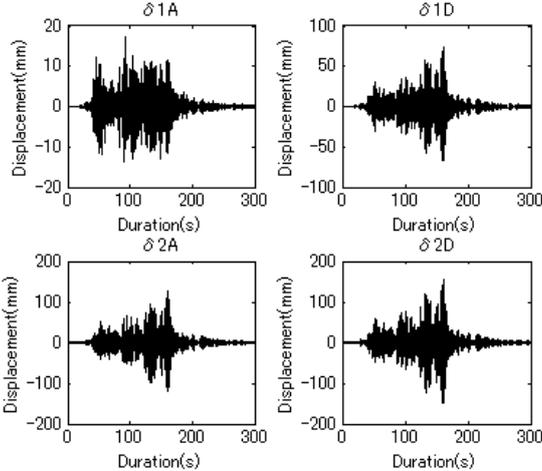
Figure 3.4. Excessive displacement between structural response and ground displacement at expansion joint points A and D, where δ_1 is axial displacement and δ_2 is transverse displacement to the pipe axis

In the numerical analysis, the spring modulus was randomly modified from the original value to smaller ones in order to obtain the largest responses that can exceed the limit boundary of the expansion joint. Figure 3.4. shows the excessive displacements between the ground responses and the structural responses in the axial and transverse directions at points A and D in Figure 3.3. δ_{1A} and δ_{1D} are the responses in the axial direction, and δ_{2A} and δ_{2D} are the responses in the transverse

direction, respectively. These figures show that the maximum response appears in the transverse direction of point D, as shown by δ_{2D} . This result does not conflict with the observation that the largest movement at the encased concrete structure occurred at point D in the transverse direction. The second largest response is given by δ_{2A} , which might support the observation that both expansion joints were simultaneously destroyed by the main shock. Figure 3.5. is the rotational response of the concrete encased structure. These structural responses as shown by the triangular and square marks in the multiple limit state diagram for the expansion joint failure modes in Figure 3.6. In this figure, three different performance limit curves are shown as boundary conditions of the joint failure. Here, two modified performance curves were prepared for reduced allowance conditions which correspond to existing settlement before the earthquake. The numerical results suggest that the expansion joints at the site might have produced an existing settlement equivalent to 1/3 to 2/3 of maximum performance before the earthquake.

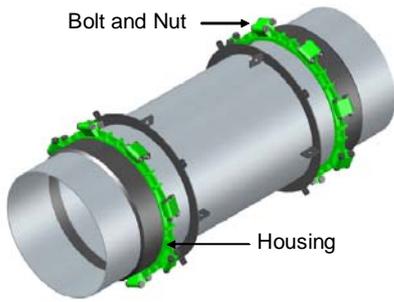
Figure 3.7. Expansion joint structure

Photo 3.2. shows the damaged expansion joint in which leakage failure occurred at the upper portion of the expansion joint. This expansion joint belongs to closer type, which has housing and rubber ring, as shown in Fig. 3.7. The sealing bolt and ring at the upper portion were hydro-blasted by high pressure water and the half portion was worn out, as shown in Photo 3.3. Fig. 3.8. shows the worn portion and its volume corresponds to 6.3% of the original volume.

From this, the following failure mechanism could be deduced: (1) The main shock of March 11, 2011 produced high pressure water leakage from a small gap in the joint; (2) this water leakage started to wear the metal portion of the sealing parts, and this wear continued for one month; (3) the deteriorated sealing ring could not stop the large scale leakage caused by shaking due to the aftershock of April 7th. In order to confirm this failure scenario, the possibility that these failure steps could occur as a result of the main and aftershocks must be evaluated by the numerical approach.

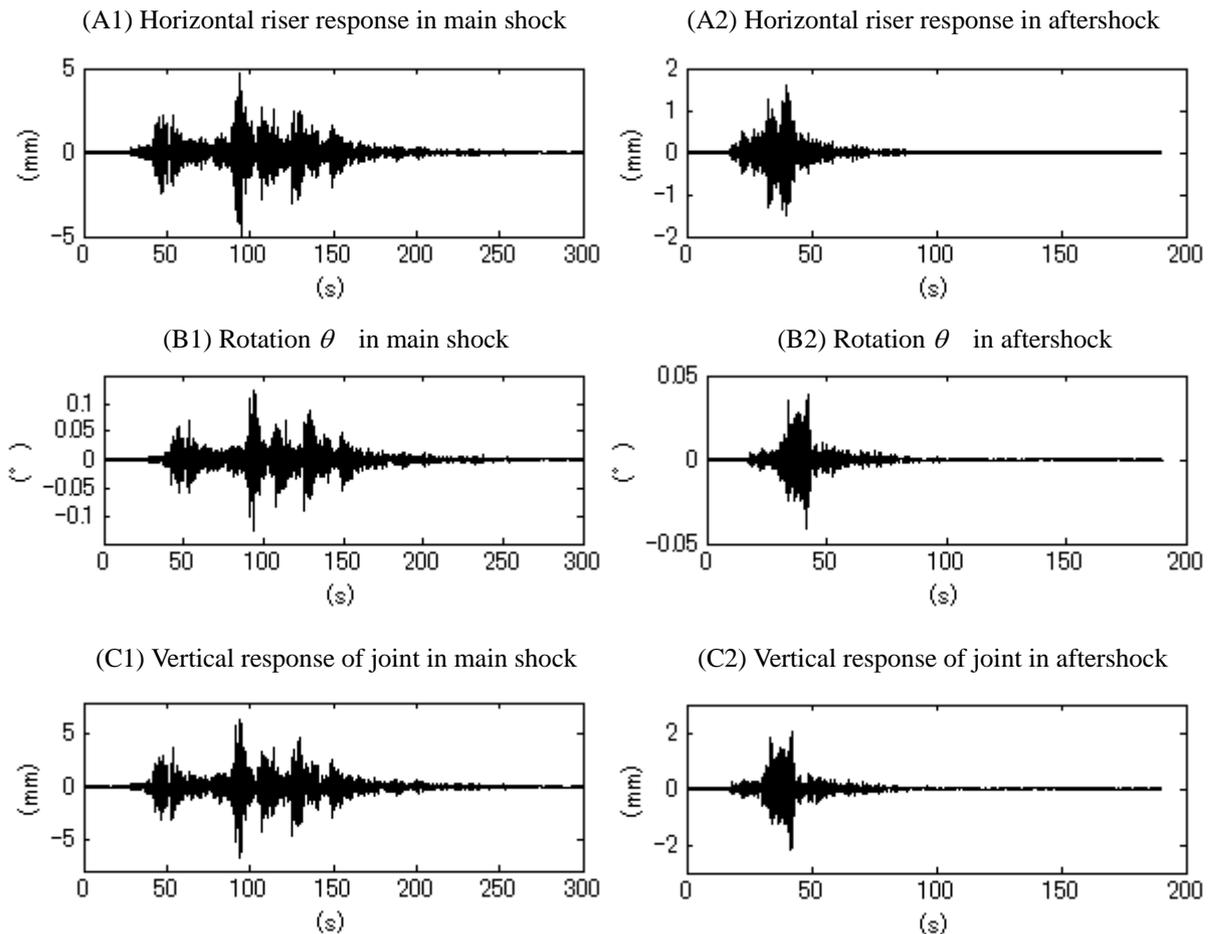
Figure 3.13. Seismic responses of riser and expansion joint in main shock and aftershock

in which x_Q, x_G, x_{si} and θ are base-rock ground motion, structural and surface ground responses, and rotation angle, as shown in Figure 3.12., and, k_i and l_i are the spring constant and the length at the i -th point from the gravity point. I_G and k_R are the rotational rigidity of the riser and its rotational stiffness for the surrounding soil and structural interaction. Figure 3.13. shows the seismic responses of the riser and the expansion joint in the main shock and the aftershock. In the main shock, the maximum rotation is less than 1 degree, which is not sufficient to destroy the expansion joint. This response led to a small leak from the joint since the pre-existing settlement had already produced rotation of 3.5 degree in the expansion joint. According to the fabricator’s specification shown in Figure 3.14., the allowable maximum angle is 6 degree, so the main shock could not cause large-scale leakage immediately after the main shock. However, one month after the first small leakage, the hydro-blasting effect had worked on the sealing ring, reducing the thickness of the bolt diameter and the ring itself. As a result, when the second shock occurred in the aftershock of April 7th, the sealing ring had already been worn out, and could easily be broken by a small impact. This is a reason the expansion joint suffered a leakage failure in the aftershock.

In the second example, the pre-existing settlement played an important role in initiating small leakage from the sealing ring, which caused hydro-blasting that reduced the metal portion of the sealing elements. This result suggests that the allowable displacement of the expansion joint should be designed not only for vertical settlement under ordinary construction conditions but also for excessive displacement by future earthquakes.
