Damage analysis due to 2010 Chilean earthquake in Viña del Mar residential buildings

SUMMARY:

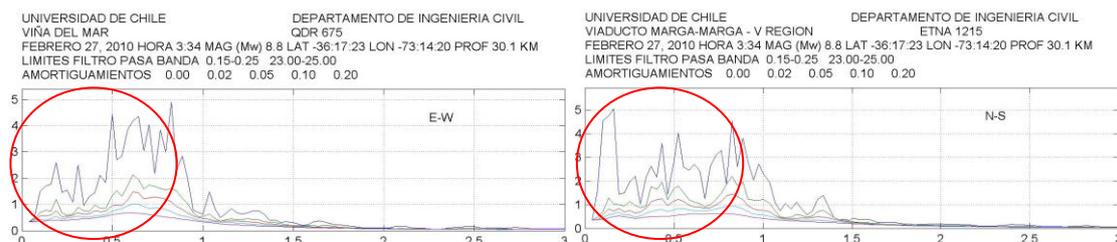
The response spectra (Fig. 3), obtained from the records of the two existing acceleration station of the city, show higher motion energy in a period range from 0.5 to 0.8 s in the case of the Viña del Mar station, and from 0.4 to 1.1s for the Viaducto Marga-Marga station. Based on the relationship $T = 0.045 N$ (period T / number of storeys N), obtained by Guendelman et al. (1997) for the RC buildings, the building with periods close to the predominant periods of the ground motion suffered more damages, particularly those with $N \geq 10$ floors. Although the shaking had a_{max} of 0.35 g and it exceeded 0.1g for more than 25 s, reaching an intensity of grade I = VIII (EMS), only 12.27% of the 2054 buildings suffered damages, and none of them collapsed (Table 2). 8.03% suffered very light damage, 2.63% suffered light damage, 1.07% suffered moderate damage and 0.54% suffered severe damage (grades 1, 2, 3 and 4 of the EMS scale, respectively).

Figure 3. Response spectra of the ground motion (in two station of Viña del Mar) for different damping (Boroscheck et al, 2010). The red circle shows the period range with higher energy contribution.
