USABILITY OF TSUNAMI PRA BASED ON ACCIDENTS OF FUKUSHIMA DAI-ICHI NPP UNDER 2011 TOHOKU TSUNAMI

Katsumi Ebisawa, Hideharu Sugino, Yoko Iwabuchi and Masahide Nishio

Japan Nuclear Energy Safety Organization, Japan

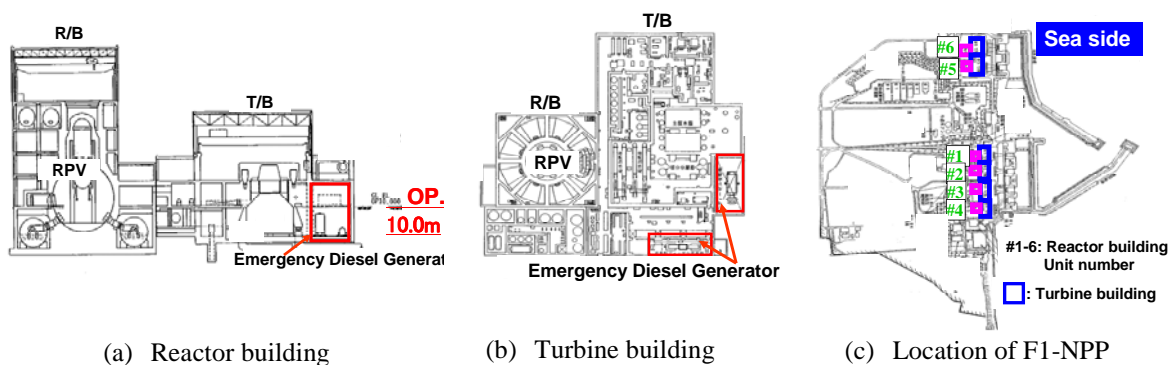
Figure 1. (a)-(c) Location of Fukushima Dai-ichi nuclear power plant

The F1-NPP is a multi-units site with 6 BWRs as shown in Fig. 1 (a)-(c). Fig. 1 (c) shows the location of each unit. Fig. 1 (a) and (b) are the EW and NS sections of reactor and turbine buildings respectively. The turbine buildings are in front on the sea. The emergency diesel generators are installed at the basement on the site of the sea in the turbine buildings.

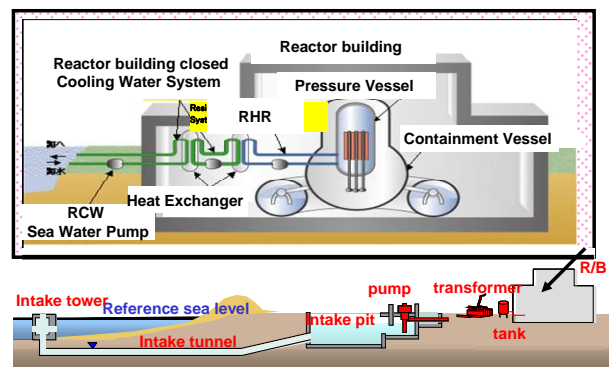
Figure 7. Collection of plant information and setting of accident scenarios

In the collection of information and setting of accident scenario as shown in Fig. 7, at first, relevant information should be gathered. Then, conduct “plant walk-down” based on the gathered information. Finally, set various accident scenario based on gathering relevant information and the result of “plant walk-down” as shown in Fig. 7.

The accident scenarios should be identified with dividing cases for tsunami run-up and backwash. Following accident scenarios are assumed in case of tsunami run-up as shown in this figure.

- Functional loss of sea water pump
- Functional loss of power supply system
- Functional loss of DG oil tank
- Functional loss of sea water intake pit
- Functional loss of sea water facilities by debris flow attack
- Functional loss of sea water intake function by deposition of sea sand
- Turn over of sea water pump cause by tsunami backwash

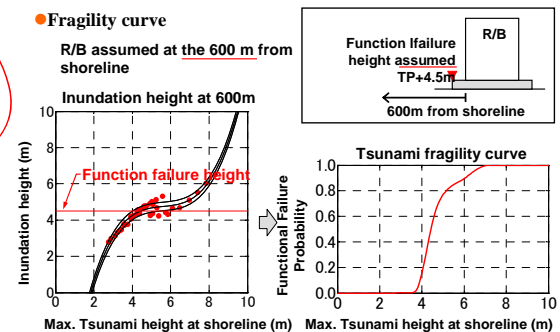
Figure 10. Example of tsunami fragility

The Fig. 10 shows an example of fragility evaluation. The results on analysis of onshore run-ups of tsunami are shown for targeted point in the Fig. 10. The Fig. 10 shows the result of fragility evaluation in case of assuming the installation point of reactor building is 600 m distant from the shoreline, and function failure is occurred when tsunami run-ups reaches to the building.

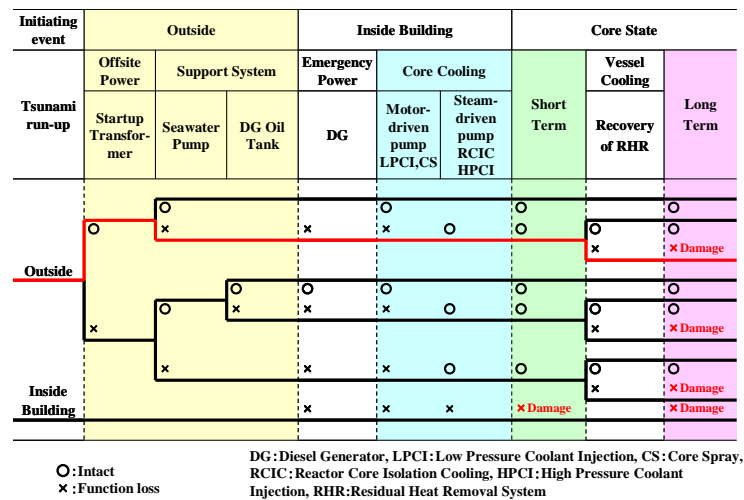
Figure 12. Example of event tree based on accident scenario of tsunami run-up

Fig. 12 shows the event tree based on an accident scenario for tsunami run-ups in a BWR. The accident scenario starts from the function failure of facilities outside buildings spreads out to functional failure inside buildings, and finally reaches core damage. When the outdoor facility is submerged in water causing seawater pumping function loss, RCIC and HPCI are able to provide cooling function to the reactor core temporarily so that the reactor core will not suddenly break down. However, if the pumping system is not recovered for long period, the reactor core will get damaged.

If the mitigation system in both the run-up and the backwash cannot be recovered within a short time, the reactor core will get damaged. Approximate time from system malfunction until core damage is calculated in this case. As a result, this time is about 100 minutes (Sugino, 2008).

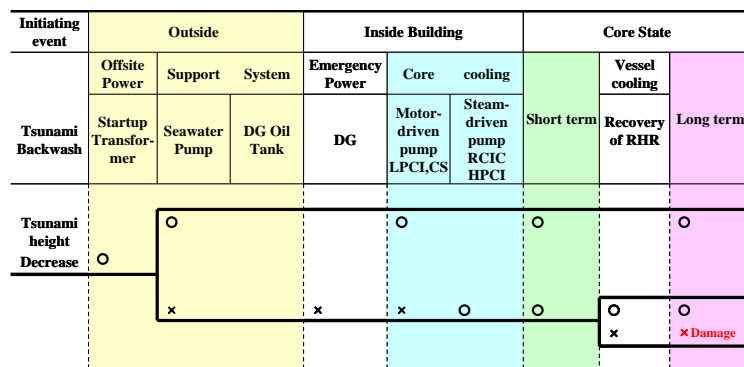
Figure 13. Example of event tree based on accident scenario of tsunami backwash

Fig. 13 shows the event tree of an accident scenario for the backwash in which case water draws back causing water level decrease (Sugino, 2008).
