The seismic performance of unreinforced stone masonry buildings during the 2010-2011 Canterbury earthquake sequence

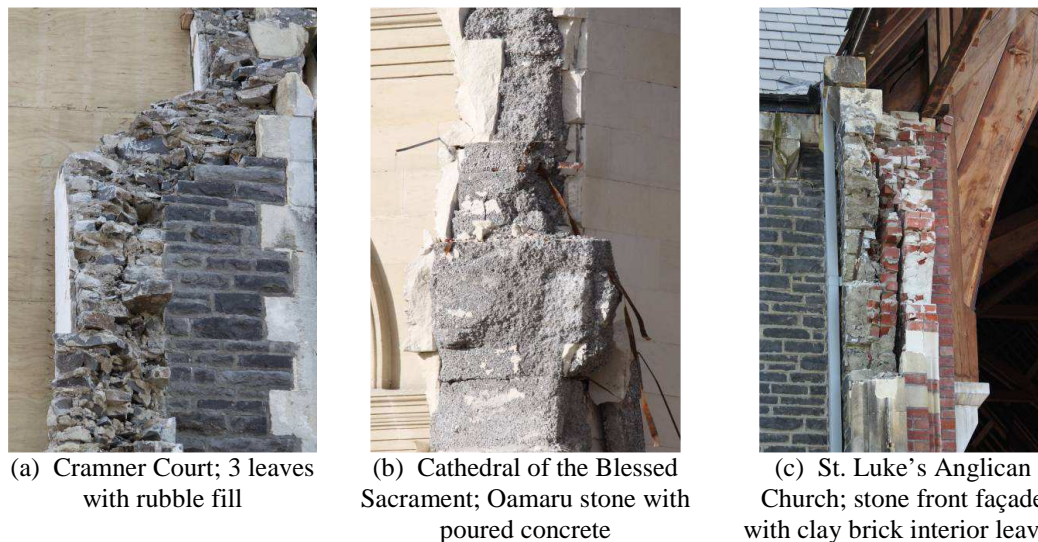
Figure 2. Representative examples of wall cross-sections for Christchurch stone masonry buildings.

- three-leaf masonry walls, with dressed or undressed basalt or lava flow stone units on the outer leaves (wythes) while the internal core consists of stone rubble fill (Fig. 2a);
- three-leaf masonry walls, with the outer layers in Oamaru sandstone and with a poured concrete core, such as for the Catholic Cathedral of the Blessed Sacrament (Fig. 2b);
- double-leaf walls, with the front façade layer being of dressed stone, either dressed basalt or bluestone blocks, or undressed lava flow units, and the back leaf constituted by one or two layers of clay bricks, usually with a common bond pattern, with the possible presence of a cavity or of poured concrete between the inner and outer leaves (Fig. 2c).

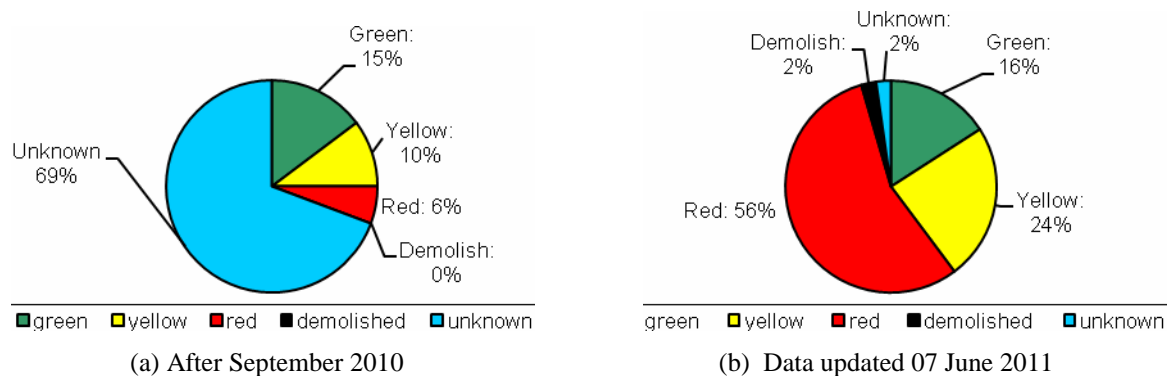
Figure 3. Distribution of safety evaluation placards applied to stone masonry buildings.

The seismic performance of stone masonry buildings was initially identified by considering the safety assessment data collected during the building safety evaluation process. Fig. 3(a) and Fig. 3(b) show the different percentages of building safety assessments after the 4th September 2010 and 22nd February 2011 earthquakes, respectively. From these figure it can be seen that there was a significant escalation of damage due to the continuing earthquake activity in the Christchurch region, although 69% of the 90 stone masonry buildings in Christchurch were not assessed after the September earthquake. At the time of the study reported here, several buildings had been demolished already because of the hazard associated with their damage state after the February 2011 event.
