Seismic Retrofitting of Reinforced Concrete Building Damaged by Tucacas Earthquake, Venezuela

A.J. Malaver & D.R. Rodríguez

Facultad de Ingeniería, Universidad Católica Andrés Bello, Caracas, Venezuela

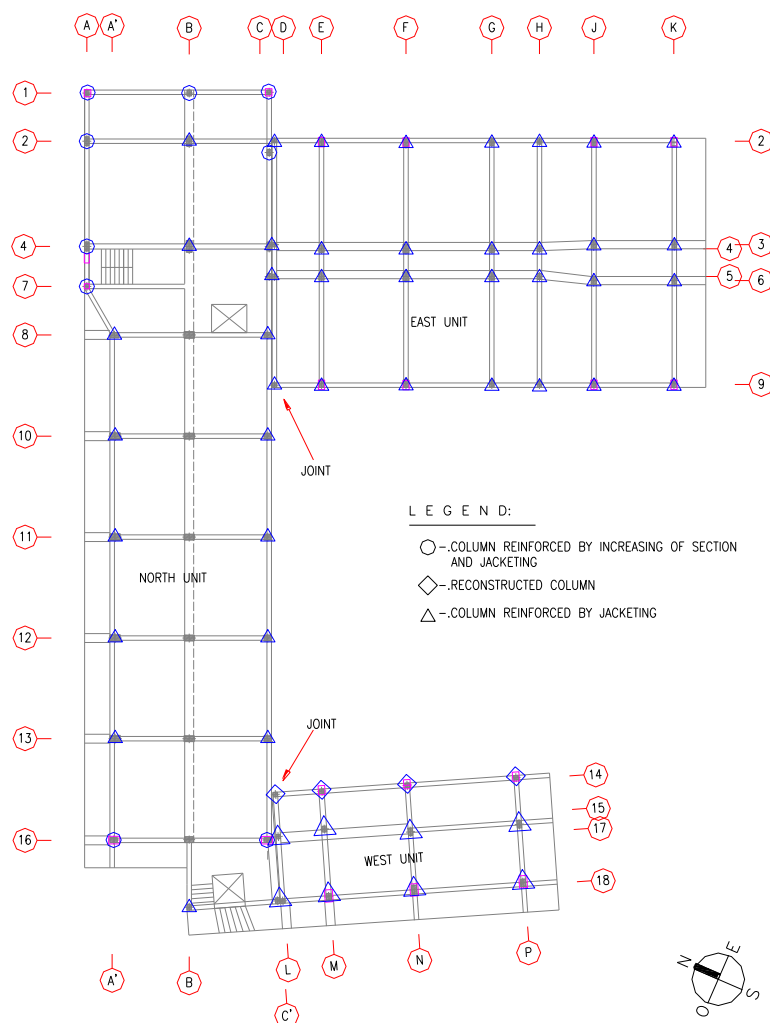
Figure 1. Plan configuration of Miramar Building. Column reinforced from Ground Floor to Level 1

The three units of Miramar building suffered damage in columns and partitions, which are concentrated mainly between the ground floor and first level. In the West Unit severe damage in the four columns of the frame 14 was observed (shoring was required) due to short column effect caused by interaction with the masonry wall that partially confines the frame (Figures 2 and 3); in the East Unit the damage was severe and widespread in columns of ground floor to level 1 from 2 to 6 axes due to the presence of soft-story (Figures 4 and 5), and in the Unit North damage was moderate and localized in the structure of the staircase between axes 4-7 and AB on the ground floor (Figure 6). The beams showed no significant damage. Damage to partitions was similar in the three units of the building and concentrated mainly on the ground floor and level 1 (Figure 7).

The reinforcement of the leather of the building consists of the following: (i) increasing the cross section (Figure 12) and jacking of columns A-1, B-1, C-1, A-2, C-2, A -4, A-7, A-16 and C-16 from ground floor to level 4 (see Figure 11), (ii) jacking of columns A'-4, A'-10, A'-11, A-12, A-13, C-4, C-8, C-10, C-11, C-12, C-13, C-18 and B-18 from ground floor to level 1 (see Figure 1); (iii) reconstruction of the stair East from ground floor to level 1.

1(see Figure 1) and (iii) reconstruction of the four columns of the frame 14 by encasing in high strength concrete with appropriate longitudinal and transverse reinforcement and separating them from the masonry wall in order to avoid the effects of short columns.
