# Seismic Response of Reinforced Concrete Buildings in Concepcion During the 2010, Maule Earthquake

**B. Westenenk, J.C. de la Llera, R. Jünemann, M. Hube & J.J. Besa**

*Pontificia Universidad Católica de Chile, Chile*

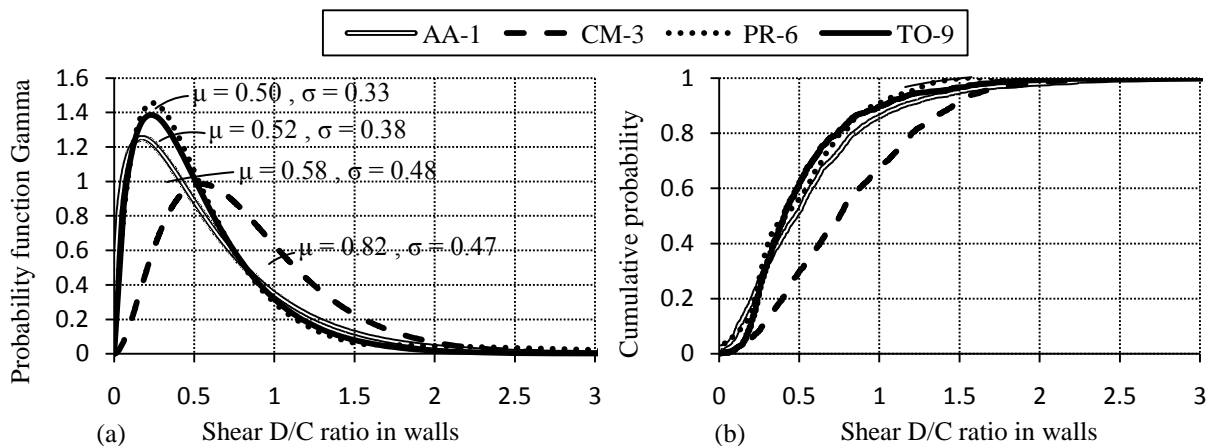
**Figure 5.1.** Damage data: (a) D/C histograms fitted to a Gamma distribution; and (b) cumulative probability for shear D/C ratios

The histograms of shear D/C ratios in walls for each building analyzed were fitted to a gamma distribution probability density function as shown in Figure 5.1.a. Cumulative probabilities are shown in Figure 5.1b. Although buildings AA-1, PR-6 and TO-9 show similar D/C distributions, the CM-3 curve is well below and displaced from the others. This emphasizes the fact that CM-3 has a weaker design condition. This behavior is confirmed by the similar axial-flexural results regarding D/C ratios.
