# Reduction of static and dynamic shear strength due to the weathering of mudstones

## SUMMARY:

An embankment of Tomei Expressway failed at Makinohara district during an earthquake in Japan. After the earthquake, detailed soil investigations and seismic analyses etc. were carried out to know the mechanism of the failure. One major reason was estimated as the weathering so called slaking of the mudstone filled about 40 years ago. In Japan there are many embankments constructed by mudstones. However weathering speed may be different in those embankments. So, the authors conducted several laboratory tests to study effect of slaking on static and dynamic strength of mudstones. Two types of test, cyclic torsional shear and triaxial tests were conducted for a fresh crushed-mudstone and a filled weathered-mudstone. Artificial weathering was applied to the crushed mudstone by heating and submerging. Test results showed static and dynamic strength decreased with the weathering. Five cycles of heating and submerging caused about 40% and 20% reductions of static strength and dynamic strength, respectively.

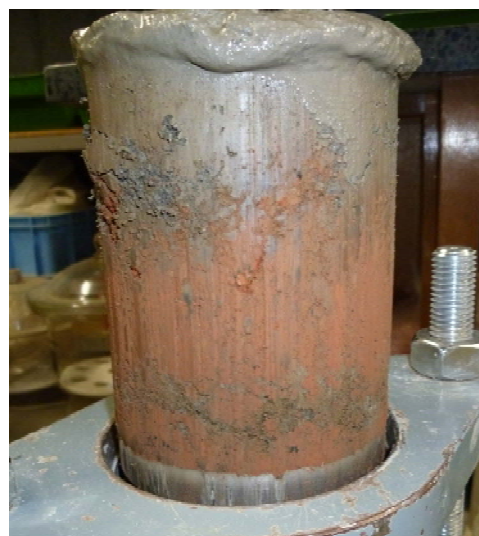
In Japan many embankments have been filled by mudstones because the restriction mentioned above was recognizes around 1973. For expressway test method for slaking was first introduced in design manual in 1985. However weathering speed of the mudstones may be different at each site. So, the authors conducted several laboratory tests to study effect of slaking on static and dynamic strengths of mudstones. Freshly crushed and not weathered mudstones shown in Figure 6 were taken at Fujieda where is near Makinohara, and properties of the mudstones are judged as similar with that at Makinohara. Artificial weathering was applied to the crushed mudstones by heating and submerging. Figure 7 shows the artificial weathering method which is similar as the testing method introduced in the design manual for expressway. The crushed fresh mudstones smaller than 19 mm in diameter were selected and filled in a mold with 10 cm inner diameter and 12.73 cm height. Then the mudstones were compacted to be 99.5% of the degree of compaction under 15% of air content. Then five cycles of heating with 110 degree by oven-dry method and wetting by submerging in a pond were repeated to cause slaking as described in Figure 7. Time of one cycle was decided as 96 hours which is twice compare with normal testing method for expressways because the mold used in this test was bigger than the mold used for normal tests. Figure 8 compares grain-size distribution curves of different degree of slaking. As shown in the figure, size of the particles of crushed mudstones decreased gradually with weathering. Figure 9 shows a sample after 5 cycles of slaking.

**Figure 9.** A specimen after 5 cycles of slaking

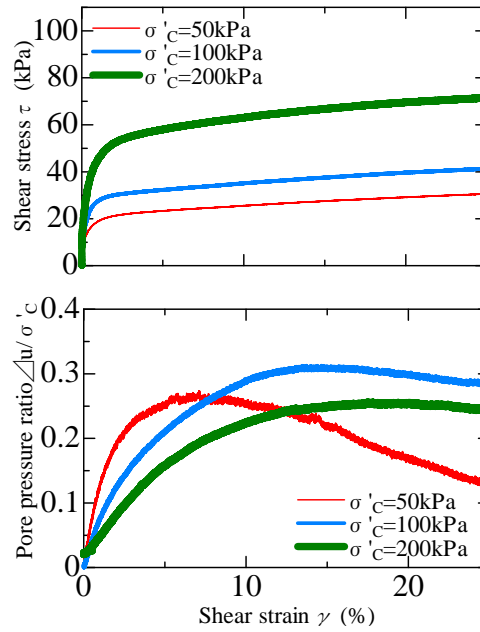
Two types of test, cyclic torsional shear and triaxial tests were conducted to obtain several kinds of static and dynamic behaviours. Of them, static stress-strain and pore pressure-strain relationships obtained by torsional shear tests for the 5 cycle weathered crushed mudstone under different confining pressures are shown in Figure 10. Shear stress increased gradually with the increase of shear strain. On the contrary, pore water pressure increased slightly in small strain then decreased with the increase of shear strain. These behaviours are similar as those of medium sands. Figure 11 shows stress paths together with failure lines for different degree of slaking and different confining pressure. Increasing rate of pore water pressure in small strain is different with confining pressure. The rate is small in low confining pressure because of the effect of overconsolidation during compaction. The failure line of fresh sample is the highest and the lines decrease with the number of slaking cycles. This means static shear resistance decreases with slaking. Reduction rate is different with confining pressure, but about 30% to 50% in the range of 50 to 200 kPa of confining pressure. Relationships between angle of shear resistance  $\phi$ ,  $\phi'$  and cohesion  $c$  and  $c'$  obtained from triaxial tests and torsional shear tests are summarized in Figure 12. Arrows show the decrease of  $\phi$ ,  $\phi'$  and cohesion  $c$  and  $c'$  with the number of slaking cycles. In the indication by effective stress,  $\phi'$  and  $c'$ , cohesion mainly decreased with slaking because the directions of arrows are almost horizontal.

**Figure 10.** Static stress-strain and pore pressure-strain relationships (5 cycle weathered crushed mudstone, torsional shear test)

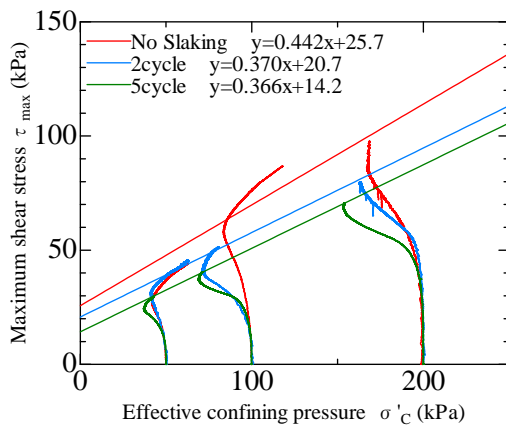
**Figure 11.** stress paths and failure lines for different degree of slaking and different confining pressure (crushed mudstone, torsional test)

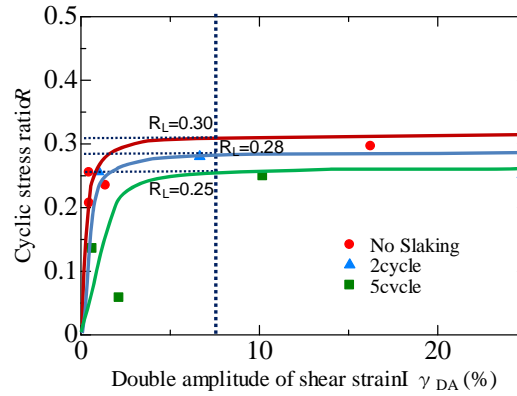
For dynamic shear tests, 20 cycles of cyclic loading with 0.1 cycles/sec. were applied to specimens as shown in Figure 13, under undrained condition and 100 kPa of confining pressure. Monotonic loading was applied under undrained condition at a speed of 10 % of shear strain/min. Time histories of shear stress, shear strain and pore water pressure during the cyclic and monotonic loading were measured. About 4 to 8 specimens were used for each test condition, and different amplitudes of cyclic loading were applied to each specimen to control the safety factor against liquefaction,  $F_L$ , which implies the severity of failure. The relationships between the cyclic stress ratio,  $R = \tau_d / \sigma'_c$  and the double amplitude of shear strain at the 20<sup>th</sup> cycle,  $\gamma_{DA} (N=20)$  are plotted on Figures 14. The stress ratio to cause 7.5% of shear strain by 20 cycles,  $R_L (\gamma_{DA}=7.5\%, N_L=20)$  was estimated. As shown in the figure,  $R_L (\gamma_{DA}=7.5\%, N_L=20)$  decreases with slaking. Reduction rate to five cycles of slaking is about 30%.

**Figure 14.** Relationships between the cyclic stress ratio and the double amplitude of shear strain at the 20<sup>th</sup> cycle

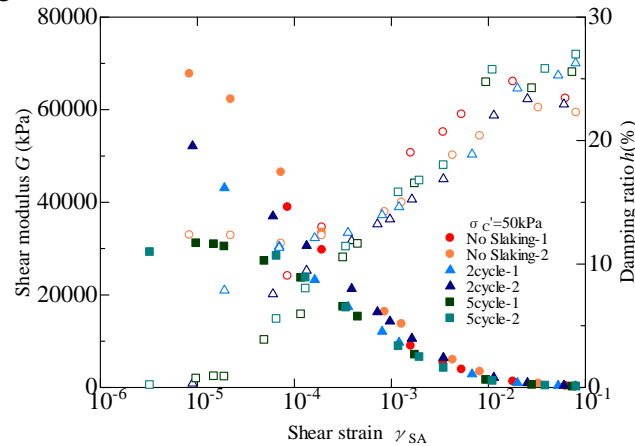
Another dynamic test was also conducted to demonstrate the effect of slaking on dynamic shear modulus and damping ratio. In the test 11 cycles of cyclic loading were applied to specimen with very small amplitude under undrained condition and 50 kPa of confining pressure. The amplitude of the cyclic loading was increased step by step up to failure. Shear stress – shear strain curves at 10 cycles in each step of loading were drawn to obtain dynamic shear modulus and damping ratios. Figure 15 shows relationships between shear strain and shear modulus, and shear strain and damping ratio in different slaking conditions. Shear modulus decreases drastically with slaking though damping ratio is not affected by slaking.

**Figure 15.** Relationships between shear strain and shear modulus, and shear strain and damping ratio
