An Investigation on the Pre- and Post- Repair Vibrational Characteristics of Two Gymnasiums Damaged by the 2011 Great East Japan Earthquake

M.Wakui, K.Araki & J.Iyama

15 WCEE
LISBOA 2012

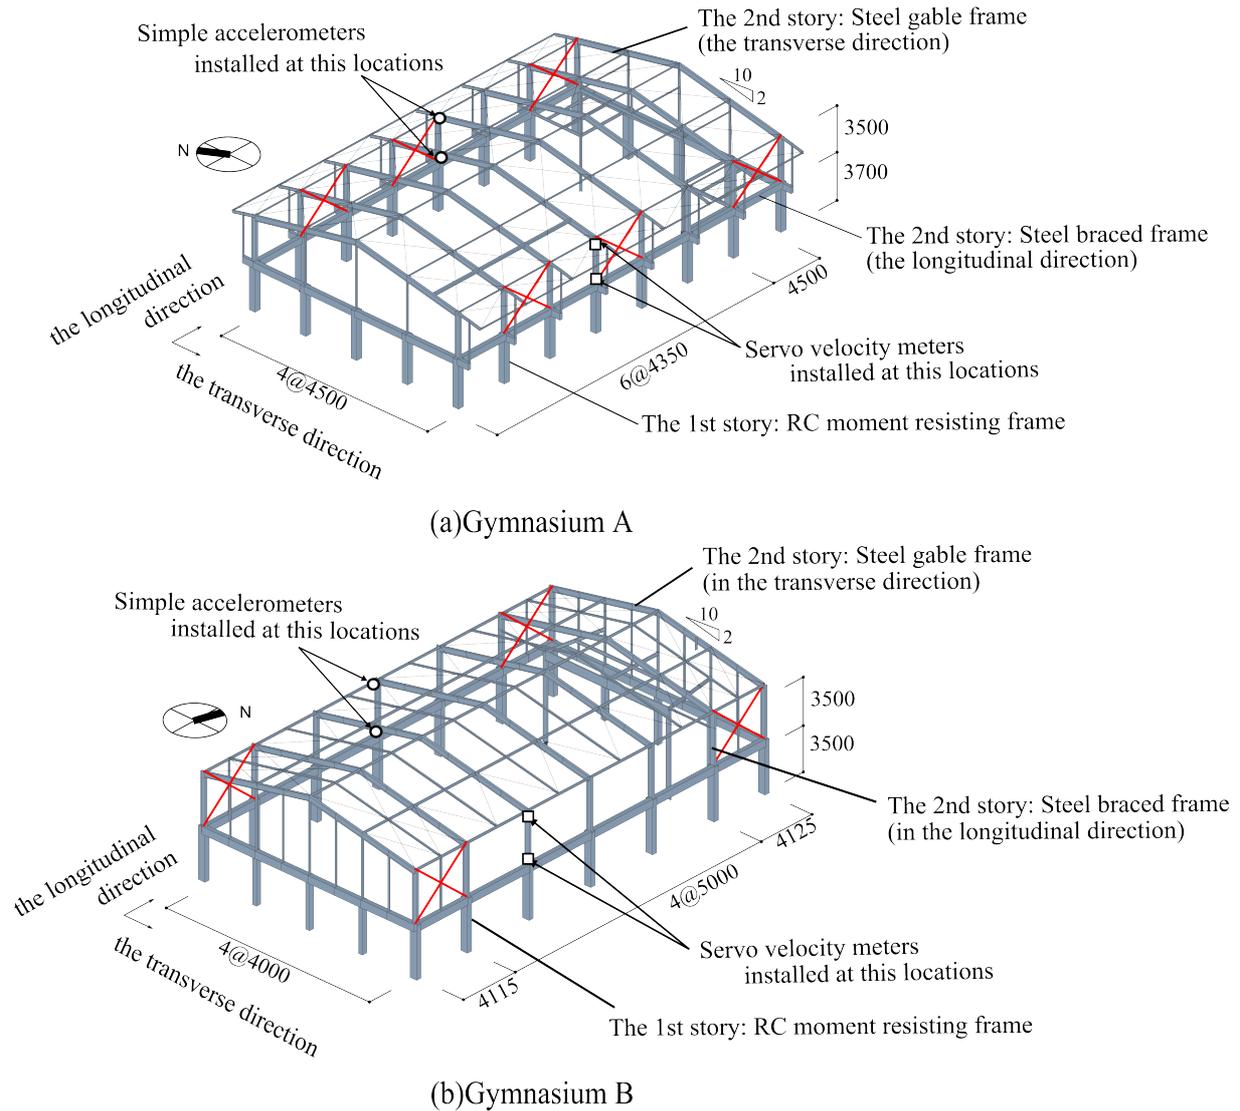
Figure 1. Diagram of the gymnasiums

The two investigated gymnasiums A and B, shown in Figure 1, are located in Sukagawa City, Fukushima. For both gymnasiums, the 1st story consists of a reinforced concrete moment resisting frame and the 2nd story a steel gable frame in the transverse direction and a steel braced frame in the longitudinal direction. Gymnasium A has rod bracing in 6 of its 14 longitudinal bays and gymnasium B equal leg single angle bracing in 4 of its 12 longitudinal bays. The structural elements used in both gymnasiums are described in Table 1. The emergency repair of gymnasium A was carried out in June, 2012 and the emergency repair of gymnasium B was carried out in February, 2012.

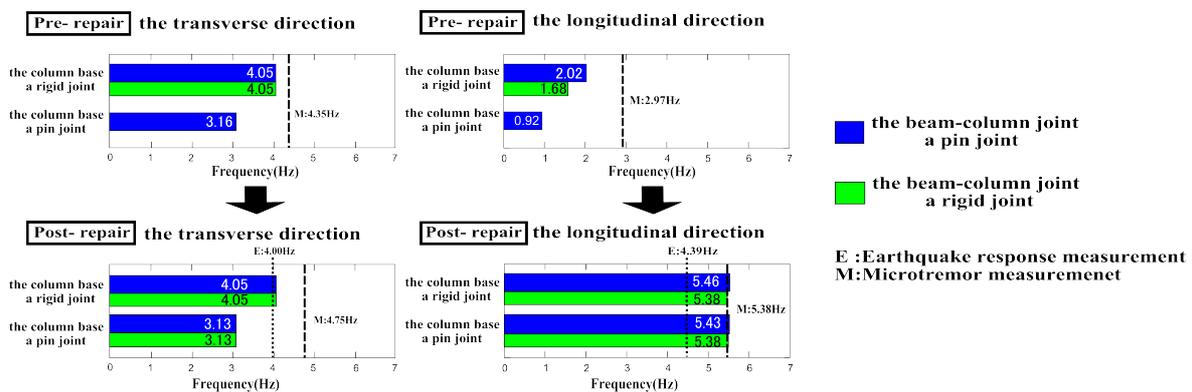
(a)Gymnasium A

Figure 6 shows the natural frequencies of vibration. The horizontal axis is the value of the frequency, and the vertical axis the analysis condition. Moreover, the thick dotted line shows the microtremor measurement results and the thin dotted line the earthquake response measurement results. In both gymnasiums, the change in natural frequency between pre- and post-repair is large in the longitudinal direction but small in the transverse direction. This is of course because the restoration only increased the stiffness in the longitudinal direction by inserting vertical braces. Since the eigenvalue analysis is a linear analysis and only considers the behaviour at small vibrations, the numerical results are only comparable with the microtremor measurements. The reason why the numerical frequencies are larger than the microtremor measurements may be because the mass was underestimated in the analysis due to neglect of the weight of the components other than the roof of the gymnasium.
