# Earthquake Damage Assessment of Reinforced Concrete Hotel Buildings in Hawaii

C.C. Simsir, C. Ekwueme, G.C. Hart & A. Dumortier  
Weidlinger Associates Inc., Marina del Rey, CA, USA

This paper presents an evaluation of damage to mid-rise reinforced concrete hotel buildings from the 2006 earthquakes on the island of Hawaii. Designed in the 1960s and 1970s with limited consideration for ductile detailing, the structural system of the hotels consisted of reinforced concrete shear walls, some of which transition to tall columns at the first two stories, providing a large open area for the lobby and the promenade. On-site damage investigation revealed that the buildings had sustained, among other structural damage, substantial cracking of the reinforced concrete shear walls and tall columns during the 2006 Hawaii earthquakes. Visual observations and concrete coring through epoxy injected cracks in the walls revealed the extent and the size of the cracks. Finite element analyses of the buildings revealed the amount and the nature of the cracking damage directly attributable to the earthquakes and differentiated it from cracking due to shrinkage. Numerically predicted regions of overs

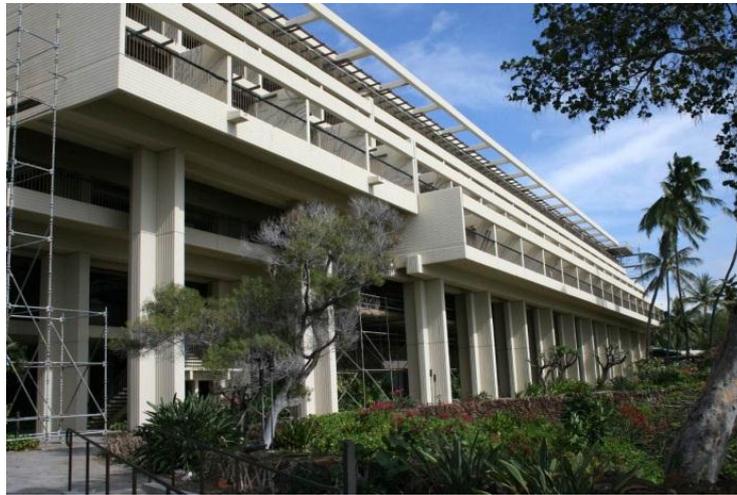
The hotels are located along the west coast of the island of Hawaii and comprised of multiple buildings that were constructed in the 1960s and 1970s. Figures 1 and 2 show overall elevation views of three buildings from three different hotel sites. The buildings typically consist of a 4- to 6-story tall, reinforced concrete structure with cast-in-place concrete flat slabs and reinforced concrete divider walls between hotel rooms and along hotel corridors. The floor slabs are typically 200 mm (8 inches) thick and supported by the divider walls, also typically 200 mm (8 inches) thick, which serve as both bearing and shear walls. Some of the buildings such as those shown in Figure 1 and Figure 2b have tall first stories where the shear walls in the upper floors transition to reinforced concrete transfer beams and tall columns, thus providing a large open space for the lobby, the promenade, and other common areas of the hotels. The tall concrete cruciform columns shown in Figure 1 vary in height between 3.7

**Figure 1.** Overall view of hotel building with tall columns at the first story.

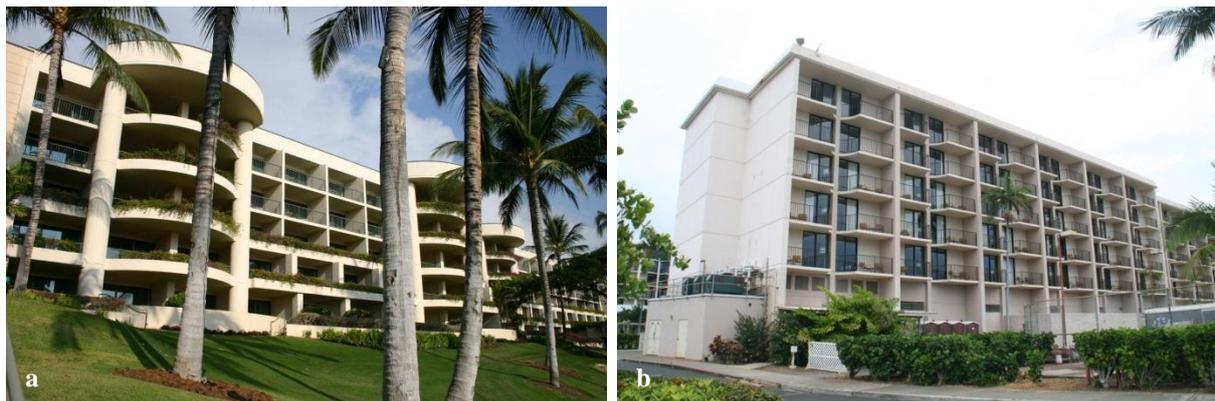
**Figure 2.** Overall views of hotel buildings with shear walls.

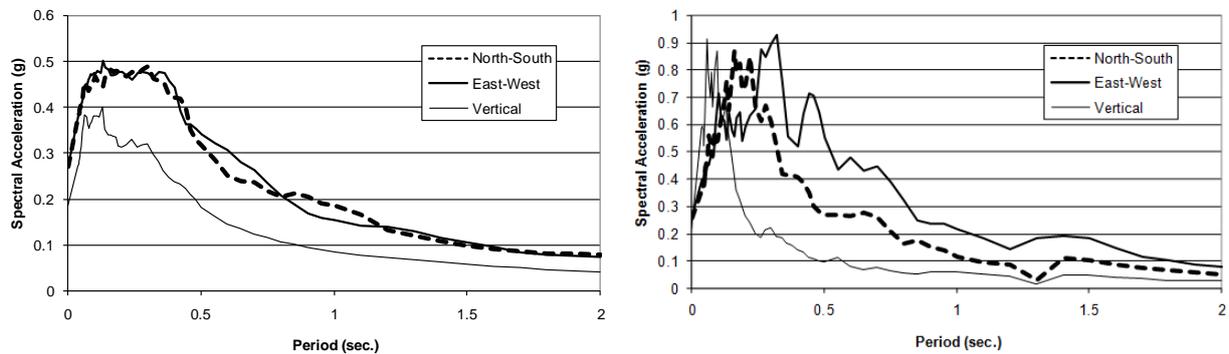
The effective peak acceleration (EPA) values of the estimated earthquake ground motion at the hotel sites are between 0.18 g and 0.23 g in the North-South direction, between 0.18 g and 0.26 g in the

East-West direction, and 0.12 g in the vertical direction. Figure 3 shows the 5% damped acceleration response spectra from the estimate of the ground motion experienced at the building sites during the 2006 Kiholo Bay earthquake.

**Figure 3.** Estimated site response spectra for the hotels for the 2006 M6.7 Kiholo Bay earthquake.

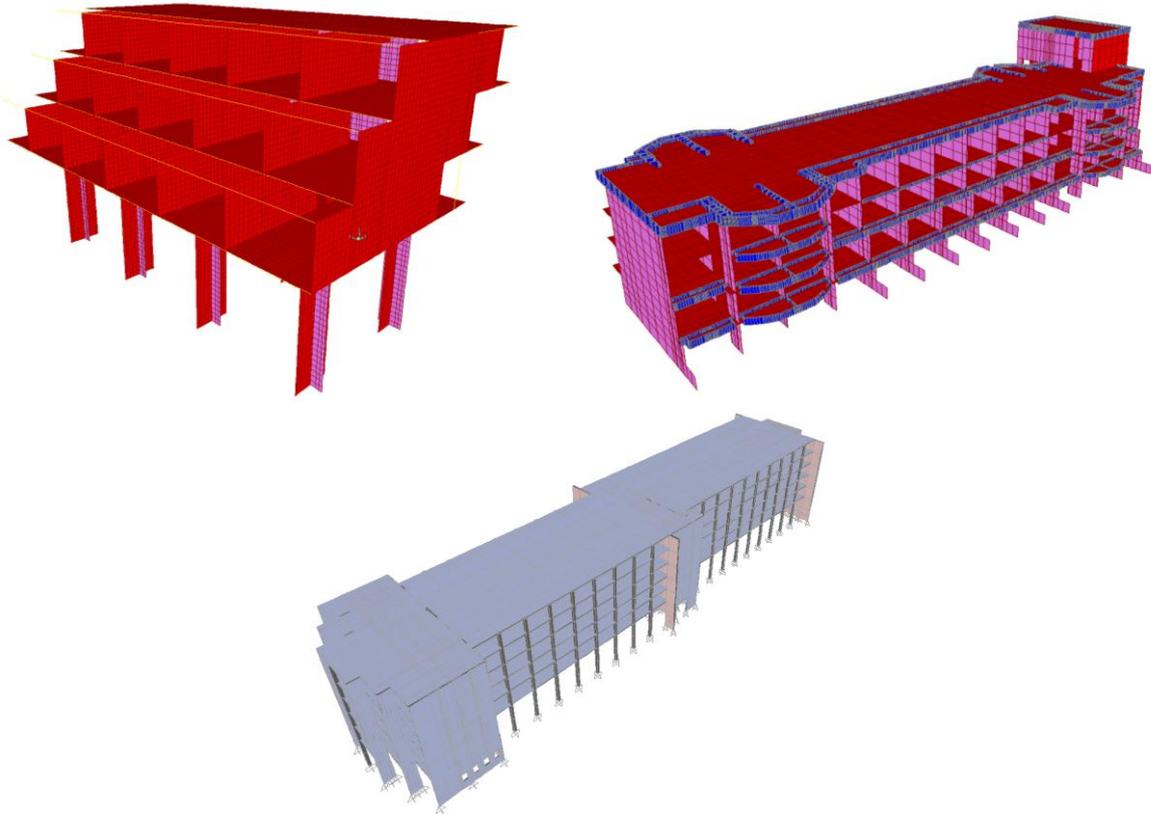
Three-dimensional computer models of various hotel buildings were developed using the SAP2000 software (Figure 11). In some cases, only a representative portion of the building was developed. These “substructure” models as well as the full building models included all the floors in the building, the concrete floor slabs, shear walls, columns, and beams. The floor slabs, shear walls, and the tall cruciform columns were modeled as shell elements; regular columns and beams were modeled as frame elements in SAP2000. The expected strength value for concrete and the effective stiffness values for concrete elements were used based on the specifications of ASCE 41 (ASCE, 2007).

**Figure 11.** Structural engineering analysis models for various hotel buildings.

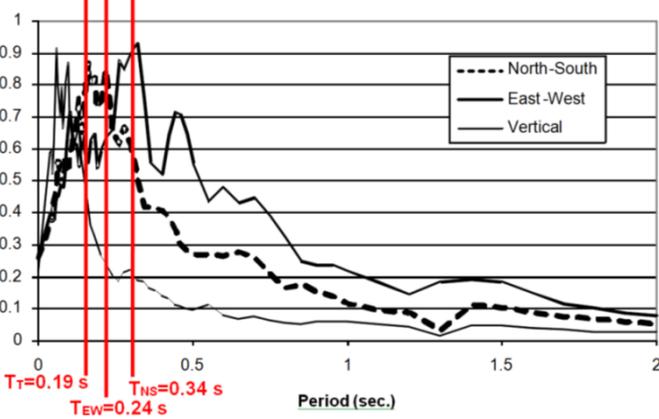
Modal analyses were performed with sufficient number of modes of vibration that contributed to more than 90% of the mass participation in both orthogonal directions and the vertical direction. The periods of vibration for the first three modes for one of the buildings are shown on the site-specific response spectra of the Kiholo Bay earthquake in Figure 12, which illustrates that these three modes with the largest mass participation coincide with the period range where the peaks of the response spectra occur. Modal analyses showed similar results for many of the other hotel buildings also. Proximity of the periods of vibration to the peaks of the response spectra results in amplified structural response due to the earthquake.

Figure 12. Periods of vibration overlaid on site-specific response spectra.

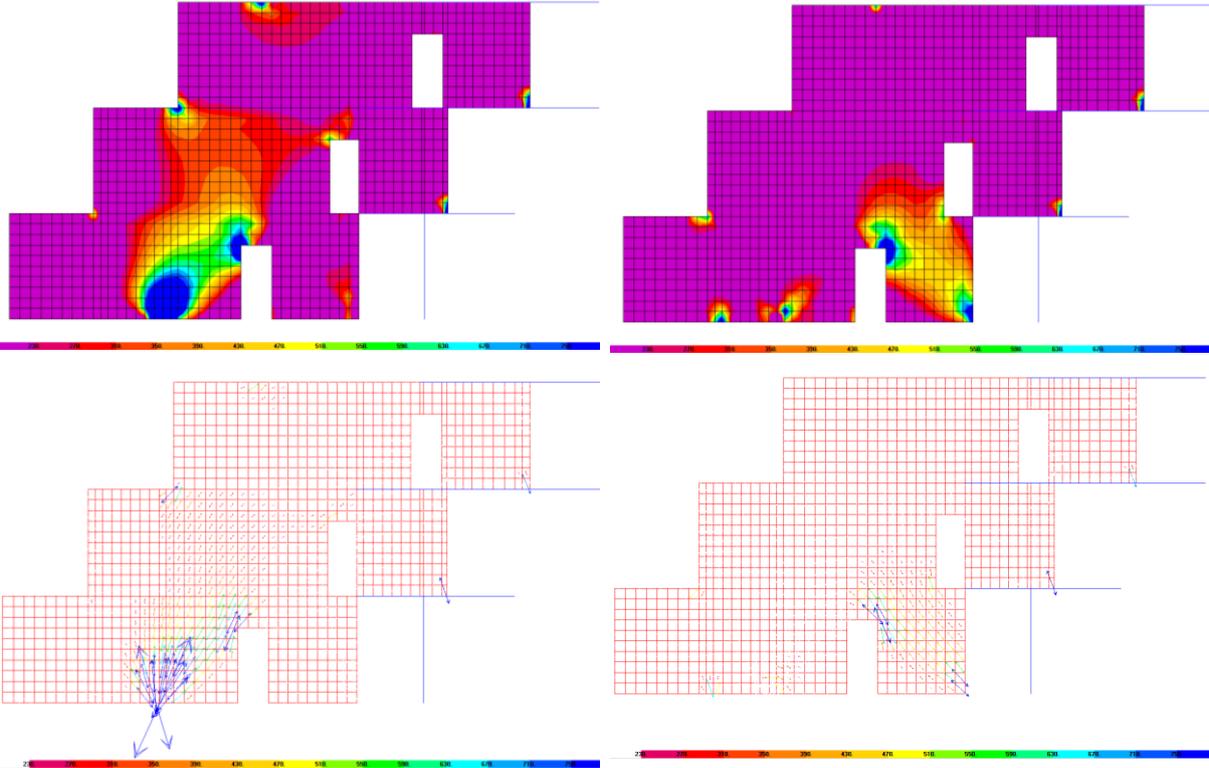
Based on the gravity and earthquake load analyses, contours of principal stresses in the shear walls and their corresponding directions were obtained for various load combinations to determine the location and magnitude of the earthquake induced stresses in the shear walls (Figure 13). Stress contours in Figure 13 are drawn such that the purple color indicates the stresses are smaller than the tensile strength of concrete and all the other colors indicate the stresses exceed the tensile strength of concrete. The direct tensile strength of concrete is calculated from equations in ACI 209R-92 (ACI, 1997). Directions of principal stresses are shown by arrows in Figure 13; the length of the arrow indicates the magnitude of the stress exceeding the tensile strength of concrete.

Figure 14a shows the location and direction of the expected cracks in the shear walls based on stress contours and arrows such as those shown in Figure 13. Cracking is typically along the direction perpendicular to the principal tensile stress direction. Figures 13 and 14a show that the stresses are greater and more widespread and the cracks are more severe in the lower floor walls than the upper floors. Stresses in the shear walls were sufficiently large to cause yielding of the reinforcing steel bars on the lower floors in some of the buildings. Figure 14b compares the pattern and direction of the observed cracks in a shear wall with the results of the computer analysis, indicating that most of the cracking is attributable to the earthquakes.

Figure 13. Stress contours and stress directions in walls.
