Preliminary Investigation of the Pile-foundation Buildings Leaned By Damage in the 2011 off the Pacific Coast of Tohoku Earthquake

SUMMARY:

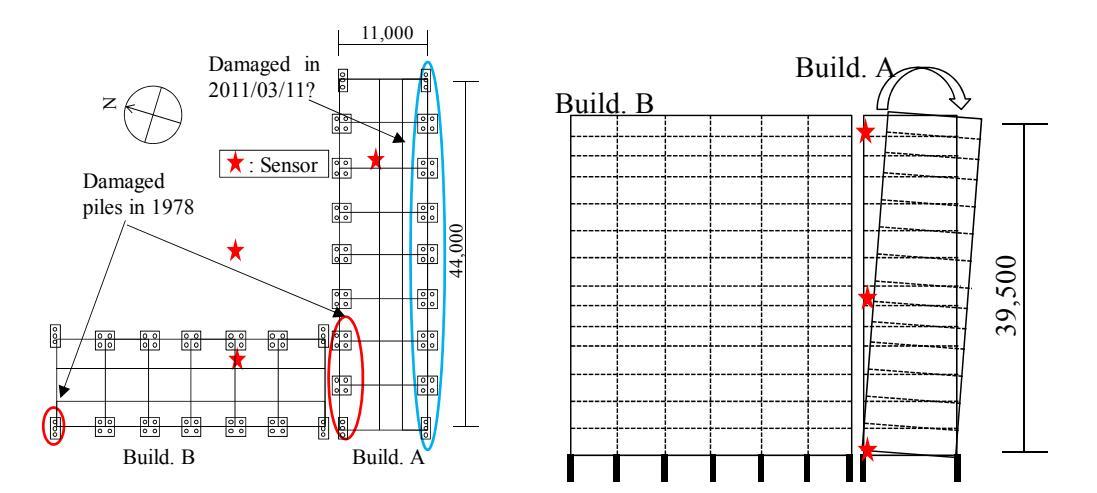
Figure 6. Schematic plan and section of the housing complex of STM

Schematic plan and section of the housing complex of STM are illustrated in Figure 6. Photos of the exterior appearance of the buildings are shown in Photo 1. Housing complex STM consists of the two buildings. Both of them are SRC 14-storey buildings supported by pile foundations. Pile foundations are organized by PC piles with autoclave technology of which diameters are 600mm and 500mm. Length of pile is 24m (two 12m-piles are connected by welding). Height of both buildings is about 40m. Construction of the buildings have completed in 1976. After the completion, the buildings suffered severe shaking and were heavily damaged by 1978 Miyagi off shore earthquake.

The buildings had been also damaged by the 1978 Miyagi off shore earthquake, and then some group piles that are marked by red circles in the left figure of Figure 6 were heavily damaged (Shiga 1980, Sugimura and Oh-oka 1981). According to the damage investigation report of the 1978 Miyagi off shore earthquake, concrete body of pile were crushed, some steel bars indicated buckling and shear cracks were observed at the pile head in some group piles as shown in Figure 7. Those buildings were restored after the 1978 Miyagi earthquake, and residents have kept living in those buildings before the earthquake of March 11 occurred.

After the main shock of 2011/03/11, the buildings have been heavily damaged by strong shaking again. Building A and B were connected by expansion joint that were demolished by dynamic behavior of the buildings. Building A and B forms L-shape plan shown in Figure 6. Dynamic behaviour of each building is completely different, because strong axes cross each other. Most characteristic damage is

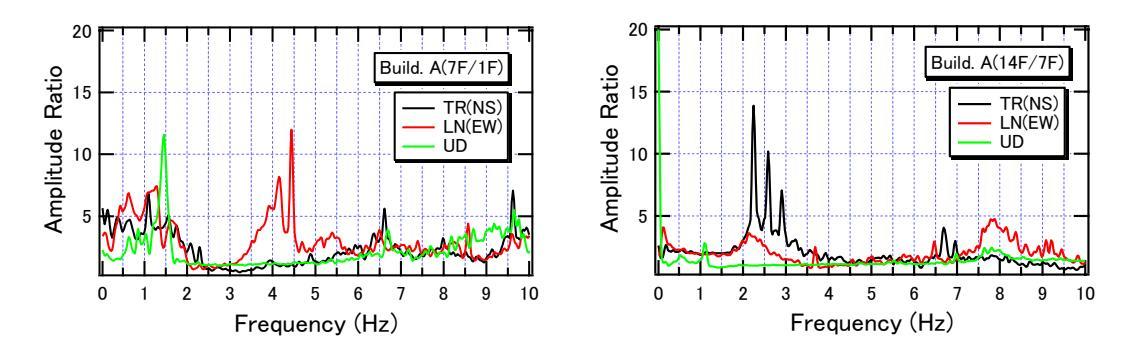
Figure 9. Amplitude ratios between 7F /1F and 14F/7F of the building A

Amplitude ratios between 7F/1F and 14F/7F of the building A are shown in Figure 9. In case of the building A, transverse direction (TR) of the building corresponds to NS direction, longitudinal direction (LN) to EW direction as indicated in Figure 6. The peak considered the first natural frequency of the building appears around 1Hz in both of TR and LN direction in case of 7F/1F. LN direction has the second distinctive peak around 4Hz. The range of the peak around the first natural frequency tends to be wide in the two horizontal directions. It should be noted that clear peak of 1.5Hz is observed in UD direction. The day when the microtremor measurements conducted was quite windy. Especially, the wind in NS direction corresponding to TR direction of the building was severely strong. Therefore, the results suggest that the effect of the strong wind might appear in the vibration characteristics of the building. In the results of 14F/7F, a few peaks can be observed over 2Hz. While TR direction has three peaks between 2Hz and 3Hz, the peak around 2Hz in LN direction looks ambiguous.

Through Figure 9 to Figure 12, the first natural frequency of the building seems to be between 1Hz and 2Hz. The second peak can be observed between 3Hz and 4Hz only in LN direction. Second peak cannot be recognized in TR direction. Based on the results, it can be assumed that dynamic behaviour in LN direction tends elastic on the other hand, rigid behaviour in TR direction. Phase difference around the first natural frequency in 7F/1F indicates the effect of strong wind. The reason that the effect of strong wind cannot be recognized in 14F/7F can be due to the assumption that the transfer function between 14F and 7F is isolated from the effect of the dynamic behaviour of the ground.

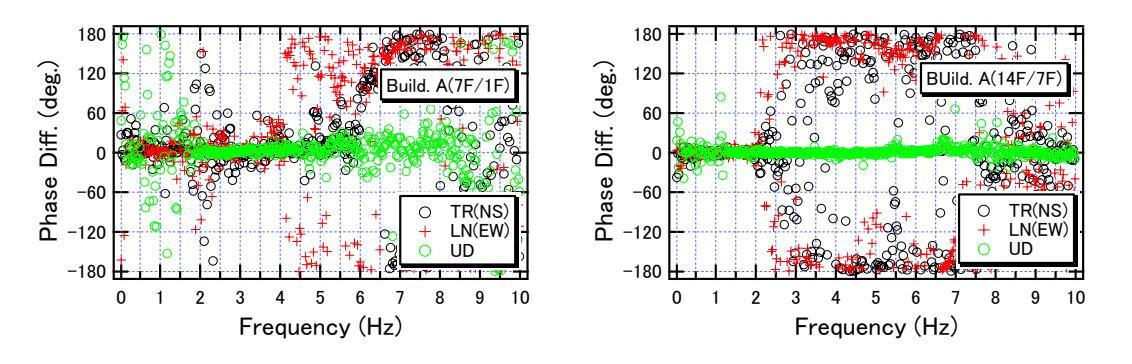
Figure 10. Phase differences between 7F /1F and 14F/7F of the building A

Figure 10 shows phase differences of 7F/1F and 14F/7F. If the peak around 1Hz of 7F/1F is considered the first natural frequency, behavior of phase difference looks odd. The behavior of phase difference around 1Hz in 7F/1F may indicates the effect of strong wind. Strange behavior around 1Hz such as 7F/1F cannot be observed in the result of 14F/7F.

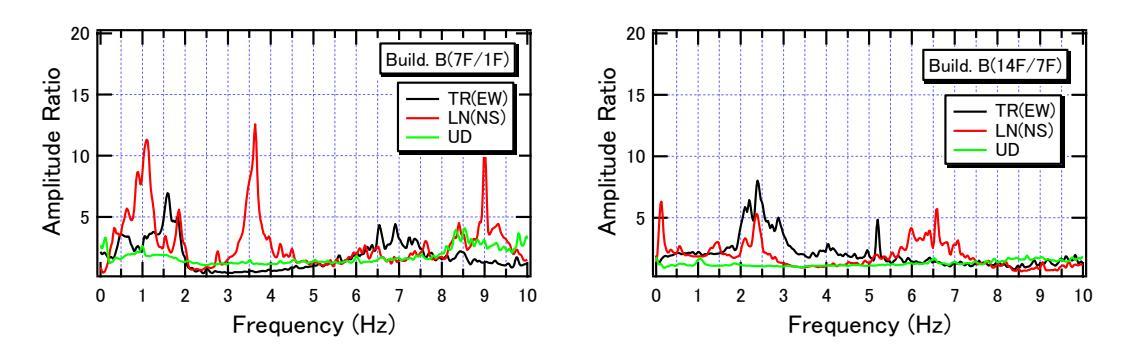
Figure 11. Amplitude ratios between 7F /1F and 14F/7F of the building B

Amplitude ratios between 7F/1F and 14F/7F of the building B are shown in Figure 11. In case of the building B, It should be noted that transverse direction (TR) of the building corresponds to EW direction, longitudinal direction (LN) to NS direction as indicated in Figure 6. Those are opposite to the building A. The peak considered the first natural frequency of the building appears clearly 1.5Hz

and 1Hz in TR and LN direction in case of 7F/1F, respectively. In LN direction, the second peak can be clearly found between 3Hz and 4Hz. Amplitude ratios of 14F/7F indicate that the first peaks appear around 2Hz in horizontal directions as well as the building A.

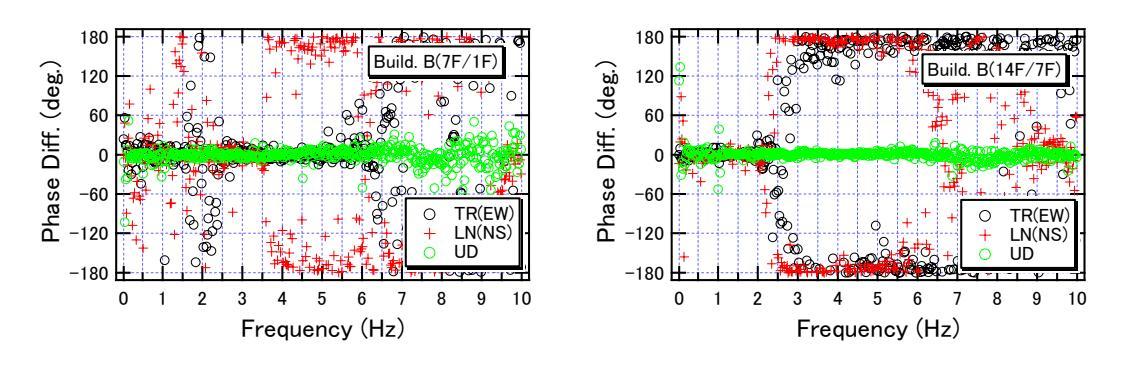
Figure 12. Phase differences between 7F /1F and 14F/7F of the building B

Phase differences around 2Hz in case of 7F/1F may indicate the effect of strong wind similarly as the building A. The effect of strong wind seems not to be observed in phase difference of 14F/7F.

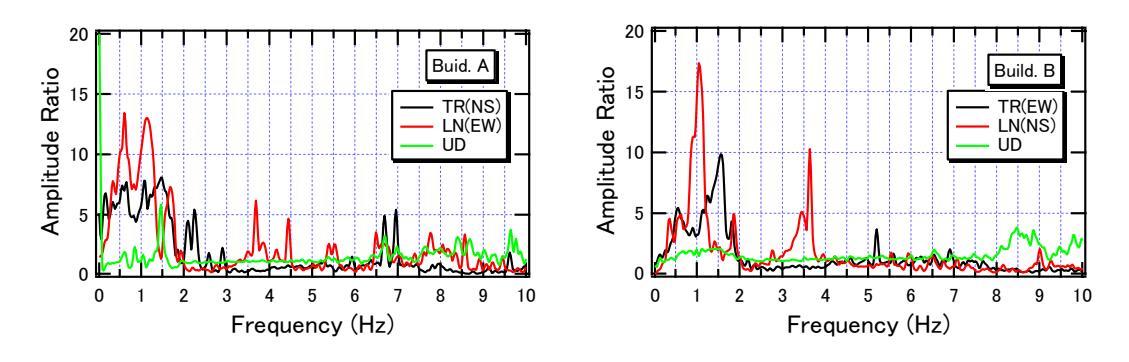
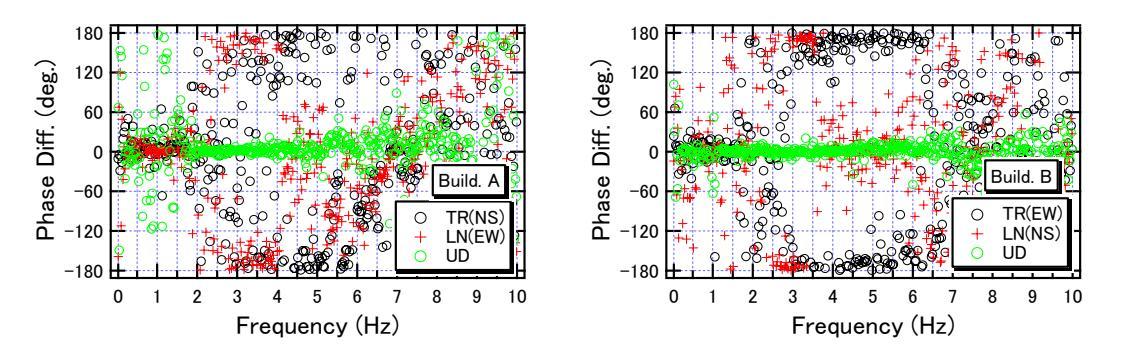
Combining transfer function of 7F/1F and 14/7F, transfer functions between 14F/1F are estimated. Estimated amplitude ratios and phase differences between 14F/1F are shown in Figure 13 and Figure 14, respectively. Left figures are the results of the building A, and right figures are those of the building B. Amplitude ratios of the building A indicate the peaks around 1Hz having the relatively wide range. Especially, the peak in LN direction split into two peaks around 1Hz. The result suggests torsional motion. LN direction has the second peak between 3Hz and 4Hz. Amplitude ratios of the building A between 3Hz and 4Hz. Amplitude ratios of the building B have clear peaks around 1.5Hz in TR and 1Hz in LN direction. LN direction has the second peak between 3Hz and 4Hz as well as the building A. Namely, TR direction has one peak around 1 to 1.5Hz, on the other hand, LN direction has two peaks around 1 to 1.5Hz and between 3Hz and 4Hz. This result can be interpreted as the fact that dynamic behavior of TR direction is close to that of rigid medium with rocking motion at the bottom. Phase difference in UD direction of the building A fluctuates around 1Hz. Broaden wide range of the first natural frequency and phase difference behavior around 1Hz in the building A can be considered to be relevant to the effect of strong wind.

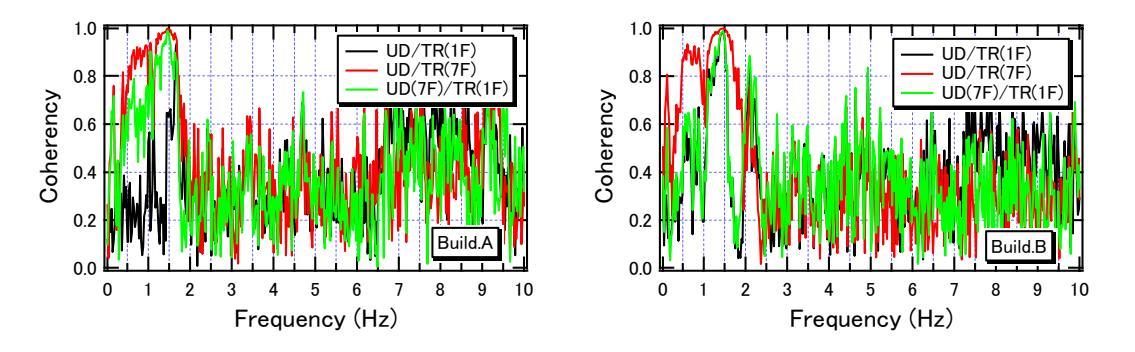
Figure 15. Coherency function between UD and TR motion of 7F /1F

To examine the spectral peak in 1.5Hz observed in amplitude ratios of UD direction of the buildings in Figure 9, correlation relations between UD and TR motions are investigated. Coherency functions representing correlation relations between 7F and 1F are shown in Figure 15. Coherency functions are obtained for three cases as UD and TR of 7F, UD and TR of 1F, and UD of 7F and TR of 1F.

Results in Figure 15 indicate high coherency from 0.5 to 1.5 Hz at 7F corresponding to the first natural frequency of the building. At the first floor of the building A, coherency function of UD and TR indicates low correlation. High coherency function from 0.5 to 1.5 Hz can be considered to be relevant to rocking motion of the building in TR direction. This phenomenon is observed in the results of both buildings.

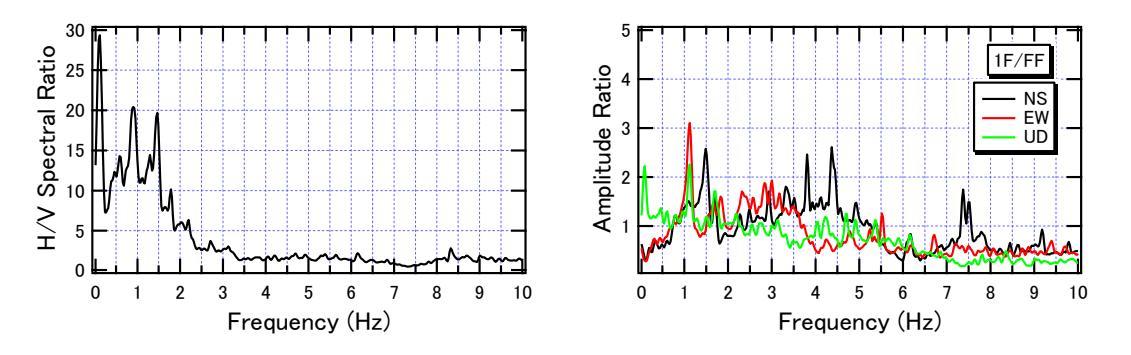
Figure 16. H/V spectrum of the ground and amplitude ratios between 1F and the free field

Measurement to obtain the dynamic characteristics of the ground was also carried out. Results of the ground are expressed by "FF (Free field)". H/V spectrum and amplitude ratios between 1F and FF are shown in Figure 16. The peak of H/V spectrum exists around 1Hz. This result doesn't meet good agreement with the results from the theoretical transfer function using estimated shear wave velocity data shown in Figure 5. Peaks are also observed around the natural frequencies of the buildings in amplitude ratios of 1F/FF.
