Study of vulnerability and damage: the case study of Castelnuovo after L'Aquila earthquake (Italy)

B. Ortolani, A. Borghini, S. Boschi, E. Del Monte & A. Vignoli Department of Civil and Environmental Engineering, University of Florence, Italy

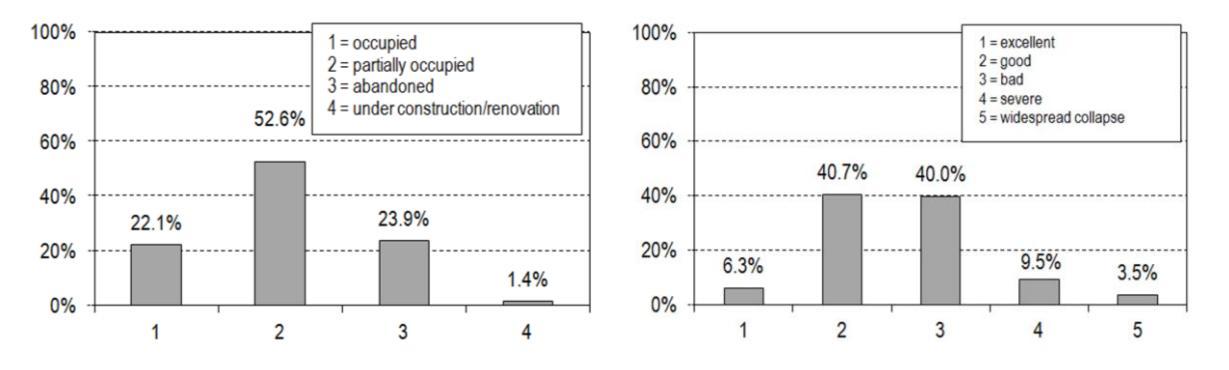
It has been also evaluated conservation status of buildings pre-earthquake (Fig. 3.2.b.). Specifically, each structural unit has been classified using one of the following items: excellent (1), good (2), bad (3), severe (4), widespread collapse (5). Buildings inside the perimeter had bad conservation status before earthquake related to the absence of occupation.

Figure 3.2. (a) Occupation status ante-earthquake. (b) Conservation status ante-earthquake

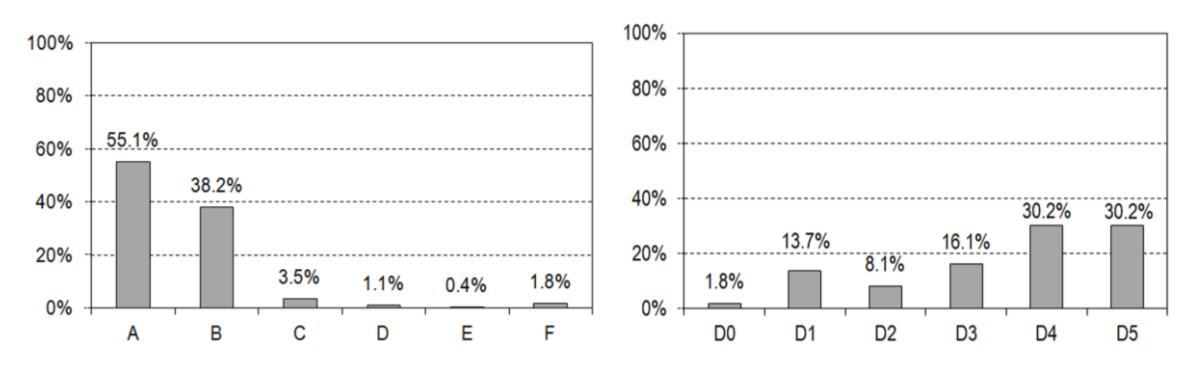
For the buildings located inside the perimeter of Castelnuovo, about 93% of the structural units lies in the most vulnerable classes (class A and B); in particular, 55.1% of the buildings belongs to vulnerability class A (irregular stone masonry with low efficient connections) and the remaining

38.2% of the buildings belongs to the vulnerability class B (irregular stone masonry with efficient connections or regular masonry with low efficient connections).

Figure 4.1. (a) Vulnerability classes. (b) Damage levels

Also the level of damage (Fig. 4.1.b.) has been evaluated with the EMS-98 scale: for the buildings located inside the perimeter it is possible to observe that 60.4% of the structural units has suffered serious damages to the structural elements (D4 and D5 level of damage), with some cases characterized by total collapses.

In particular, only 15.5% of the units has not suffered damages to the structural elements (D0 and D1 level) while 76.5% is characterized by considerable damages to structural parts (D3, D4 and D5). It is important to underline that the concentration of serious damages (D4 and D5) is mainly located on the top and central part of the village, where the older buildings were.

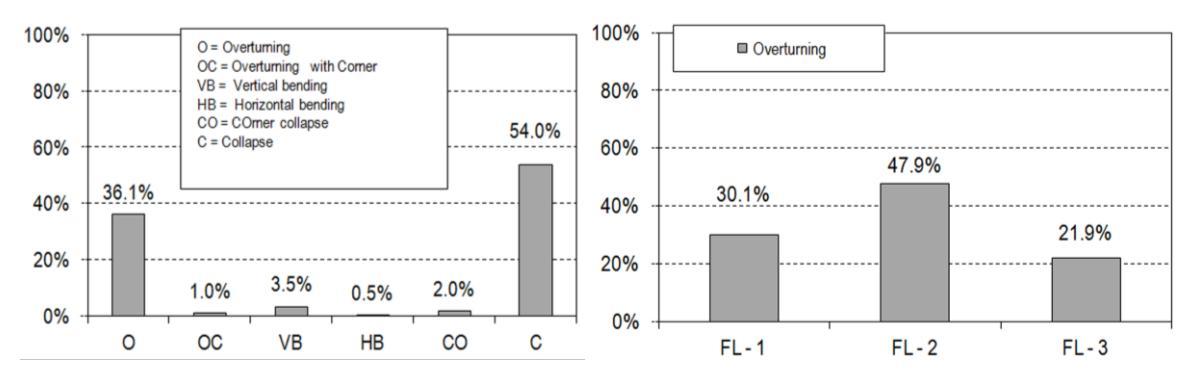
The percentages of out-of-plane mechanisms are shown in the first histogram above (Fig. 4.4.a.) for stone masonry structural units with high damage level (D3, D4 or D5): the majority of activated mechanisms is classified as overturning of a monolithic wall (36.1%) and it concerns both principal and rear façade of buildings. An high percentage is referred to collapse of walls (54.0%) and it is linked to the structural units with D5 assigned damage level. For each type of local mechanism the number of floors involved is identified. It is significant to report only the result for overturning mechanism because of the large involved data (Fig. 4.4.b.). 30.1% of cases is referred to a single floor

Figure 4.4. (a) Out-of-plane mechanism. (b) Floors involved in overturning mechanism

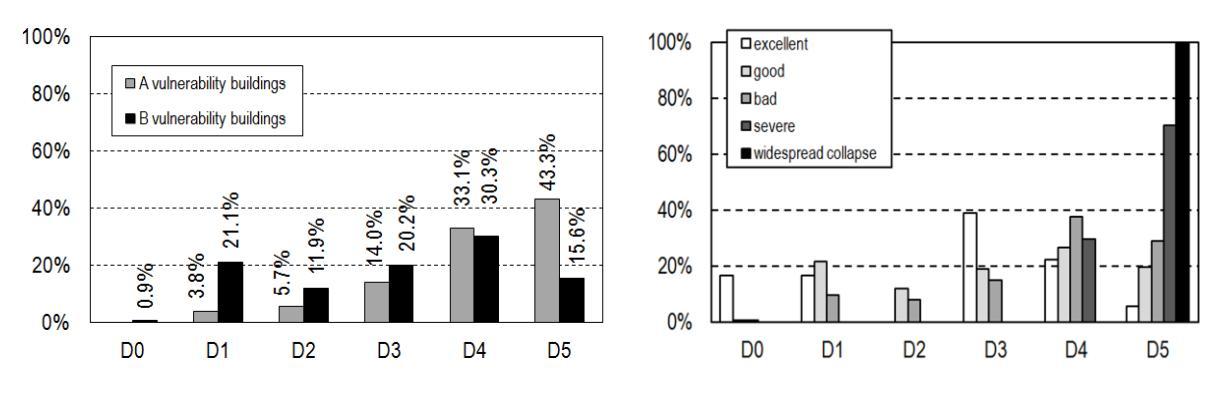
Analyzing the correlation between vulnerability and damage levels (Fig. 4.5.a.), as expected, emerges that the most vulnerable buildings also have higher level of damage. In particular, 76.4% of the buildings in vulnerability class A has suffered significant structural damage (D4 or D5 class). The second histogram (Fig. 4.5.b.) shown that the buildings with a very bad conservation status ante

earthquake (53%) have suffered relevant damage (D4 or D5) in 88% of cases, while the buildings for best-preserved this percentage drops to the 66%.

Figure 4.5. (a) Correlation vulnerability-damage. (b) Correlation conservation status-damage

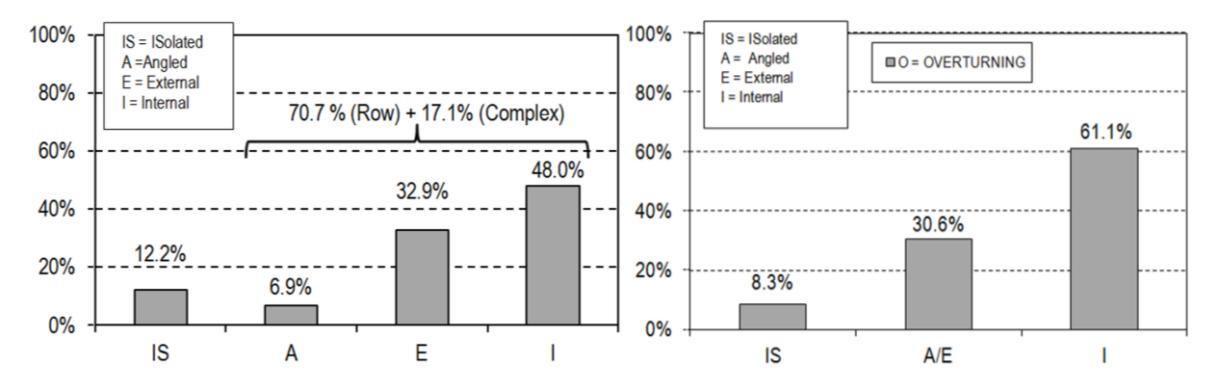
Analyzing the position occupied by structural units in which overturning mechanisms are activated, it is possible to notice that these mechanisms involve aggregate buildings rather than isolated ones. More precisely, within row and complex aggregates, the overturning occurs for 61.1% in the internal structural units, in facades (Fig. 4.7.b.). These walls are particularly vulnerable to this type of mechanism because of the limited connection with orthogonal walls and the lack of tie on the top.

Figure 4.7. (a) Aggregation of buildings. (b) Position of structural units involved in overturning
