"ANALYSIS OF THE BEHAVIOUR OF THE PUERTO MONTT, BANCO CENTRAL
DE CHILE STRUCTURE"

"ANALYSIS OF THE DAMAGE CAUSED BY THE 1960 EARTHQUAKES IN A
BUILDING OF THE CHIPRODAL FACTORY IN LLANQUIHUE, CHILE"

THE DEPARTMENT OF SCIENTIFICAL AND TECHNOLOGICAL RESEARCH
OF THE CATHOLIC UNIVERSITY OF CHILE

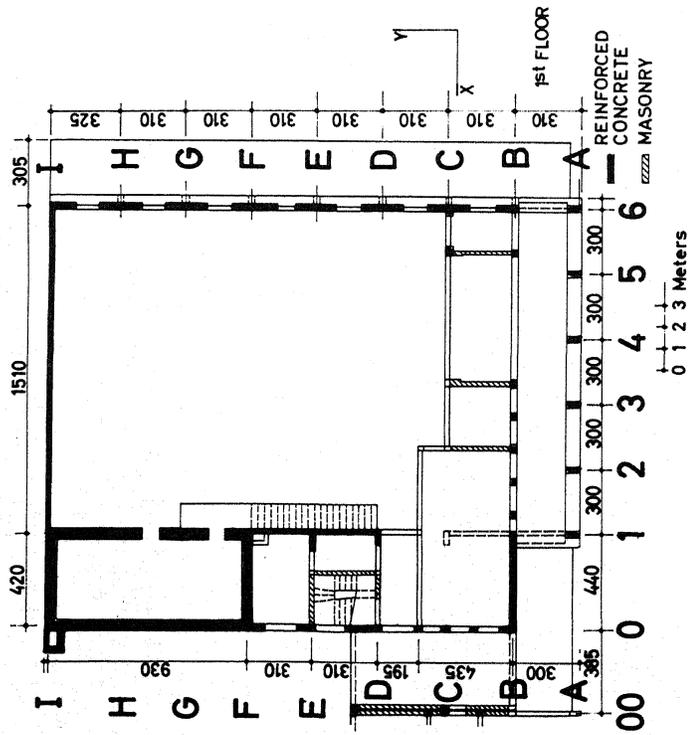
FIG. 11

The damage observed in the building after the earthquakes is principally concentrated around a part of the structure, that is, the intersection of axis 1 and B. (According to indications on the Figs. 10, 11 and 12).

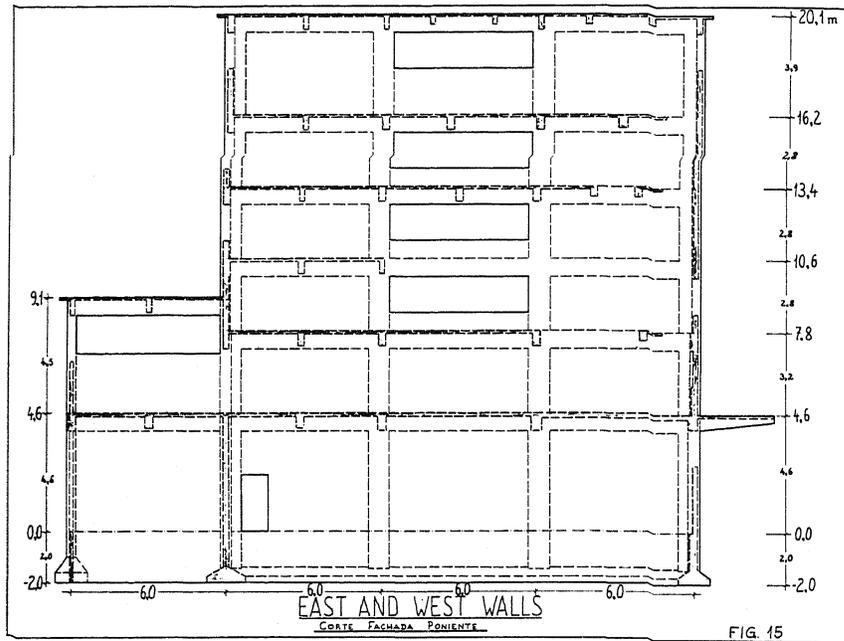
FIG. 14

See figures No. 13 to 16.
