## Experimental analysis of one-tenth scale reinforced concrete model of a ten storey building

**ABSTRACT:** Results of tests conducted on small-scale reinforced concrete models are presented in this paper. Models of vertical cantilever beams, isolated walls and a whole earthquake resistant system of an actual building that withstood the March 3, 1985 earthquake in Viña del Mar (Chile), were constructed at a scale 1:10 and tested under reverse cyclic loads.

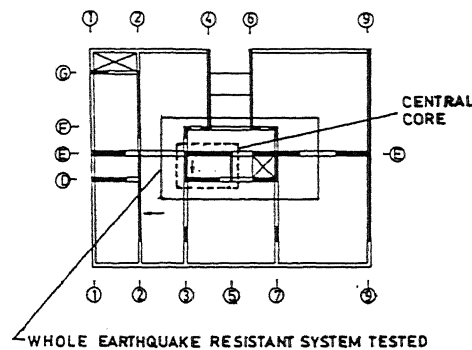
Figure 1. Plan configuration of the earthquake resistant system on the Villa Real building.

The main structure is a slab-girder wall system, founded on a 70 [cm] mat-type foundation. The layout of the earthquake resistant system of the building is shown in Figure 1, there the area studied in 1:10 scale model is included. Figure 2 shows building cross-section sets and indicates cracks observed in the actual building after the earthquake, for the N-S direction effect. Structural damage due to the earth-

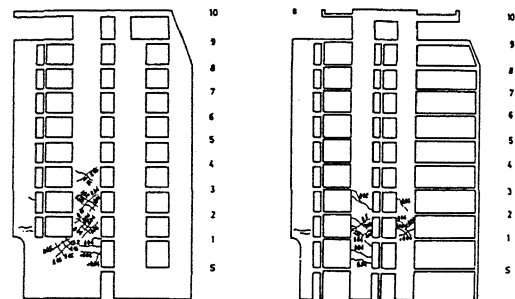
Figure 2. Villa Real cross-section sets. Cracks observed after of March 3, 1985 earthquake are indicated

quake was minimal and was concentrated near the base of the structure. Diagonal cracking was observed in the structural walls of the first, second, and third stories with most cracks measuring less than 0.2 [mm] wide. Additional information related to the building dimensions, including the specified material properties, is listed in Table 1.

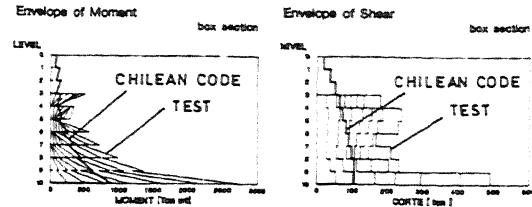
Figure 4. Shear and bending moment distribution in height at the box section.

Horizontal cyclic monotonic loads were applied at the top of both specimens. Comparison between shear and bending moment distribution in height at the box section obtained during test, and results from analysis according to the Chilean Code NCh 433 of 72 are plotted in Figure 4.

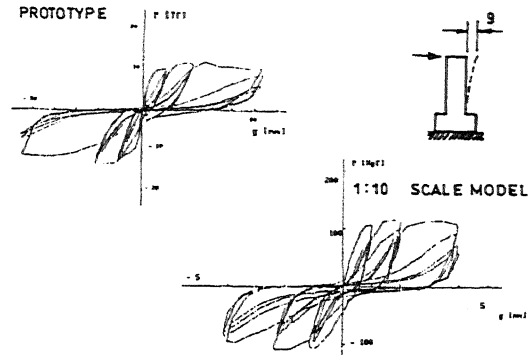
Figure 5. Load-displacement relationships in prototype and model for cantilever beams.

The load-displacement results from tests of both the model and prototype are presented in Fig. 5. It is evident from this Figure that strength, stiffness, and hysteresis loop properties are similar in the prototype and in the model.

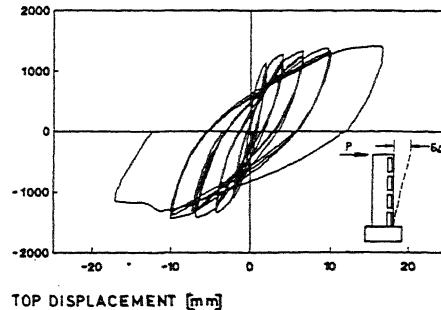
Figure 6. Force vs roof lateral displacement relationship, supplied bending moment and shear strengths at the central core.

Crushing of concrete and buckling of steel occurred at final cycle of 20 [mm] roof displacement. Force vs roof lateral displacement relationships, and supplied bending moment and shear strengths are shown in Figure 6.

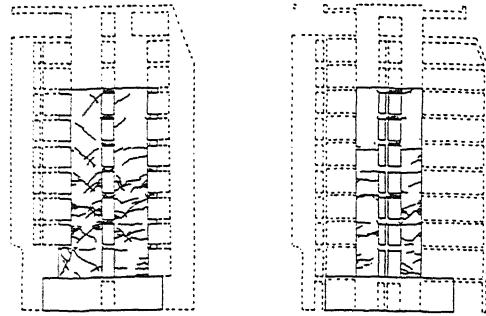
Figure 7. Final cracking in model

Failure of the box section, due to steel fracture in the flange (axis 3) occurred at the third floor at a top lateral displacement of 30 [mm] (1.63 % of total height). Before fracture, a bar buckled in one corner of the box section. Final cracking in model is shown in Figure 7.

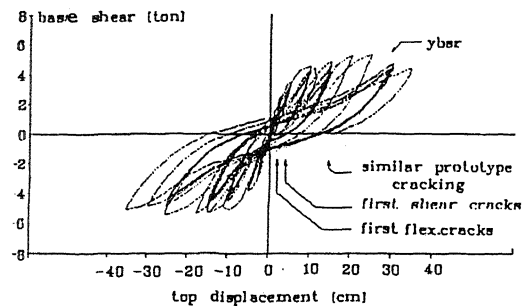
Figure 8. Roof lateral displacement versus normal base shear

In Figure 8, roof level lateral displacement versus normal base shear is plotted, indicating the load level at which cracks appears. YBSR indicates yielding of both the flexural and mesh reinforcement in the extreme tensile regions of the walls.

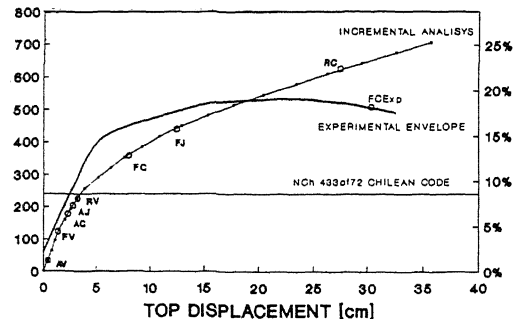
Figure 9. Roof level lateral displacement of the whole earthquake resistant system specimen

Initial cracking in all coupling beams started at a roof displacement of 2.5 mm [0.14% of height]. Figure 8 shows analytically predicted using Drain 2D [Kanaan & Powell (1973)] and test results values of floor level lateral displacements for the whole earthquake resistant system specimen.
