## **VIBRATION-BASED IDENTIFICATION AND ASSESSMENT OF A 3D COMPOSITE FRAME STRUCTURE AT DIFFERENT DAMAGE LEVELS**

### **SUMMARY**

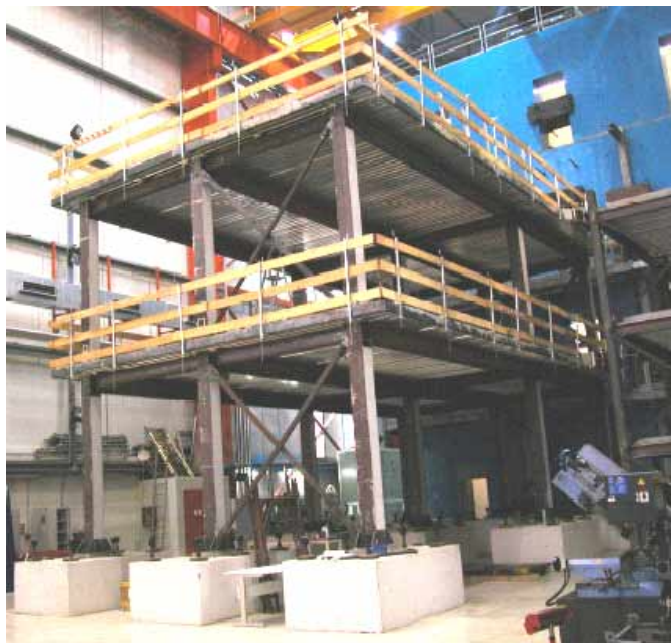
Fig. 5. Front-side picture of the test structure

Partial-strength beam-to-column joints have been designed to provide a joint rotation of 35 mrad associated to a residual strength of at least 80 % of the maximum strength. A sketch of the specimen and a joint detail are shown in fig. 5 and 6, respectively. Similar performances have to be guaranteed by base joints, composed by a thick extended plate welded to the columns and connected to the reinforced concrete foundation blocks by hooked rebars threaded at the upper end. The gap between the plate and the foundation has been filled with grout. A complete description of the structure and utilized materials can be found in [24].
