DEVELOPMENT OF DAMAGE REPAIR PROCEDURES FOR EARTHQUAKE DAMAGED BUILDINGS

This paper briefly outlines the preparation by BRANZ Ltd of an Earthquake Damage Assessment Catalogue for the New Zealand Earthquake Commission (EQC) to assist with the efficient assessment of house damage and repair strategies following a major earthquake. The paper describes a series of experimental investigations to simulate earthquake damage and develop repair strategies for elements of construction where a lack of recent earthquake activity has meant that there is no available documented description of damage and engineering judgment has been used to formulate the repair strategy in the Earthquake Damage Assessment Catalogue (EDAC).

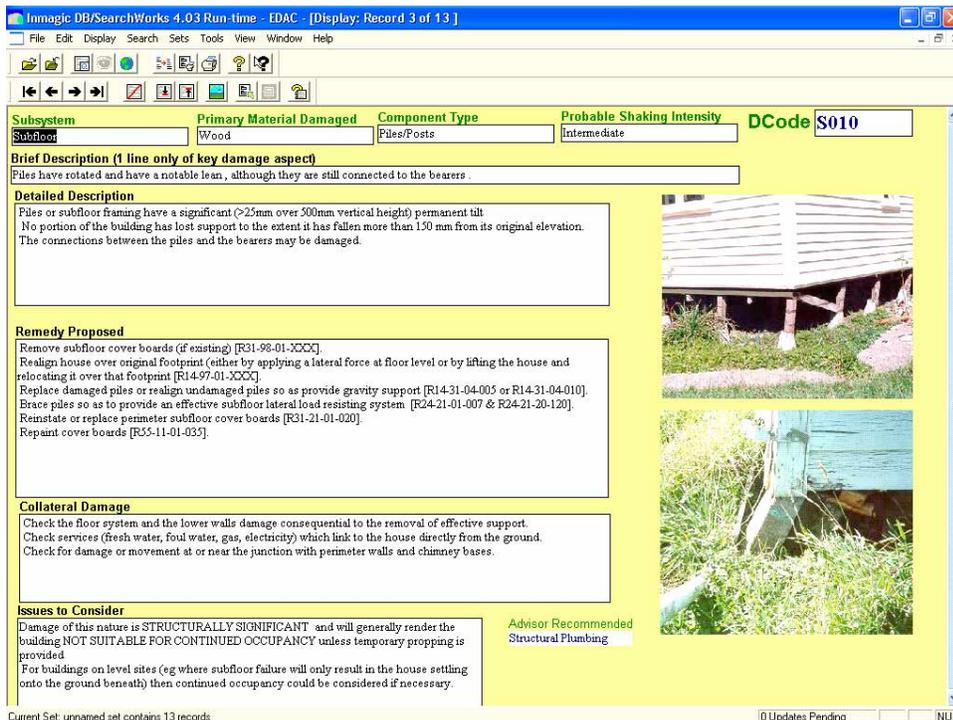
Figure 1 EDAC database record

The EDAC has been developed by BRANZ Ltd [1] for the use of the building damage estimators who will be engaged by insurance loss adjusters to make an assessment of the damage sustained in an earthquake and formulate an appropriate repair strategy in keeping with the observed damage. Most estimators are expected to be builders. The catalogue contains written explanations of observable damage, supplemented with photographs taken following actual earthquakes, if available, or sketches. The pictorial descriptors are critical in that they assist the estimator to recognise the specific characteristic being observed as being consistent with the written description of damage. The EDAC has been sectioned into key areas of house construction (eg foundation, floors, walls, etc) to allow rapid retrieval of damage descriptors. An electronic version of the EDAC contains a purpose-made search facility centered on key areas of the house construction so that the search may be narrowed quickly. A typical record in the EDAC is presented in Figure 1.

It can be seen in Figure 1 that as well as the detailed damage description and the proposed remedy, there are further boxes containing information on expected collateral damage, issues to consider and whether or not the assistance of an advisor is recommended. Within the proposed remedy box, there are references inside square brackets. These refer to the appropriate associated entries within a separate costing database.

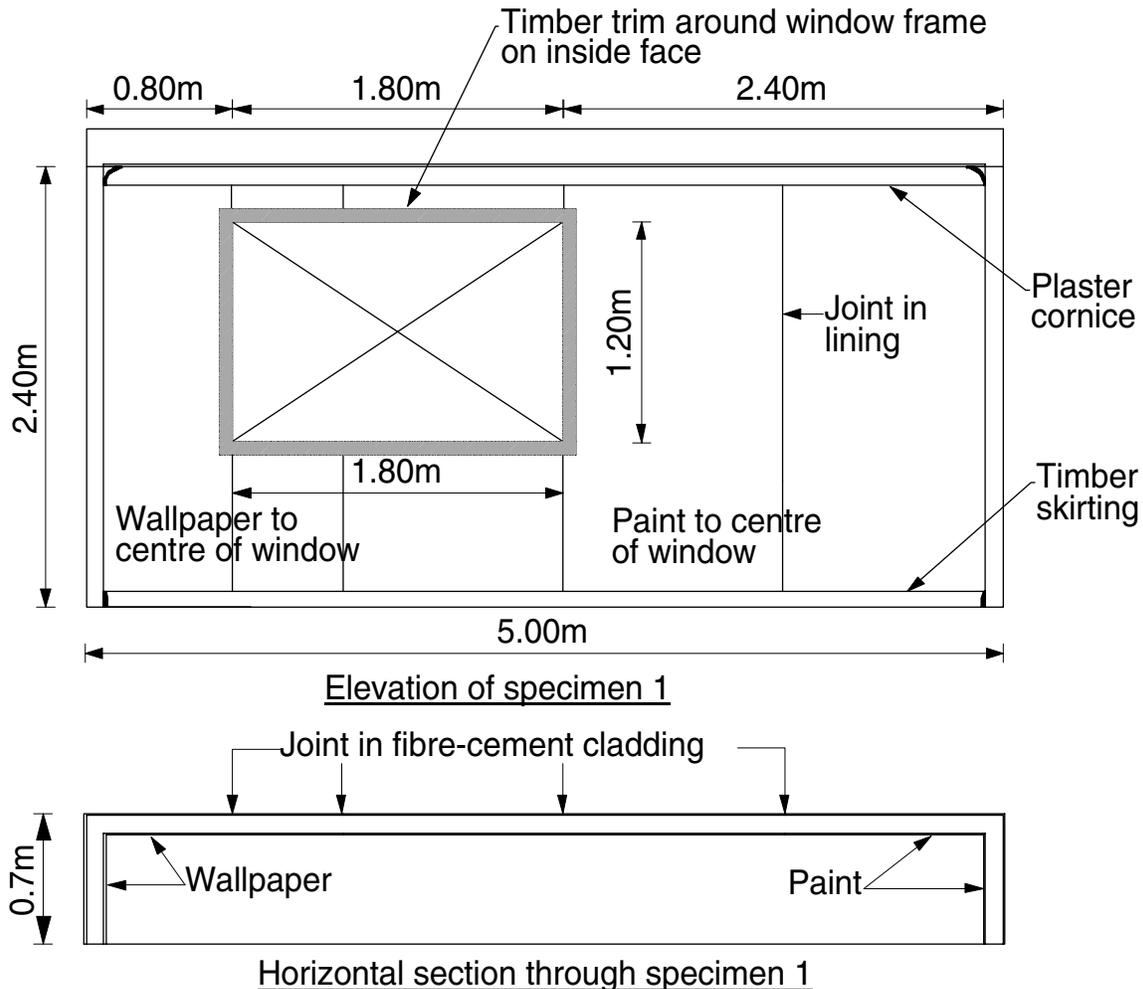
Figure 2 Details of specimen 1

Systems of wood framed walls with external sheet bracing cladding were common before the Code of Practice for Light Timber Framed Buildings not requiring specific design [2] was first introduced in 1978. They rely on bracing being provided by the exterior fibre cement sheet sheathing and the function of the plasterboard lining is purely to provide a surface for interior decoration. Because of this, the plasterboard sheets have often been nailed at large centres and sometimes not at all behind skirting boards. Both conditions were replicated in the test specimen. Details of the test specimen are presented in Figure 2.

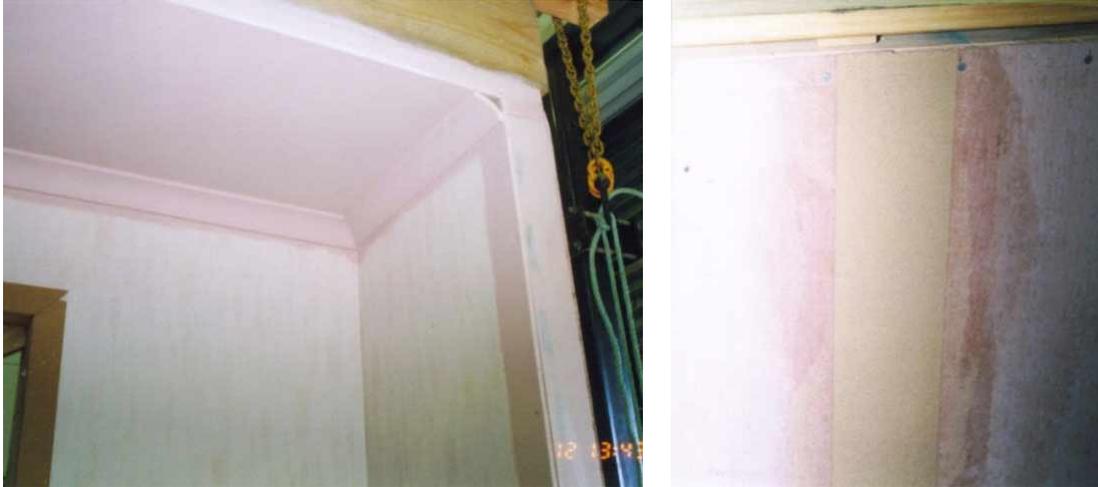
Figure 3 Plaster cornice between wall and ceiling and filled tapered joint in exterior cladding

The specimen bottom plates were coach-screwed to timber beams which were in turn fixed to the laboratory strongfloor to simulate a concrete foundation system, and a section of plasterboard ceiling, complete with cornice, was included to model the junction between the walls and the ceiling (Figure 3). One end of the interior face was painted while the other was wallpapered, to investigate the differences in observed damage formation. On the exterior face, the fibre-cement board was nailed in accordance with the manufacturer's literature. The tapered edge joints between the sheets were filled with a proprietary joint filler (Figure 3). No texture coating was applied to the surface of the fibre-cement board. Although it is not recommended by the manufacturers, the sheets of plasterboard and the fibre-cement sheets were joined at the edge of the window to represent what has been common practice by the construction industry.

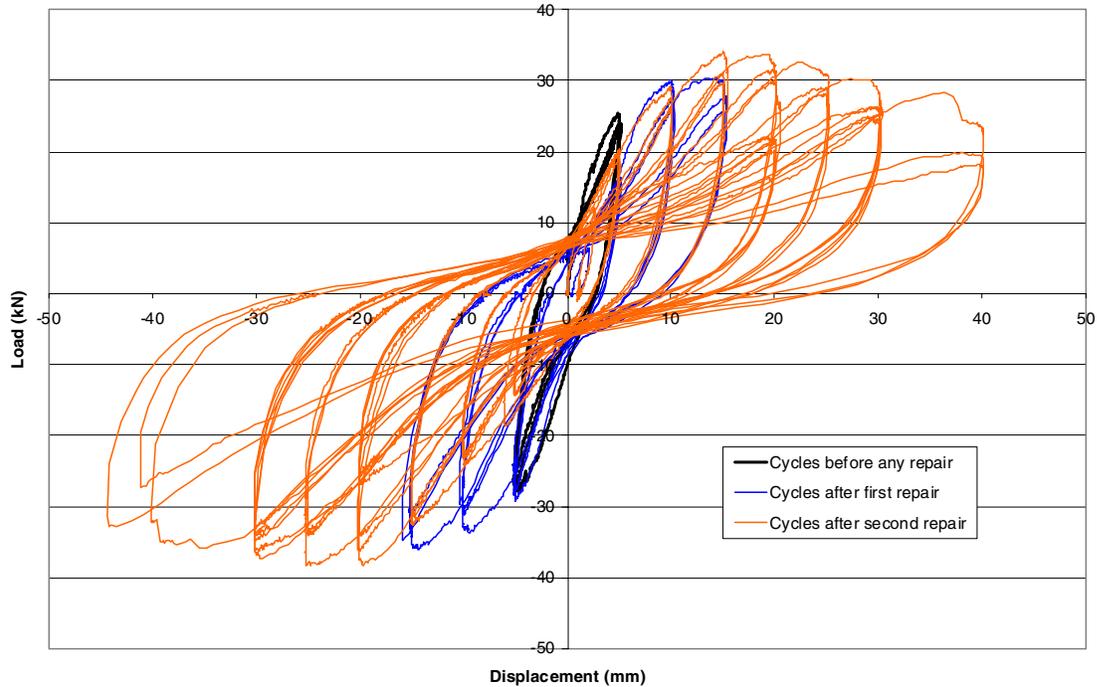
Figure 4 Load-deflection plot for Specimen 1 after repairs

The exterior cladding sheets remained in sound condition but the joints showed signs of increased cracking and the fixing nail heads began to damage the surface locally as the displacement increased. The joints were ground out and a “V” shaped groove was fashioned at the junction. After the 15 mm cycles, extra nails were added between the existing ones to resurrect the wall stiffness and strength. The cycling continued on to ± 40 mm displacement and the feasibility of various repairs was evaluated at this point. Although the strength of the specimen up to 15 mm displacement was slightly less after the repairs, once the displacement cycles passed 15 mm, the resistance returned to its original strength and thereafter continued to increase until the peak resistance was achieved at 20 mm to 25 mm displacement, as expected from a virgin specimen (Figure 4). No damage was observed at the cornice up to 40 mm displacement.

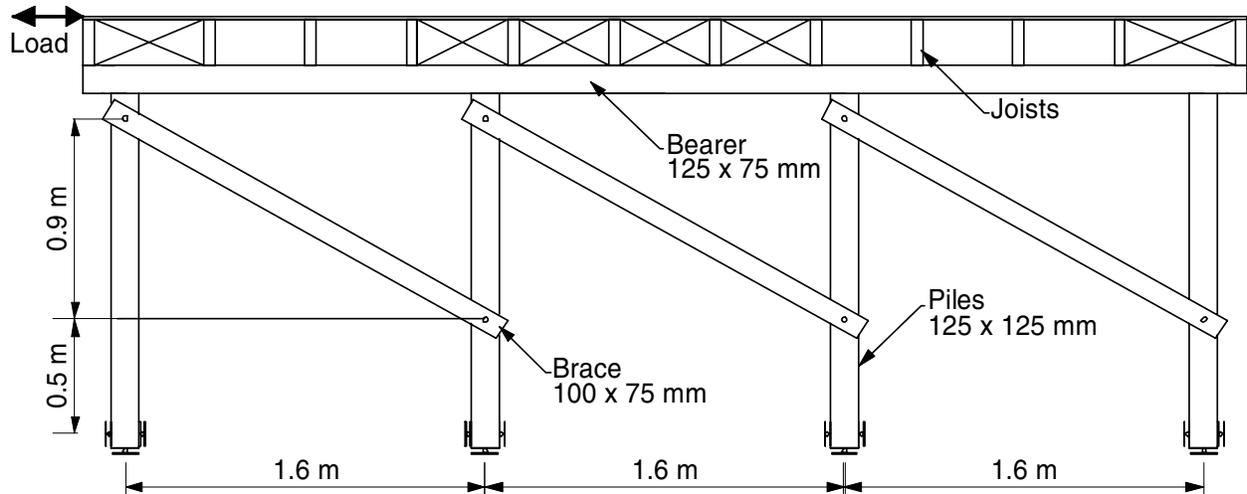
Figure 5 Braced pile test specimen

A specimen which included four piles and three diagonal braces was constructed to determine the repair procedure for various levels of damage that may occur in an earthquake. The pile members were 125 mm x 125 mm in cross section and the brace members were 100 mm x 75 mm. Dimensional details are presented in Figure 5. Construction of the braced piles replicated the requirements of NZS 3604 [3]. All bolted connections were M12 galvanised bolts through close-fitting holes in the timber. A 50 mm x 50 mm x 3 mm flat washer was installed beneath each bolt head and under each nut. The bolts were tightened firmly with an adjustable spanner, as would be expected to occur in practice. To simulate the “pinned” support from the ground, the bases of the piles were restrained against movement along the line of the piles 500 mm below the bottom brace connection, but were allowed to rotate to simulate expected ground deformation.

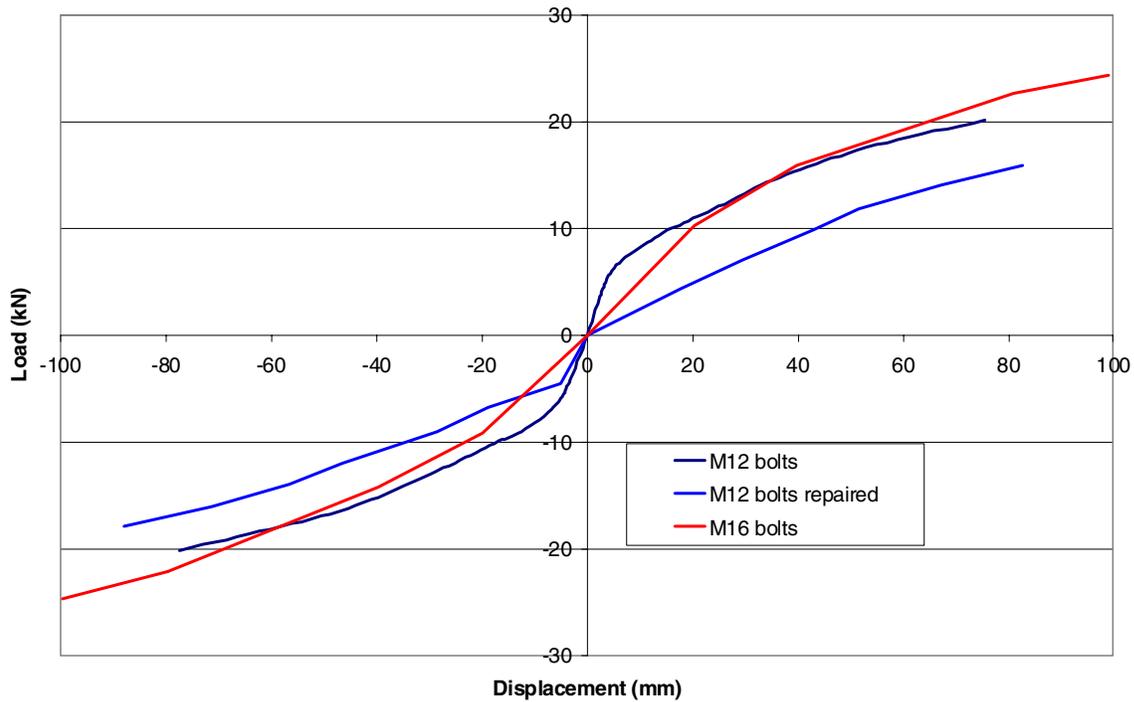
Figure 6 Load-displacement response of pile system

Load was applied at the floor level and the specimen was cycled to increasing increments of displacement of the bearer, up to ± 100 mm. The backbone curve of the first cycle load peaks is presented in Figure 6. It was not possible to see any damage in the system at the completion of the cycling despite there being a significant permanent offset. A brace was removed to determine the damage at the bolted connections. The bolt had distorted significantly and the holes in the timber members at their adjacent faces were elongated. Two repair options were considered. The first involved filling the holes with all-purpose plastic putty, re-drilling and installing new M12 bolts. The specimen was cycled again after this repair and achieved approximately 70% of the initial strengths at corresponding displacements (Figure 6). In the second option, the M12 bolts were removed and the holes were drilled out to accommodate M16 bolts. These were installed and the specimen was cycled once again. It can be seen in Figure 6 that the stiffness of the M16 repair was less than the original M12 stiffness up to 20 mm displacement, but the strength of the repaired specimen matched the original strength beyond this level.

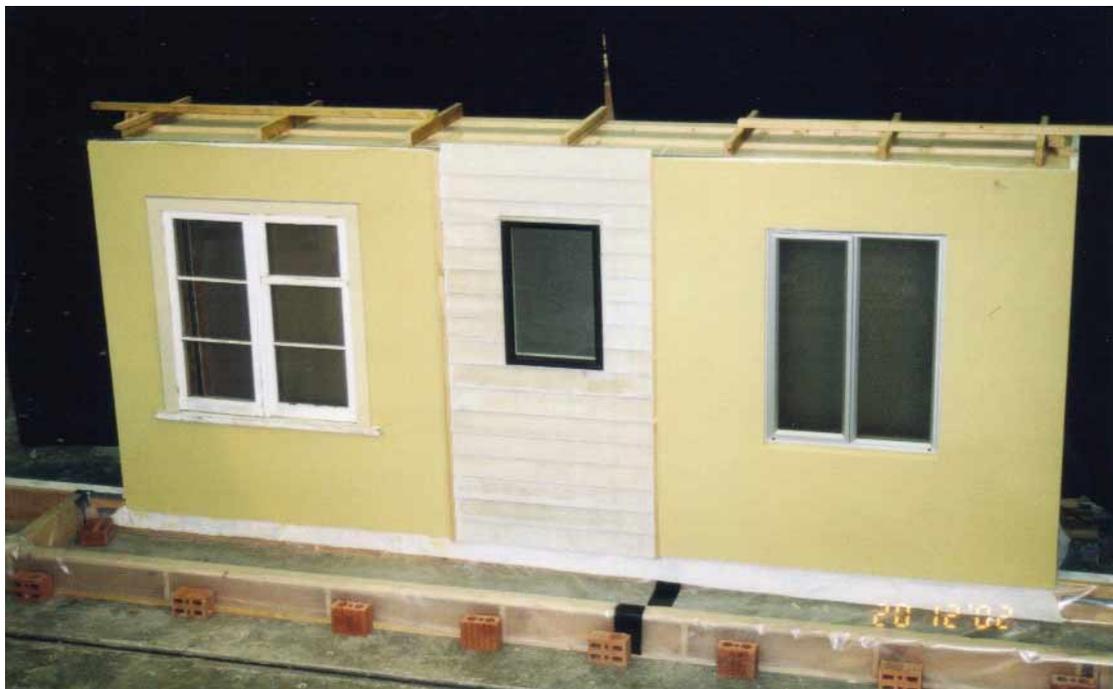
Figure 7 View of the exterior face of the specimen 3 wall

The left end of the wall in Figure 7 was clad with fibre-cement sheet described by the manufacturer as a monolithic textured cladding solution for lightweight construction. The fibre-cement was coated with a single size aggregate textured coating and painted with a high build acrylic paint. The fibre-cement sheets were cut around the window opening with joints formed above and beneath the centre of the opening. The window included in this section was recycled from a pre-1980 dwelling and was flashed with metal flashings typical of the era. The central section was clad with a reduced density, fibre-cement, bevel back weatherboard system and the window was a fixed pane aluminium window flashed with proprietary flashings supplied by the weatherboard manufacturer. The right end was clad with an exterior insulation and finish system (EIFS) which comprised 40 mm thick expanded polystyrene foam overcoated with a polymer-modified cement texture plaster with irregular grain size which was troweled over the wall. This was painted with a high build acrylic paint. The aluminium window in this section contained a fixed light

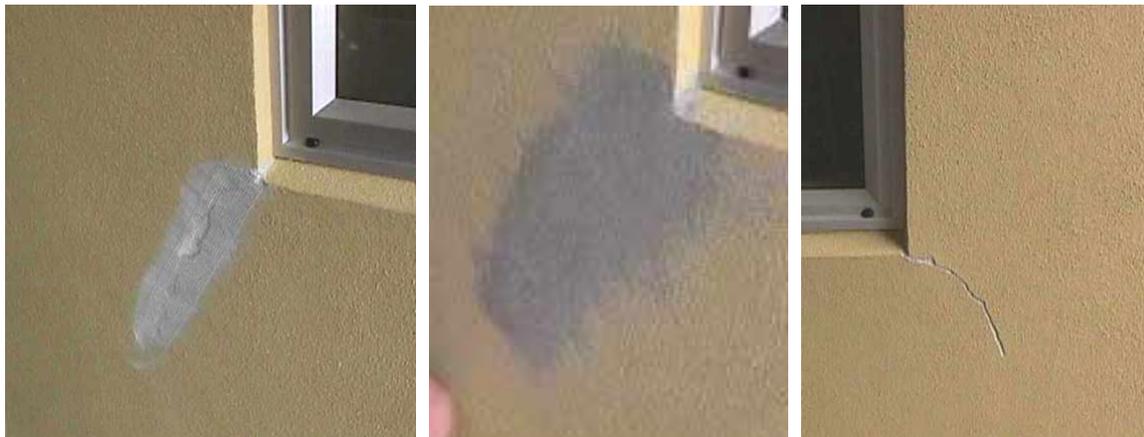
Figure 8 Crack repairs in EIFS cladding

At 24 mm displacement, the cracks in the EIFS cladding extended some distance diagonally away from the corners of the window opening (Figure 8). The three smaller cracks were “V”ed out to a 5 mm width through the thickness of the coating and the cracks were filled with polymer modified cement plaster, trowelled on and feathered out with a sponge. The fourth (larger) crack was scraped out to a taper finish over an approximately 100 mm width, a length of fibreglass mesh was laid over the crack and polymer modified cement plaster was trowelled over the joint and “sponged”. The surface was painted over after three days and though not obvious, the repaired areas were still visible.

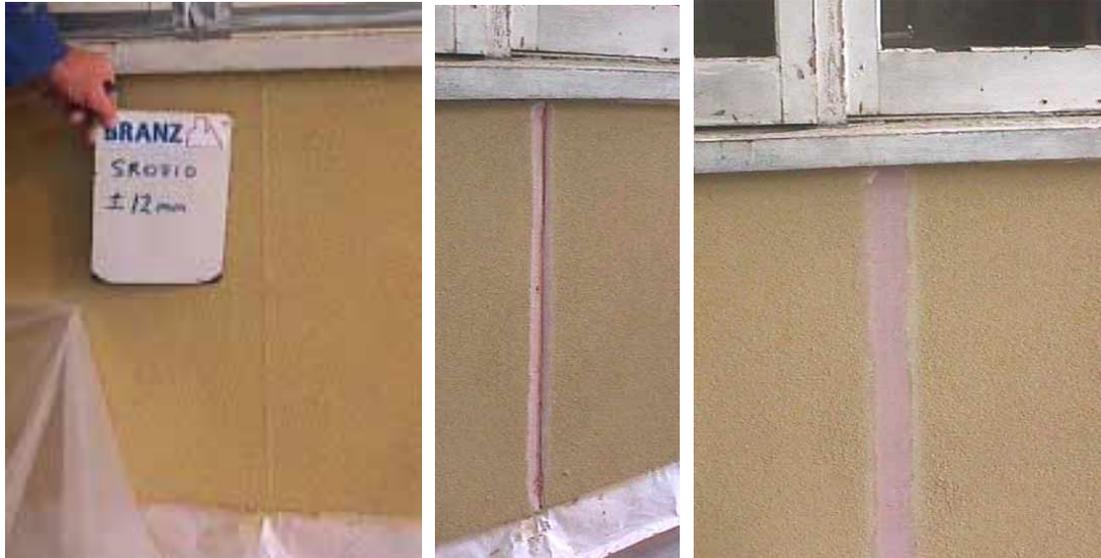
Figure 9 Repair to bulged joint between fibre-cement panels

Beneath the timber window, the bulged joint between the fibre-cement sheets had become more pronounced (Figure 9). It was scraped out to a wide taper finish and trowel-filled with acrylic flexible jointing material. The typical repair procedure proposed by the plasterer for the diagonal cracks involved filling the crack with a flexible and paintable modified silicone sealant which was smoothed with a finger and then dabbed with a dry paper towel to give the same appearance as the surrounding plaster. This process was only partially successful and a new textured coating would be required if it was essential to remove all signs of the repair.

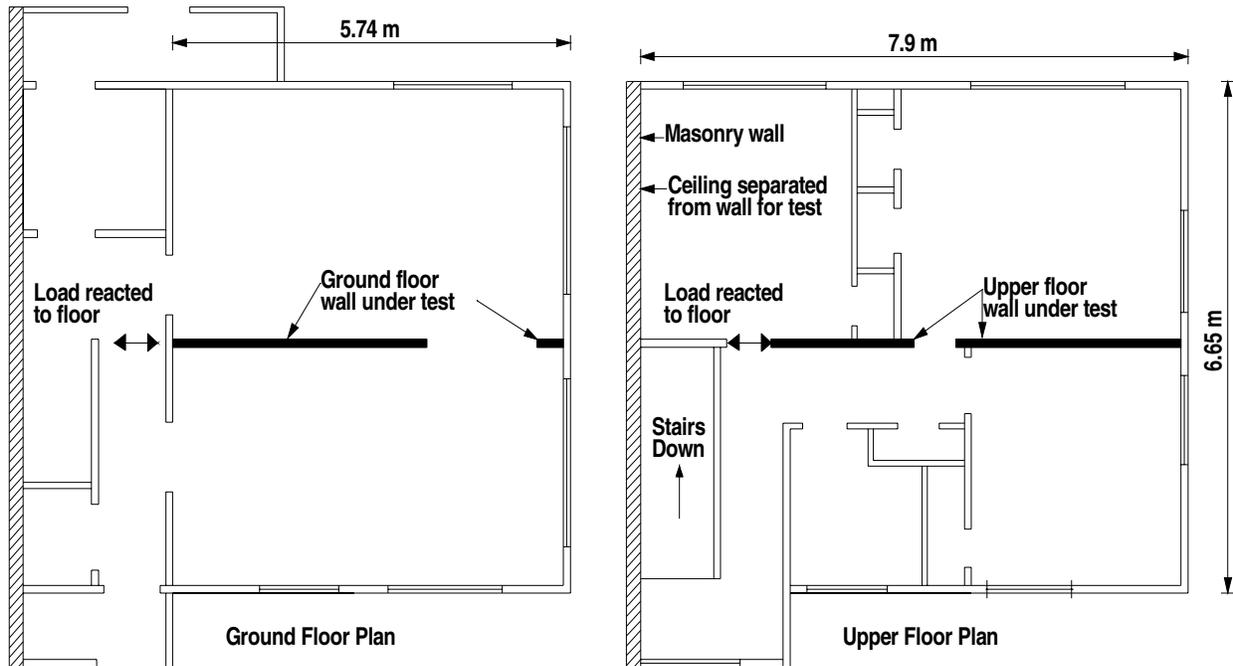
Figure 10 Two storey duplex unit floor plans

The exterior cladding was bevelback weatherboards over the upper storey and asbestos cement sheets over the bottom storey. Ceiling linings in both the upper and lower storeys were fibrous plaster, while the wall linings were gypsum plasterboard. Both the upper and lower storey floors had nominal 80 mm wide tongue and groove floor boards over 200 x 50 mm floor joists at 450 mm centres on the top floor and 125 mm x 50 mm joists at 450 mm centres on the lower floor. Wall framing was generally 100 mm x 50 mm at 450 mm centres on both storeys. The top and bottom plates of the lower storey were 100 mm x 75 mm. Floor plans are presented in Figure 10.

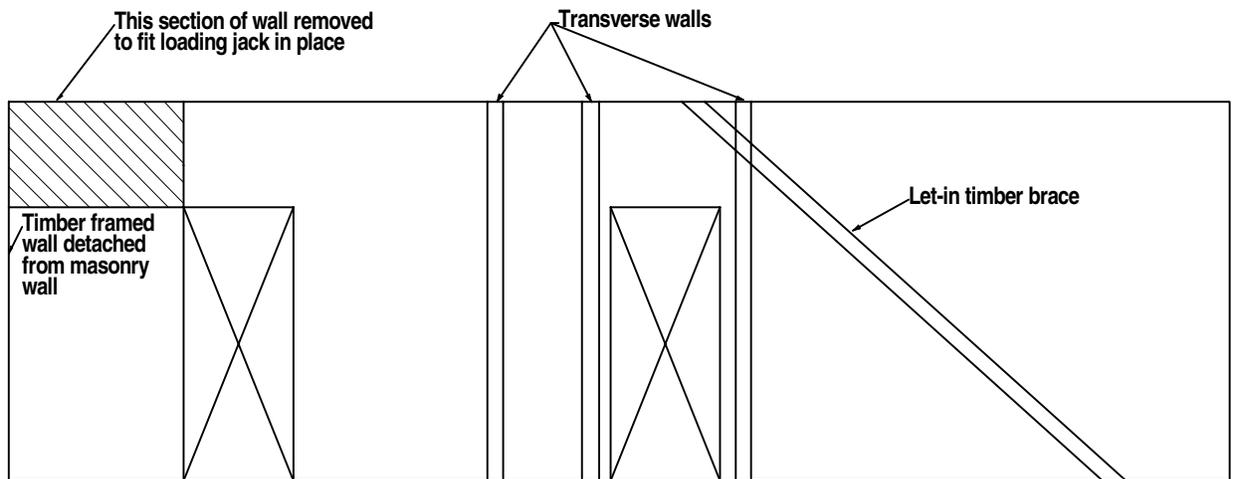
Figure 11 Elevation of upper storey test wall

Testing began by applying load along the line of the top plate of the upper storey test wall (Figure 11) in both directions. Initially the ceiling was left intact and during loading it appeared to be rotating in a horizontal plane about points midway between the test wall and the outer walls as the loading approached 125 kN. There was some cracking damage on the joints between the plasterboard at the top corners of the doorway which would have required re-taping and re-stopping before redecoration (either paint or wallpaper). The section containing the let-in timber brace (see Figure 11) retained its shape and tended to rotate as a rigid body with the bottom plate lifting from the floor at the edge of the door opening. It was clear that significant load was being transferred to the outer walls via the ceiling lining so this was cut on two lines parallel to the test wall and about 1 m either side of the wall. The stiffness of the specimen

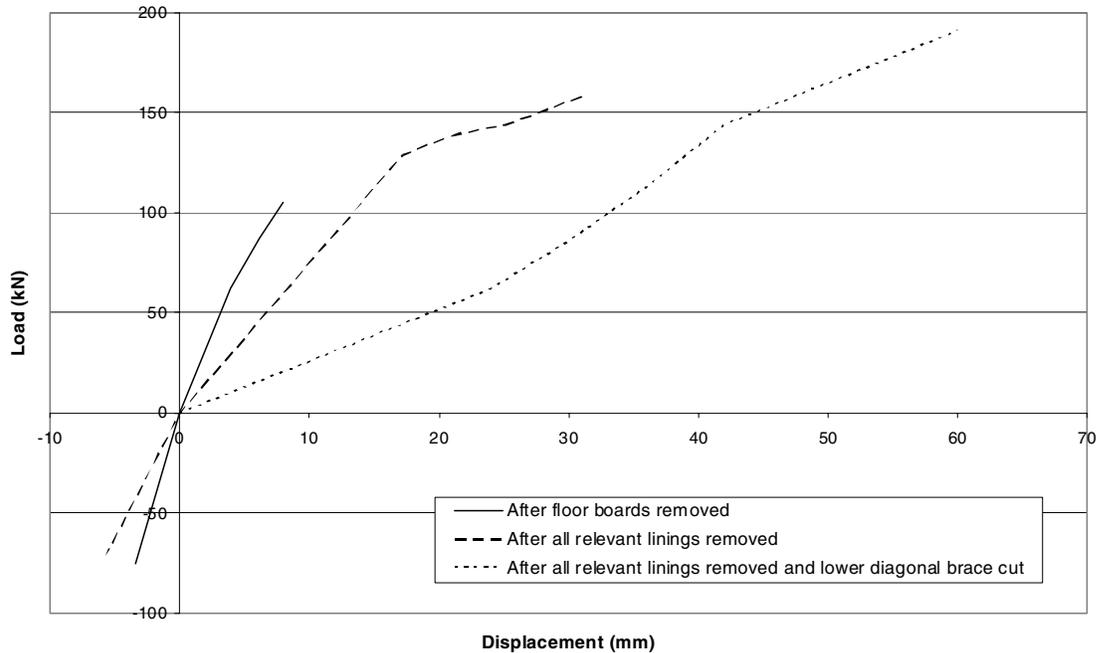
Figure 12 Comparison of the backbone curves before and after the diagonal brace was cut in the test wall

The test rig was relocated to the ground floor and installed so that the racking load was introduced to the underside of the upper floor joists approximately 350 mm on either side of the top plate of the wall under test. The ground floor ceiling was cut in the same manner as the upper floor ceiling and then four floor boards were removed on either side of the wall in an attempt to prevent forces reaching the outer walls. Following this, the linings were all removed from the parallel wall in the hallway and the top plate of the orthogonal wall was cut on the lines of the ceiling cuts. Each alteration caused a small decrease in the stiffness of the test wall but the same peak loads were still able to be achieved. Finally, the 150 mm x 25 mm let-in timber brace contained within the test wall was cut. Backbone curves enveloping the hysteresis loops achieved for each condition are plotted in Figure 12.

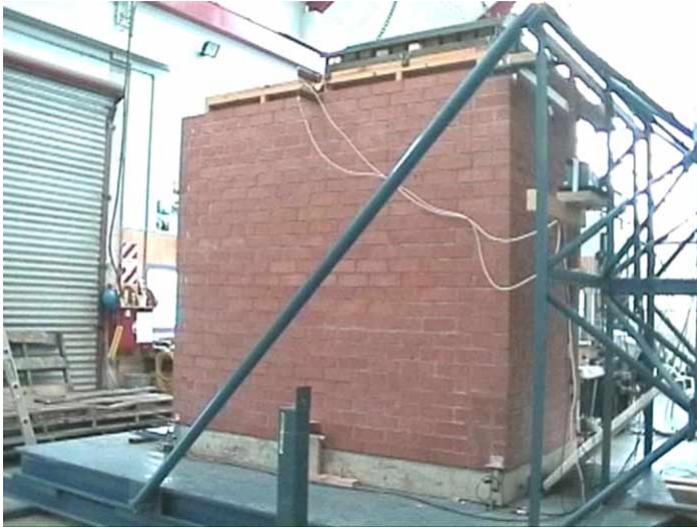
Figure 13 Brick veneer corner specimen mounted on the shaking table

Damage to brick veneers has been widespread in historic earthquakes. A corner section of brick veneer cladding was constructed on a concrete foundation to simulate the corner of a house. The veneer length was 2.6 m and the return section was 1.4 m long. The veneer was connected to a 90 x 45 mm timber-framed wall with proprietary veneer ties on a grid of 300 mm x 600 mm (stud spacing), fitted so that the bottom flat face of the ties rested on the top of the brick to represent historic construction practices. The inside face of the framing and a section of ceiling framing was lined with standard gypsum plasterboard. To simulate the mass of a heavy concrete tile roof, 1000 kg of steel weights were supported on the framing at top plate level. The specimen was mounted on a shaking table (Figure 13) and accelerometers and displacement gauges were installed to monitor dynamic performance.

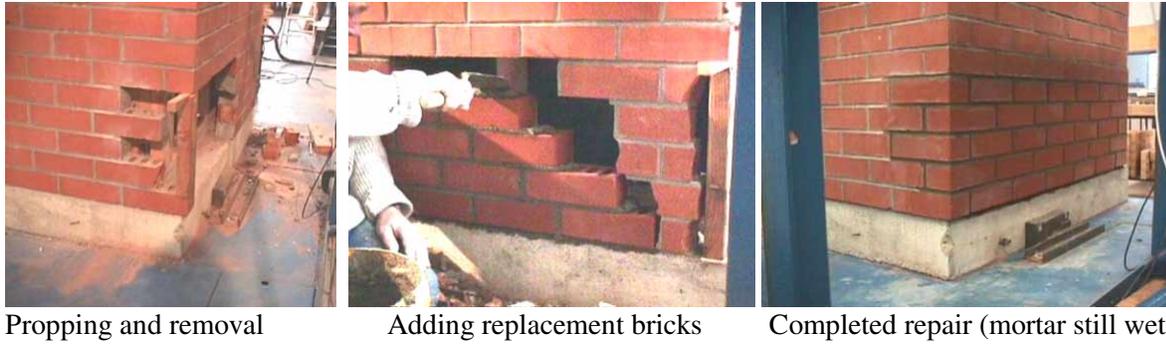
Figure 14 Sequence of veneer repair

An experienced bricklayer advised that the damaged section of the veneer could be carefully removed and replaced with new matching construction. This repair process was undertaken (Figure 14). Fine cracks in the mortar (<0.5 mm) were left on the basis that free water would not penetrate these and any seepage would be drained as usual behind the veneer. Attempting to repair the cracks would have been more obvious than leaving them as they were. Having also determined that the ties were no longer supporting the veneer, it was decided to install proprietary spiral stainless steel ties in a grid pattern similar to the spacing of the original ties. To install these ties, a hole is drilled through the veneer and the helical tie is screwed through the hole into the stud behind. To ensure that the ties are correctly positioned to match the stud positions, it would be necessary to employ a “stud-finder” or a cover meter. The top of the tie hole is normally filled with coloured grout to match the veneer colour.

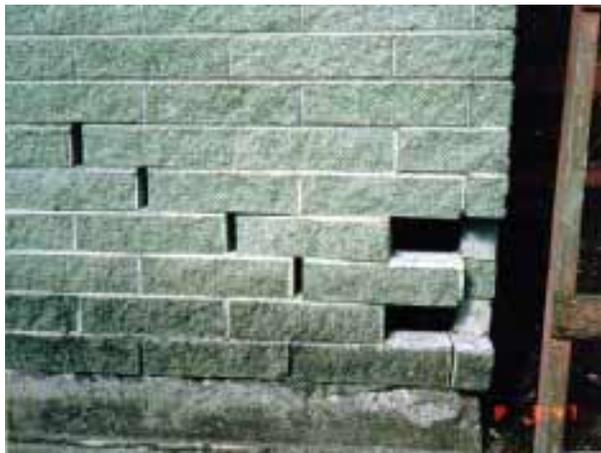
Figure 15 Corner veneer damage observed in a real earthquake

The testing successfully replicated the sort of veneer damage observed in real earthquakes (Figure 15). The major difficulty with brick veneers that are not obviously damaged in an earthquake is in determining the integrity of the tie connections without invasive investigations. Often there will be movement on the joint between the veneer and the foundation because the bottom course of mortar has failed and this may be an indicator of loss of tie integrity. Significant movement on this joint will mean that removal and rebuilding of the veneer will be necessary. Proprietary helical ties which can be installed through an existing veneer are an effective means of re-securing the veneer to the timber framing.
