## **IMPROVED ADOBE MUDBRICK IN APPLICATION – CHILD-CARE CENTRE CONSTRUCTION IN EL SALVADOR**

### **SUMMARY**

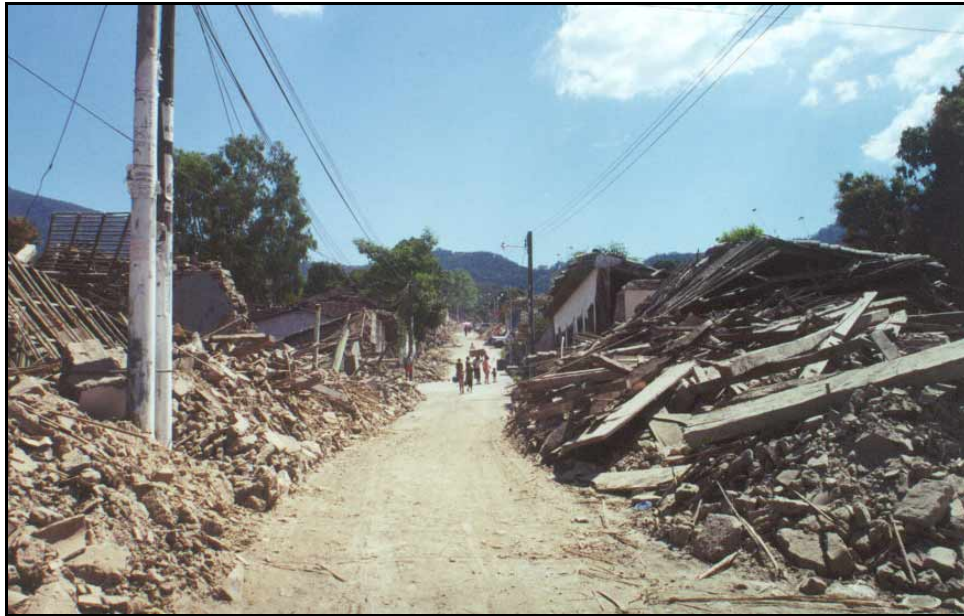
**Figure 1. Destroyed adobe houses, El Salvador (López [5])**

There are two main reasons why adobe houses performed so poorly in the earthquakes. Firstly, adobe is a low-strength, brittle material, which yields under much lower stresses than ‘modern’ materials, such as steel, concrete and conventional masonry. Secondly, traditional adobe houses are often poorly constructed and/or maintained due mainly to resource and skill limitations. These features mean that, in general, adobe structures are more vulnerable to damage during seismic events.

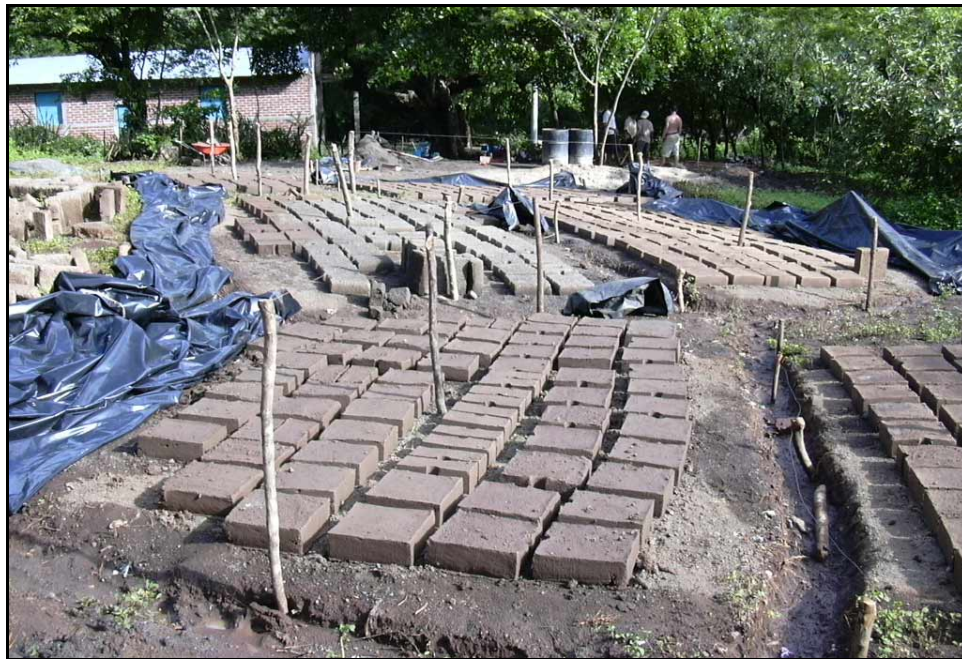
**Figure 3. Drying bricks (Note: drainage ditches and plastic covers)**

Timber and steel moulds were used to fabricate full size bricks (300 x 300 x 100mm), half size bricks (300 x 140 x 100mm) and channel bricks (for use in the ring beam, as described below). Voids for vertical reinforcement were included in the moulds. The bricks were made on a bare soil or sand ground surface (Figure 3) and covered immediately with opaque plastic sheeting to prevent cracking due to the differential drying of the brick in the hot sun. After two to three days the bricks were turned on edge and allowed to dry in direct sunlight. Bricks were rotated every couple of days to ensure thorough baking throughout. After a period of two to three weeks the bricks were stacked ready for transportation to the

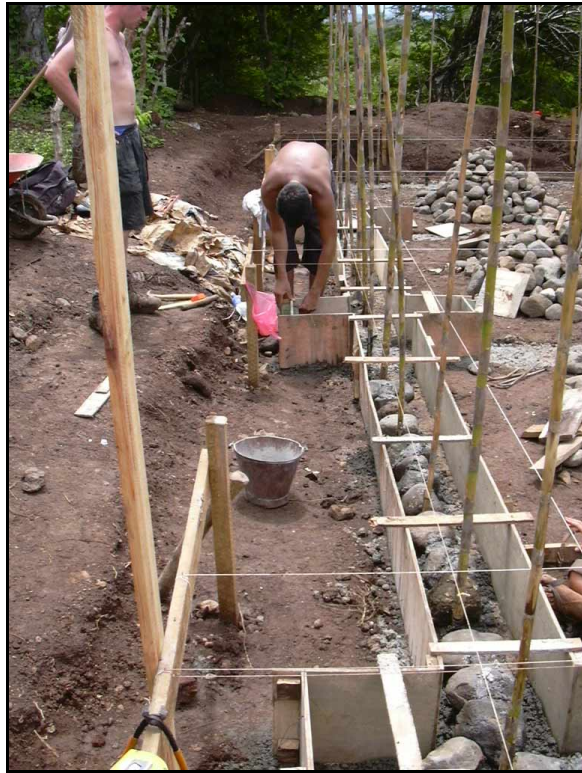
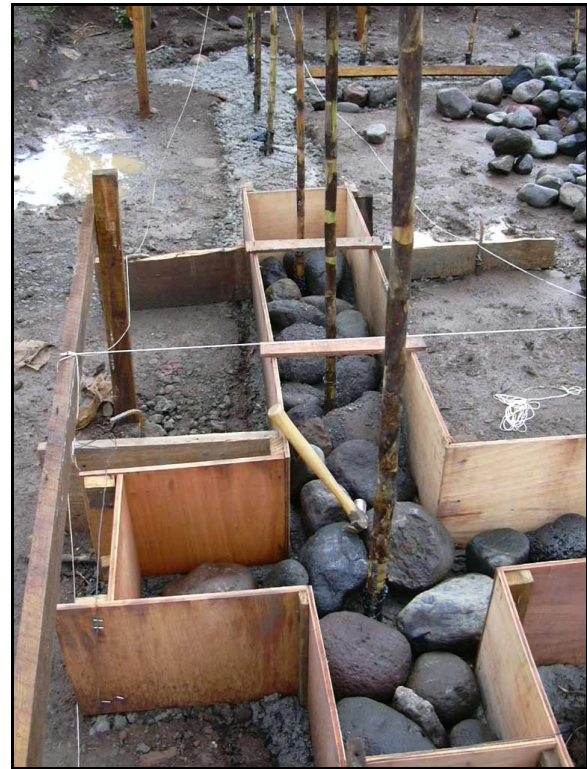
**Figure 4. Location of vertical reinforcement and preparation of plinth formwork.**

A local cane/bamboo, *vara de castilla* (*Gynerium sagittatum*, Hays [15]), was used as internal (within the wall) vertical reinforcement, placed every 640mm (Figure 4). It was attached to the foundation via L-shaped steel bars (tied with wire prior to pouring the plinth / 'top foundation') and connected to the ring beam at the top of the wall, thus creating a continuous matrix of reinforcement, tying the structure together. The placement of the vertical reinforcement presented significant problems. Firstly, during the pouring of the foundations a number of the steel L-shaped bars were knocked slightly out of alignment. This misalignment, combined with the natural and unavoidable curvature of the bamboo meant that the reinforcement was not in the precise location as per the design. As each course of the wall was laid, certain bricks needed to be trimmed and cut to fit. This created delays and frustrations during the construction of the wall, and highlights the need to ensure accurate alignment of the vertical reinforcement.

The inclusion of pilasters increased the complexity and resource requirements of the project. Firstly, the preparation of the formwork for the plinth layer became a complex task, requiring multiple right-angled corners and various adjustments (Figure 4). The configuration of the bricks around the pilasters was different to that commonly used by local builders and this created some initial confusion, although this was overcome as the wall construction progressed. The inclusion of the pilasters necessitated the expansion of the roof cover in order to maintain the desired minimum overhang of 600mm. This resulted in an increase of 13% in the plan area of the roof, with various elements of the roof structure designed to support cantilever actions of over one meter. These increases in costs and complexity should be considered in conjunction with the aseismic contribution offered by the pilasters and should be the subject of further research.

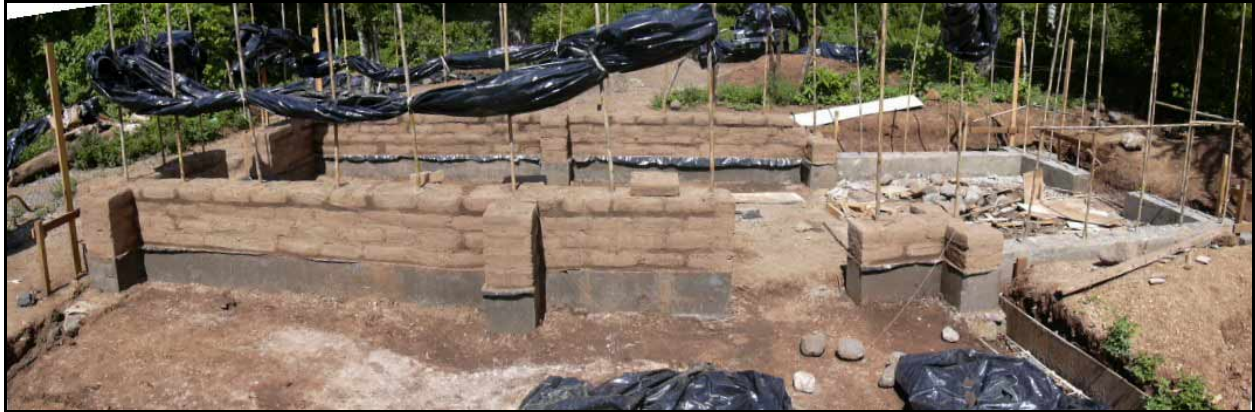
**Figure 5. Adobe walls under construction, including plinth, pilasters, vertical reinforcement, plastic rain covers (Note: figure alignment offset due to photograph splicing).**

The walls were 300mm wide, 2.24m high load-bearing walls, which consisted of the plinth layer, 15 courses of adobe bricks and a ring beam. The mortar joints were ~ 20-25mm wide and were made of the same material (mud) as the adobe bricks (Figure 5). String-lines were used to maintain alignment and plumb of the walls. There were some initial problems with the placement of blocks in the walls as the workers adjusted to the new technique. On several occasions blocks needed to be removed and the configuration changed. This was to be expected, but relied on fairly constant supervision to correct errors quickly.

Pilasters were constructed externally at each corner of the building and both internally and externally at third points along the long wall (Figure 5). The pilasters were 320mm deep (equal to one block plus one mortar joint) and extended to the top of the wall (2.24m).

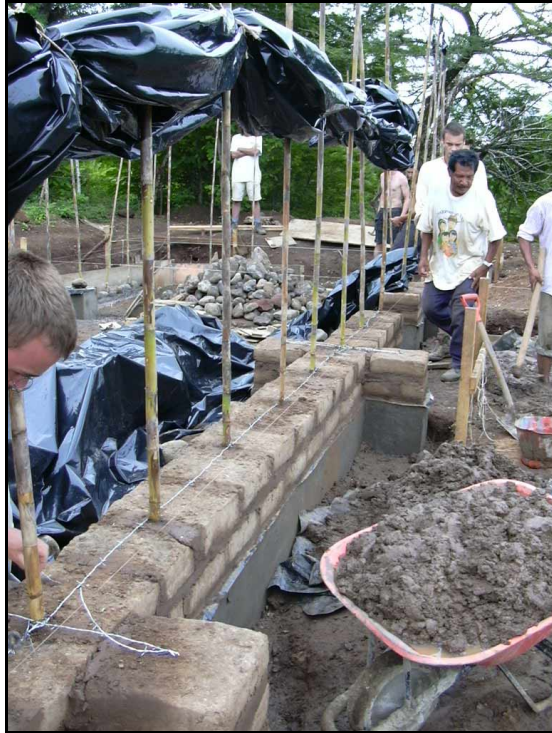
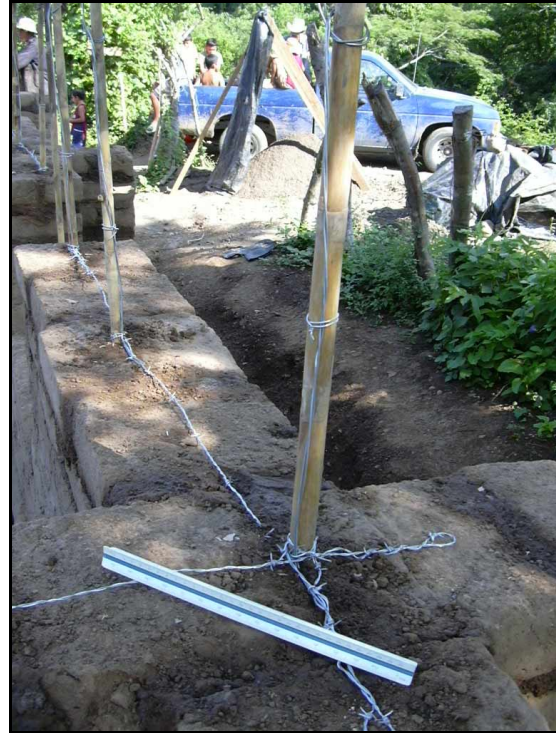
**Figure 6. Adobe walls under construction, including plinth, pilasters, vertical and horizontal reinforcement, plastic rain covers.**

Two strands of galvanized barbed wire were placed in the horizontal mortar joints every three courses (Figure 6). The barbed wire strands were weaved between and tied to the vertical bamboo reinforcement to promote continuity. The strands of barbed wire were extended into the pilasters, with U-shaped nails/staples used to connect the wire to the bricks. In some cases, this caused cracking of the bricks, and should be undertaken with caution. In the upper part of the wall (between courses 11-12 and 14-15) a strip of chicken wire mesh was placed horizontally in the mortar joints to augment the barbed wire in this critical section.

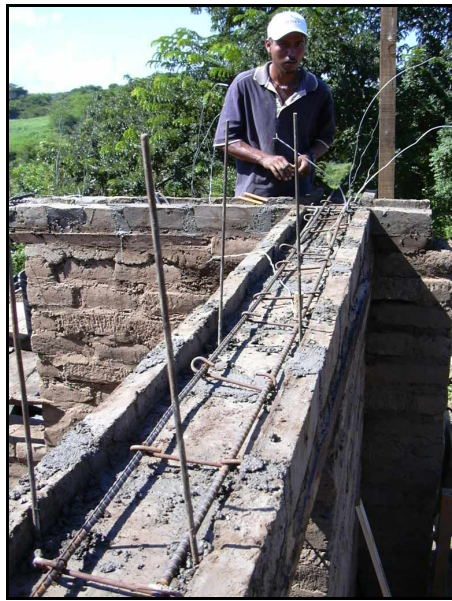
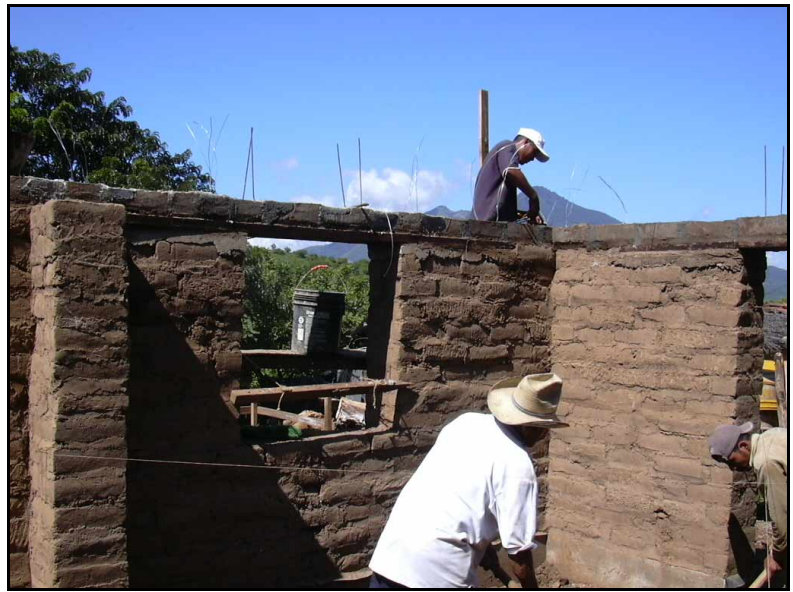
**Figure 7. Ring beam channel blocks and reinforcement (Note: steel pins and wire straps for roof attachment).**

'Channel' blocks were formed with special moulds, using a soil-cement mix of 7:1. The channel blocks were wet cured for a minimum of seven days. The ring beam channel blocks were placed on the top course of adobe bricks, using a soil-cement mortar (7:1). Where necessary, holes were bored in the channel blocks to accommodate the vertical bamboo reinforcement. A horizontal reinforcing mesh consisting of two 1/2" steel reinforcing bars with 1/4" stirrups every 250mm was placed in the channel (Figure 7). This reinforcement was tied to the vertical bamboo reinforcement and roof anchors. Finally, the channel was filled with a 5:1 sand-cement mix. At the places where the vertical strands of wire passed through the ring beam, it was difficult to level off the cement mix evenly. This created elevated points, which become points of concentrated load where the timber wall plate rests on the ring beam. One option to prevent this occurring would be to place the timber wall plates whilst the cement mix is still fresh enough to be manipulated to create an even contact surface with the wall plates.

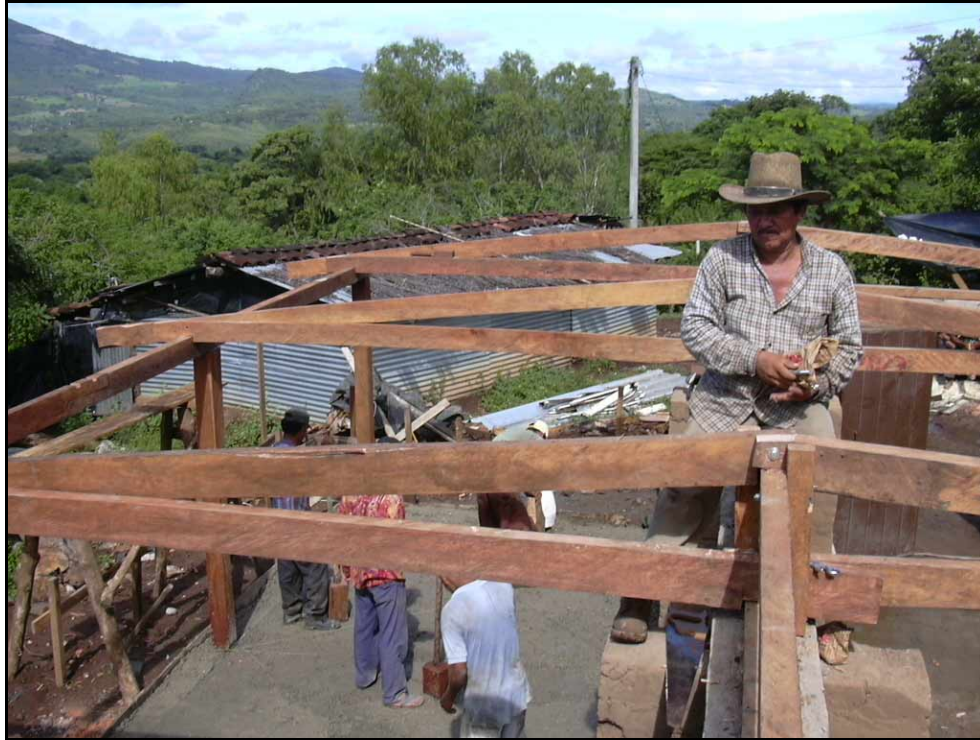
**Figure 8. Roof under construction.**

The roof consisted of a double-pitch timber roof structure with a Zinc-Alum sheeting cover. The structure comprised of timber wall plates supporting a timber lattice beam, trusses, purlins and diagonal bracing (Figure 8). Connections were bolted, nailed and / or strapped, as appropriate. The wall plate was tied to the ring beam and walls using heavy gauge wire and steel rods, as described above. A minimum overhang of 600mm was maintained around the building to protect from water damage due to rain. One pitch of the roof covered the verandah area, which was supported by timber columns in concrete footings. The gables were closed with welded mesh and screen mesh to allow free flow of air, whilst ensuring a secure and safe building.
