SEISMIC VULNERABILITY ASSESSMENT OF DENIZLI CITY, TURKEY WATER SUPPLY SYSTEM

SUMMARY

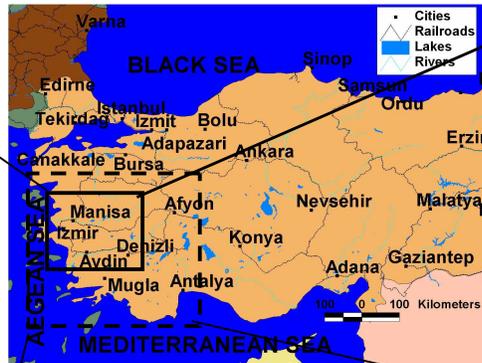
(b) Seismic Activity Around Denizli

Figure 2b shows historic earthquakes that occurred in the region before 1900 with their maximum intensity values and earthquakes between 1900-2004 with a magnitude greater than 5. The data are obtained from Kandilli Observatory and Earthquake Research Institute KOERI [3]. As shown in the figure, the Aegean extensional province had many historic earthquakes with intensities of IX and X. Some of these earthquakes was around Denizli and caused heavy damage and casualties. Altunel [4] summarized the historical earthquakes and their damage to Denizli and its proximity. The historical development of the ancient cities in this area was affected significantly by earthquakes. The ancient cities around Denizli, e.g. the former Roman City of Hierapolis (modern Pamukkale), and faulted archeological relics are the subject of many earthquake related research activities Hancock [5]. The most recent earthquake that caused major damage around Denizli was in Menderes graben in 1899 (Intensity IX).

The recent earthquakes that occurred around Denizli was smaller than M6 (Figure 2b). However, many damaging earthquakes occurred in the region. During the 1965 Denizli-Honaz earthquake (M5.7), 14 people were killed, 217 people were injured and 488 structures were damaged. During the 1976 Denizli earthquake (M4.9), 4 people were killed, 28 people were injured, and 3200 structures were damaged KOERI [3], MTA [6]. The 1976 earthquake affected particularly the central part of Denizli.
