## SEISMIC BEHAVIOUR OF GRAVITY-DESIGNED RC FRAME RETROFITTED BY FRP

### ABSTRACT:

Fibre reinforced polymer (FRP) is being used widely in repairing and retrofitting structures which suffer from damage or some design deficiencies. For gravity-designed (or generally nonseismically designed) structures, FRP strengthening also appears to be an obvious choice when comes to the need of upgrading for improved seismic resistance. However, typical FRP strengthening is known to be susceptible to debonding and such problem is expected to become more serious under cyclic deformations. This paper investigates the effectiveness of FRP retrofitting for enhancing the seismic performance of RC frames. A half-scale reinforced concrete test frame, originally designed without considering any seismic requirements, is constructed and subsequently subjected to simulated earthquakes until a significant degree of damage is generated. The damaged frame is then repaired using glass fibre reinforced polymer (GFRP) following a typical repairing procedure. The repaired frame is subsequently tested until final failure. The observed responses before and after the repairing are compared. The effectiveness of the

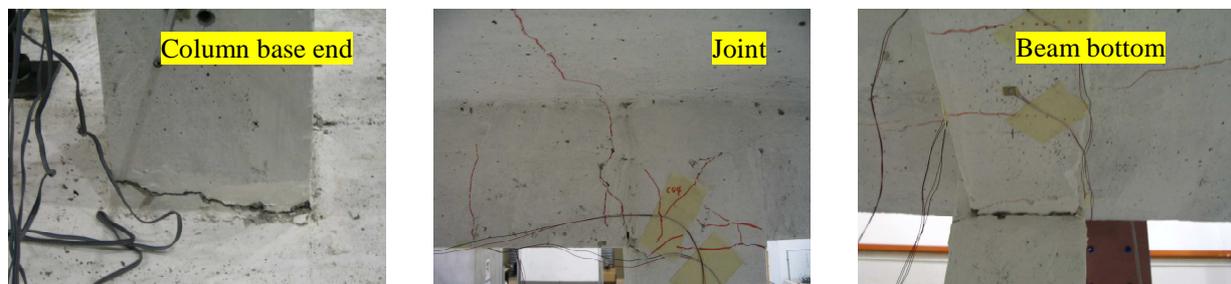
Figure 3 Typical crack patterns of original frame after 0.46g test

The frame exhibited significant damage after the 0.46g test, with wide spread cracks throughout the whole frame, especially at the bottom ends of the columns and around the beam-column joints. Figure 3 shows some typical crack patterns. The maximum inter-storey drift was measured to be about 2.5% (first storey).
