TEST ON 2-BAY 2-STORY CES FRAME SUBJECTED TO LATERAL LOAD REVERSALS

This paper summarizes the results of static loading test carried out on a two-bay two-story concrete encased steel (CES) frame. The structural members of the CES frame consist of only encased steel and fiber reinforcement concrete (FRC). The specimen was about a half-scale model, which simulated the lower 2.5 stories and 2 spans of the middle frame in 15-story CES frame buildings. It is predicted that the beam flexural failure near the interior beam-column joint occurred on the CES frame followed by the failure on all the bottom of columns. However, the failure on the joint panel of the interior beam-column joints also occurred at R of 0.01 rad. The specimen reached the maximum ultimate shear force at R of 0.02 rad. The results also showed that the use of FRC in the CES frame reduced the damage of the concrete in the frame. In addition, the hysteresis loops showed a stable behavior with almost no degradation of load carrying capacity until maximum story drift angle, R of 0.05 rad., indicating that the CES frame has excellent seismic behavior.

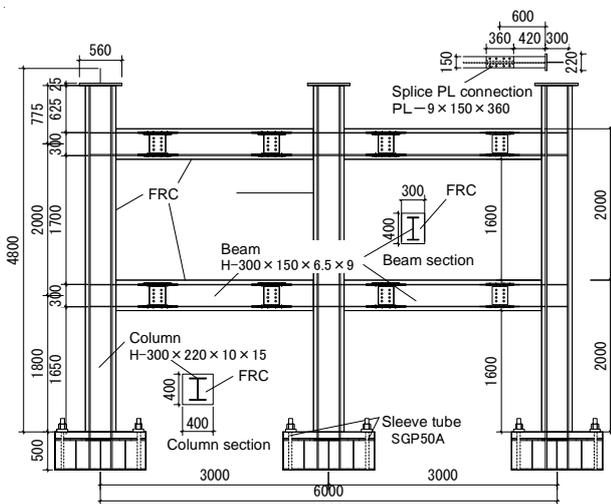
Figure 1 Test specimen

A 2-bay 2-span CES frame specimen was tested in this study. The specimen was about a half-scale model, which simulated the lower 2.5 stories and 2 spans of the middle frame in 15-story CES frame buildings. The dimensions and details of the specimen are shown in Fig. 1. The frame had columns with 400x400mm square sections and the story height of 2,000mm. The total height of frame from base floor to the top pin bearing was 4,800mm. The sections width and depth of the beams were 300x400mm with the span of 3,000mm. Built-in steels H-300×220×10×15 and H-300×150×6.5×9 were used to the columns and beams, respectively. The built-in steel continuous along the column height, while there was a bolt connection for built-in steel of beam at the position of 600mm from the column centers. Failure mechanism of the specimen supposed the entire collapse mechanism with beam flexural yieldings. Calculation results of maximum strength for columns, beams and joint panels are shown in Table 1. The strengths of the columns and beams were calculated using flexural analysis with superposition method, while the joint shear strength was calculated using AIJ standard for structural calculation of SRC structures (AIJ, 2001).

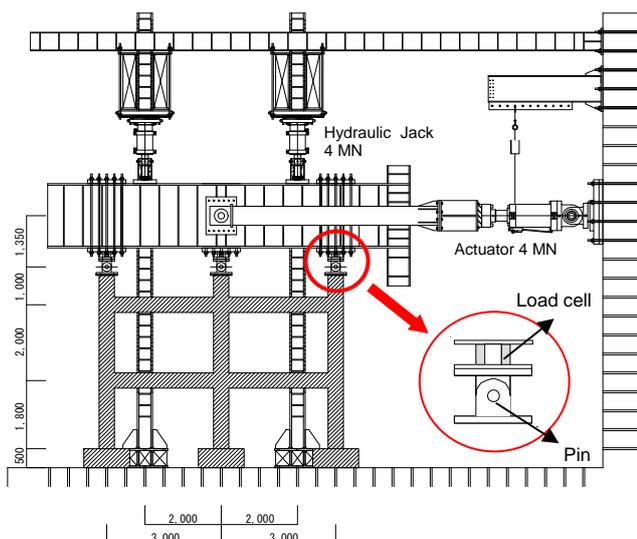
Figure 2 Schematic view of test setup

The specimen was connected to the loading devices through the pins which were installed in the inflection point of the 3rd story columns, as shown in Fig. 2. The applied axial force for the interior column was 1,920 kN (axial force ratio $(N/bD \sigma B = 0.3)$), while for the exterior columns were 1,620 kN ($N/bD \sigma B = 0.25$). The specimen was loaded by axial force and simultaneously loaded by lateral cyclic shear forces. The incremental loading cycles were controlled by average frame story drift angles, R , defined as the ratio of lateral displacements at the center of the 3rd floor interior beam-column joint, δ to the height of column from the base of column to the center of the 3rd floor beam, h (3,800mm). The lateral load sequence consisted of one cycles to each drift angle, R of 0.00125 and 0.0025 rads., followed by two cycle to each R of 0.005, 0.01, 0.015, 0.02 and 0.03 rads., and then half cycle to R of 0.05 rad.

In this experiment, the measurements of vertical and the horizontal direction loads, i.e. applied axial force and shear force were carried out by the load cells, which were installed on the top of 3rd floor columns (Fig. 2). Displacement at each story, deformations of beam-column joints, deformations of horizontal and axial directions in beams and columns were measured using the displacement transducers. The measurement of steel strain was carried out by installing the uniaxial strain gauges to the beam and column steels, and installing the three axial strain gauges to the joint panel of the beam-column joints.

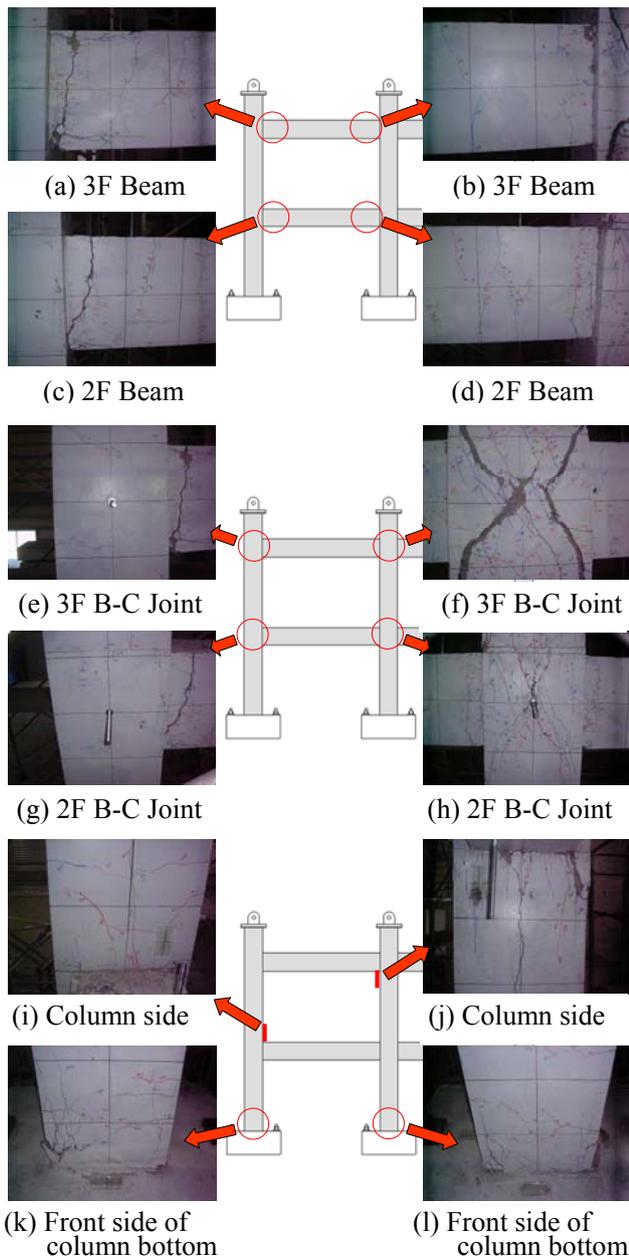
Figure 3 Crack modes at R of 0.05 rad.

Failure modes of specimen after loading are shown in Fig. 3. At R of 0.00125 rad., flexural cracks occurred near all beam ends. These cracks increased at R of 0.005 rad., and there was almost no new crack occurred in the beams. At this stage, however, new cracks occurred in the base of column for each floor and on the side of the interior and exterior columns, which were vertical cracks (Fig. 3(i) and (j)). The shear cracks also occurred in the 3rd floor interior beam-column joint in this stage. At R of 0.01 rad., the cracks of the various parts of the beams and columns extended with the increase of story drift angle, and new shear cracks occurred in the 2nd floor interior beam-column joint. At R of 0.015rad., flexural cracks of beam almost didn't develop, however, cracks in various parts of the column significantly increased and concrete spalling was observed under the beam of the 3rd floor near beam-column joints. At R of 0.02 rad. cracks in various parts of the column increased and compression cracks was observed to all base of column sections in the 1st floor. At R of 0.03 rad., the cracks of the beam extended and shear cracks on interior beam-column joint of the 3rd floor significantly increased. In addition, the concrete spalling was observed in this stage.

In all beams, the flexural cracks developed at a position around 200 mm from the joint (Fig. 3(a) to (d)). For exterior beam-column joint with shear capacity magnification (SCM) factor of 2.24, almost no shear cracks occurred in the joint panel (Fig. 3(e) and (g)). However, the shear cracks in the joint panel was observed significantly in the interior beam-column joint (SCM factor = 1.34), which increased with the increase of drift angle (Fig. 3(f) and (h)). This indicates that the different SCM factor of beam-column joints resulted in different failure characteristics of the joints. For the column, furthermore, flexural cracks concentrated on the base of column at each floor. The compression failure of the column was clearly observed with the increase of the story drift angle (Fig. 3(k) and (l)).

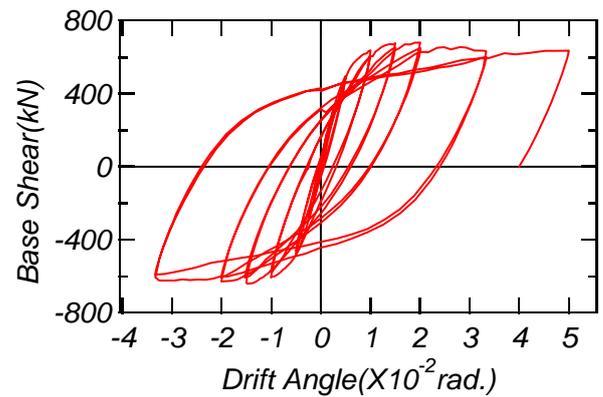
Figure 4 Shear versus average story drift angle relationships

Base shear versus average story drift angle relationships of the specimen is shown in the Fig. 4. The based shear was calculated by summing the total of the shear forces which were measured on the top of the columns. The failure of specimen was initiated by yielding of the beam flange at R of 0.003 rad. The yielding of the beam increased at R of 0.01 rad., however, almost no strength degradation occurred in this stage. In positive loading, the specimen reached the maximum strength of 680.4 kN at R of 0.02 rad., while in negative loading, the maximum strength was reached at R of -0.015 rad with a base shear of -641.4 kN. The strength of the specimen in both positive and negative loading sides was almost kept constant until large drift angle, R of 0.05 rad. The strength of the specimen at last drift angle, R of 0.05 rad was 635.9 kN, which was approximately 90% of its maximum strength. From this figure, it can be seen that the CES frame specimen had a stable-spindle shaped hysteresis loops with large energy absorption, indicating that the specimen had excellent seismic performance.

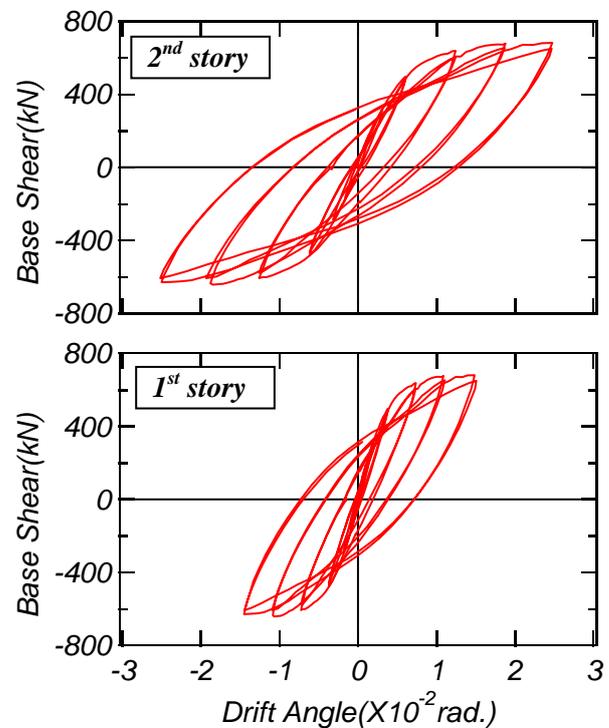
Figure 5 Shear versus drift angle relationships at each story frame

Figure 5 showed the relationships between base shear versus 2nd story drift angle, R2 and between base shear versus 1st story drift angle, R1. The data used in this figure was measured until average story drift, R of 0.02 rad., where the maximum strength was reached. As seen in the figure, the deformation in the 2nd story was about 1.5 times that of in the 1st story due to the large development of residual cracks width in the 2nd story.

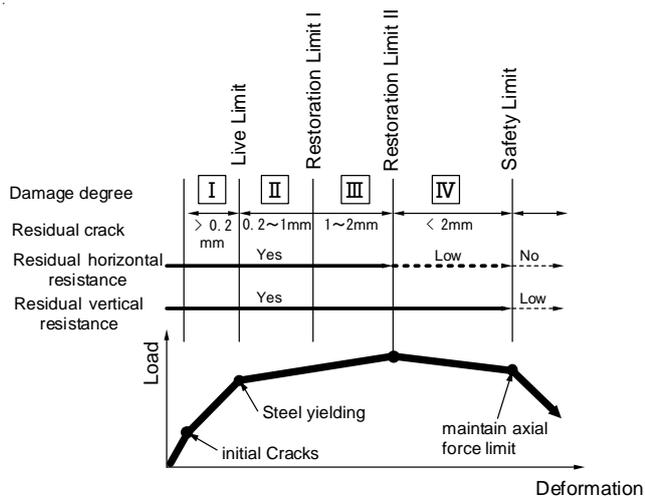
Figure 6 Schematic degree of damage (AIJ)

Definition of the degree of damage for the structural component is shown in Fig. 6. The degree of damage for structural members mentioned in AIJ guidelines considering the scale of the structural repair which becomes necessary for damage circumstance and after the earthquake such as concrete which responds to limit state, residual cracks and compressive destruction, which is evaluated appropriately. The degree of damage was classified into 4 categories according to the limited state of the component, namely: degree of damage I (enable continue to use the structure), degree of damage II (easy to repair), degree of damage III (repairable) and degree of damage IV (maintain axial force limit). In this study, the degree of damage for each structural component of the frame such as columns, beams and beam-column joints, and the whole 2-bay 2-story CES frame was examined.

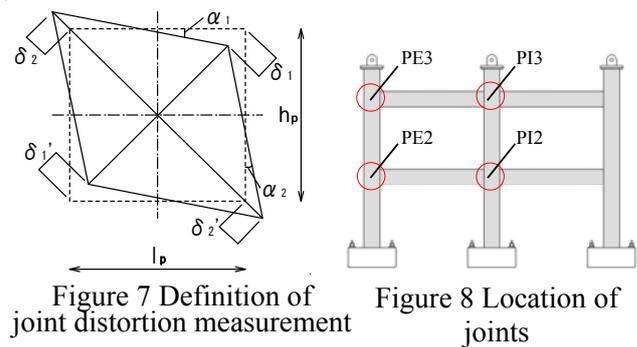
Figure 7 Definition of joint distortion measurement

Figure 8 Location of joints

Figure 9 shows the base shear force versus joint distortion responses for joint panels (Fig. 8) until R of 0.03 rad. The joint distortion, γ_p , on the horizontal axes was calculated using Eqs. 3.1 and 3.2. Figure 7 shows the definition to calculate the joint distortion.

where h_p , l_p and δ_1 , δ_1' , δ_2 , δ_2' are shown in Fig. 8.

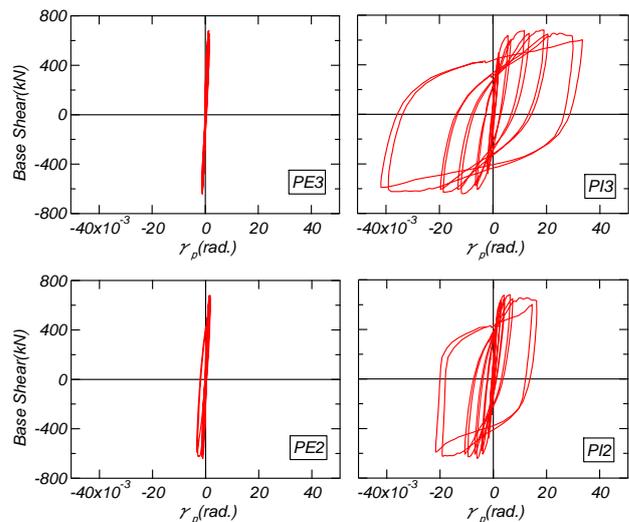
Figure 9 Joint distortions of beam-column joints

As seen in this figure, the joint distortions of exterior beam-column joints in the 3rd and 2nd floors were relatively small until R of 0.003 rad. In the interior beam-column joints, however, the joint distortions of the 3rd and 2nd floor reached around 0.03 rad. and 0.015 rad., respectively. The different SCM factor between exterior beam-column joints (2.24) and interior beam-column joints (1.34) clearly recognized the difference of joint distortion in the joint panels. For the same SCM factor, moreover, the joint distortion of the interior beam-column joint in the 3rd floor was approximately 2 times that of in the 2nd floor, indicating that the joint distortion increased in the higher story of the frame.

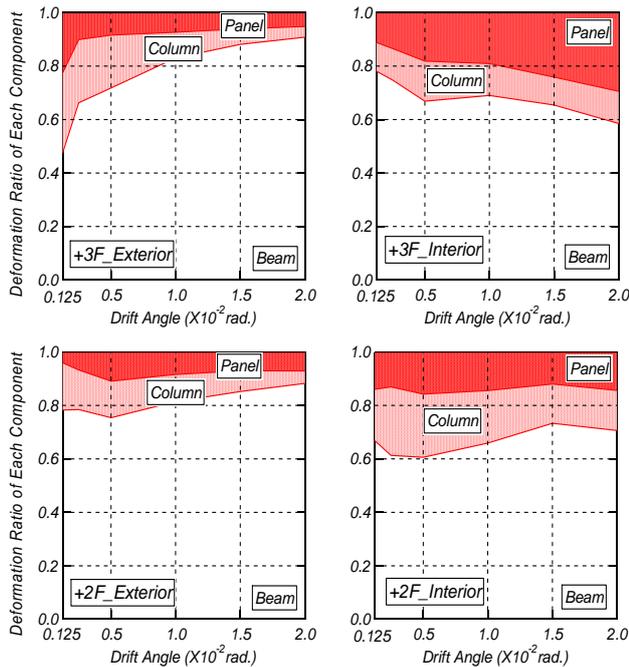
Figure 10 Deformation ratio of each component

Figure 10 shows the contributions of deformation by the column, beam, and joint panel to the total deformation of the joint panels for all beam-column joints of the frame until R of 0.02 rad. The values were obtained by measuring the deformations of beam, column and panel zone from transducers installed on the steels of each component (Fig. 12). The deformations of the column and the joint panel were converted into the deformation of beam, as described in Fig. 11. In interior beam-column joint of the 3rd floor, the deformation ratio of the beam decreased with the increase of drift angle and it fluctuated in the 2nd floor, while deformation ratio of the column was almost constant in the 3rd floor at approximately 10 % and slightly decreased in the 2nd floor. In panel zone, moreover, the deformation ratio of the joint panel increased in the 3rd floor, while it keeps constant at approximately 15% in the 2nd floor. In exterior beam-column joints, the deformation ratio of the beam in both stories increased significantly with the increase of drift angle, while the deformation ratio of the column and joint panel decreased. By comparing the interior and exterior beam-column joints, there was a tendency where deformation ratio of the interior joint panel becomes large due to the influence of SCM factor.

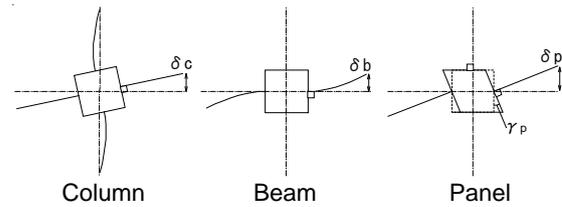
Figure 11 Definition of joint deformation of each component

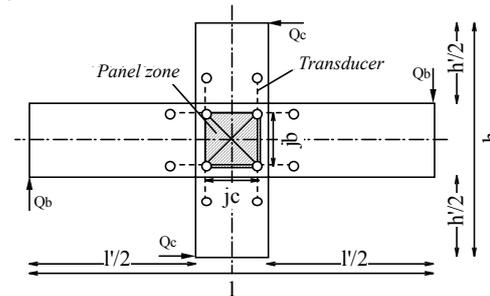
Figure 12 Definition of shear force in panel zone
