RAPID SEISMIC REPAIR OF SHEAR DAMAGED CONCRETE BRIDGE COLUMNS BY TRANSVERSE PRESTRESSING

M. Yarandi¹ and M. Saatcioglu²

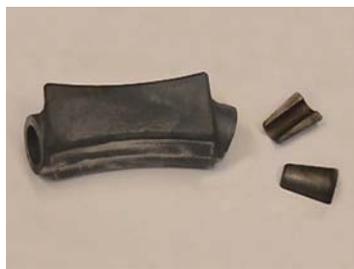
a) Anchor

The RetroBelt repair technique consists of external transverse prestressing, applied by means of strands that are connected through special anchors. Figure 2 illustrates the hardware necessary to employ the repair technique. The transverse prestressing is done by means of standard 7-wire strands. In the experimental program reported in this paper, each strand had a 9.53 mm nominal diameter and 55 mm² steel area. While the strands are directly applied on circular columns, taking advantage of uniform hoop tension that develops in a circular geometry, they require raiser frames on rectangular and square columns to produce a parabolic tendon profile and activate hoop tension. The raiser frames are manufactured from hollow steel sections or cast iron pieces with

semi-circular disks of different diameters welded on each side to raise the level of strands. This ensures reasonably uniform application of confinement forces on each face of column. In the experimental program, the raiser frames were manufactured from hollow steel sections (HSS 31.8x31.8x6.35mm). A specially manufactured anchor is used to perform the prestressing operation. This anchor is placed directly on the concrete surface for circular columns and on one of the raiser frames for square and rectangular columns. Round steel pieces are placed around square and rectangular column corners or small piece of greased steel strips are placed around each corner to reduce stress concentration and prevent damage to corners, while allowing the strands to slide freely during prestressing. The locations of RetroBelt hoops are first marked on the column. The hoops are hand held by one person while the other person performs the prestressing operation. For application to square and rectangular columns the raiser frames are first nailed to column concrete to ensure proper positioning during prestressing. The strands are wrapped around the raiser frames or directly on columns (for circular columns), and are locked in the anchors by means of two pairs of wedges. The use of two jacks simultaneously may be more effective. The first jack applies the prestressing force. Upon reaching the desired level of prestressing, the second jack can be used to push and lock the wedges into the anchor to eliminate anchorage losses. The level of prestressing is monitored through a pressure gauge.

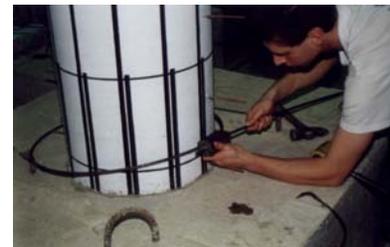
c) Installation on a circular column

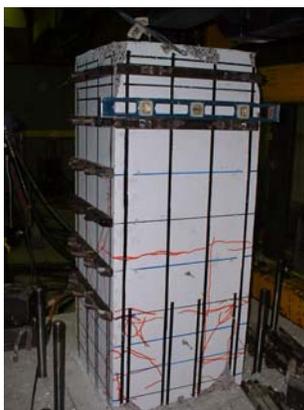
g) Placement of raiser frames

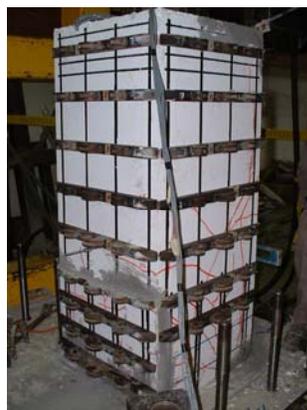
h) Repairing a square column
