AN EXPERIMENTAL STUDY OF RC COLUMNS WITH CAPTIVE COLUMN SHEAR FAILURE REPAIRED BY CFRP

O. Tunaboyu⁽¹⁾, Ö. Avşar⁽²⁾

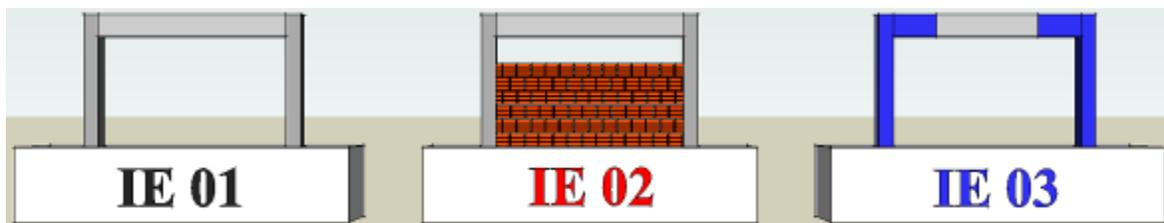
Fig. 1 - Properties of the test specimens

Two 1/3 scale, one-story one-bay RC frames, all of which were designed with certain deficiencies such as low strength concrete, plain bars with improper detailing, to represent the existing substandard RC buildings in the Turkish RC building stock were tested to investigate their performance. The project consisted of three testing series: The first test specimen (IE01) was the bare frame, which was considered as the reference specimen. The reference specimen was constructed without infill wall. The second test specimen (IE02) was constructed with a partial infill wall between the columns leaving an opening at the top to cause captive column defect. The ratio of the opening height to the wall height is approximately 25%, which is a typical ratio for a strip window in existing RC buildings. The partial infill wall was constructed by a mason, who is actively working in the building constructions for constructing infill walls. Hence the infill wall was constructed in the test specimen IE02 represents the infill walls in the existing RC buildings. The geometric dimensions of the brick units and the overall infill wall dimensions were scaled in accordance with the scale of the RC frame. After the severe damage was observed with the same loading history of the reference specimen, damaged IE02 specimen was repaired with CFRP sheets and the repaired specimen was named as IE03. Before repairing the IE03 specimen, the damaged infill wall was removed from the frame and the damaged columns were wrapped with CFRP sheets. After the repair, no infill wall was constructed between the columns of the IE03 to prevent the recurrence of the captive column defect. In real life applications, in case of any requirement for the construction of infill wall with the opening resulting in a captive column defect, the partial infill wall should be separated from the frame with sufficient amount of gap between the frame. At the same time, the out-of-plane failure of the infill wall should be prevented by taking relevant precautions. This will enable the frame to behave like a bare frame without formation of captive column defect. With this approach, the infill wall was removed after testing IE02 and not reconstructed in the repaired specimen. All the three tested specimens were subjected to similar lateral displacement loading protocol and vertical loading. General view of the tested specimens is shown in Fig. 1.

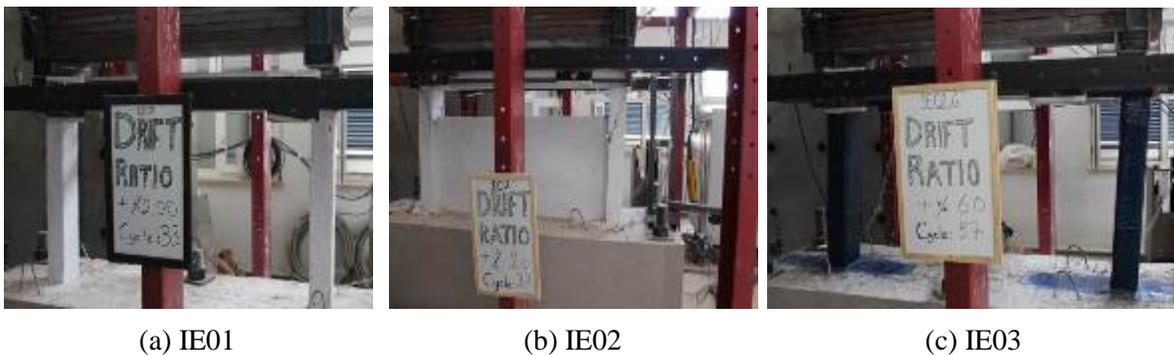
Fig. 6 - Damage pattern of the test specimens at 2% drift ratio

After the damage occurred in IE02, it was repaired with CFRPs and retested as IE03, which was the repaired frame. The maximum lateral load of IE03 was recorded as 21.8 kN, which is almost twice the lateral load capacity of the reference specimen. The test was ended at the top displacement of 50 mm (6% drift ratio). Since the columns, beam and joints of the frame were wrapped with CFRPs, crack formation in the RC members as well as the rupture of the CFRP sheets could not be monitored apparently. After 4% drift ratio, some of the inner CFRP layers were ruptured, which caused strength deterioration specifically in the second cycle for the 4.4% drift ratio in the positive direction and in the first cycle of the 4.3% drift ratio in the negative direction (Fig. 8(c)). Although a ductile behavior was observed up to 4% drift ratio, a sharp decrement in the strength occurred as a result of rupture in the inner layer of CFRP sheets. The damage pattern of all the test specimens at 2% drift ratio are shown in Fig. 6. Nevertheless, only IE01 and IE03 specimens can displace up to 6% drift ratio.

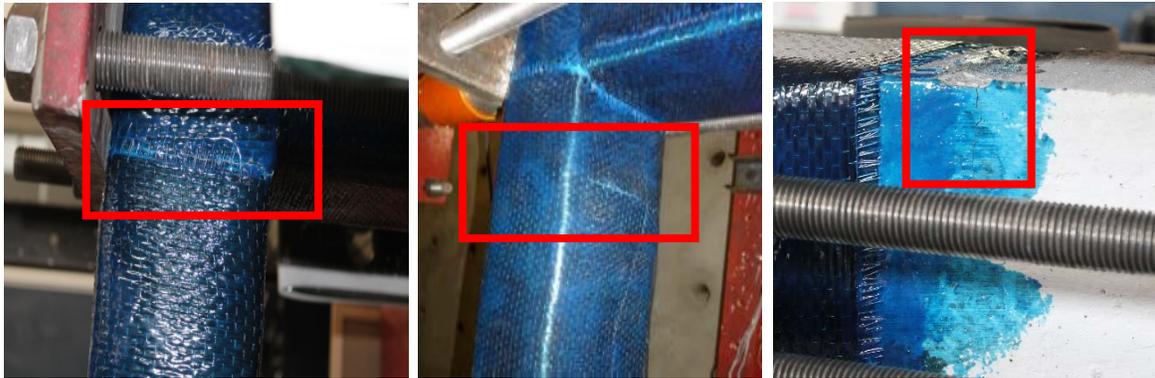
(a) CFRP fracture of column (b) CFRP swelling (c) Flexural crack in the beam

Fig. 7 - Failure pattern of CFRP

Since the section cracks have remained under the CFRP layers, they could not be apparently seen in the IE03 specimen. The first fracture at the interface of the column and joint CFRP sheets in the column initiated at 1.5% drift ratio as seen in Fig. 7(a). In Fig. 7(b) the swelling of CFRP sheets was observed as the drift ratio increased. After the 5% drift ratio, flexural cracks were observed at the middle part of the beam, which was not wrapped with CFRP (Fig. 7(c)). In Fig. 8(c) two sudden decrement of load values were monitored when the target drift ratio was 4% in the negative direction. At that point a sound similar to the fracture sound was heard. However, the fracture of the CFRP sheets could not be apparently observed from the outer CFRP layers of the repaired specimen.
