## Seismic performance of tailings sand dams in Chile

J. H. Troncoso <sup>(1)</sup>, R. Verdugo <sup>(2)</sup>, L. Valenzuela <sup>(3)</sup>

### Abstract

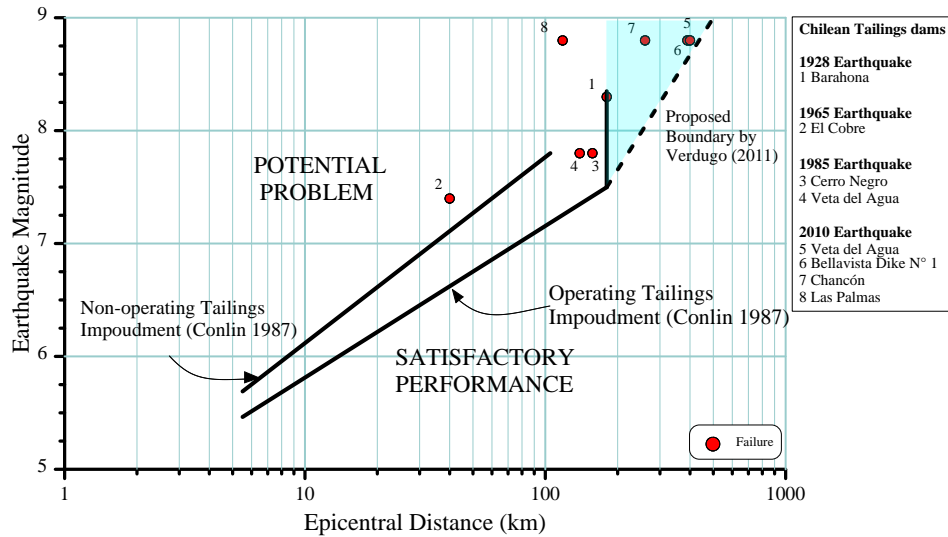
Fig. 4 – Susceptibility of upstream tailings dams to suffer damage due to earthquakes (Conlin [15]; extended by Lo et al [16] and by Verdugo [17]).

Figure 4 includes the graph prepared by Conlin [15] and complemented by Lo et al [16] and Verdugo [17], showing several of the upstream dams that have failed, according to the magnitude of the earthquake and the distance from the epicenter in the case of each dam, indicating a possible boundary between the two types of behavior.

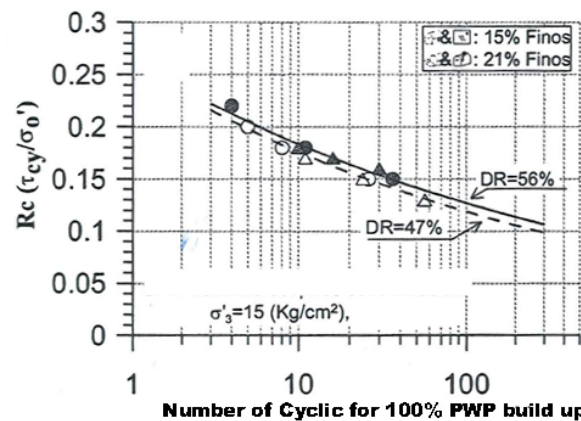
Fig. 11 – Cyclic strength at high confining pressure [23]

On the other hand, Campaña [23] has shown that at high confining pressure the effect of fines on the cyclic strength tends to disappear. Typical experimental results are shown in Fig. 11 for a tailings sand with 15 and 21% of fines, tested under a confining pressure of 15 kg/cm<sup>2</sup> (1.5 MPa).
