COSEISMIC FAULT DISPLACEMENTS ON THE PEDRO MIGUEL FAULT FOR DESIGN OF BORINQUÉN DAM, PANAMÁ CANAL EXPANSION

Abstract

Keywords: Fault Rupture; Dam Design; Paleoseismology; Panamá Canal

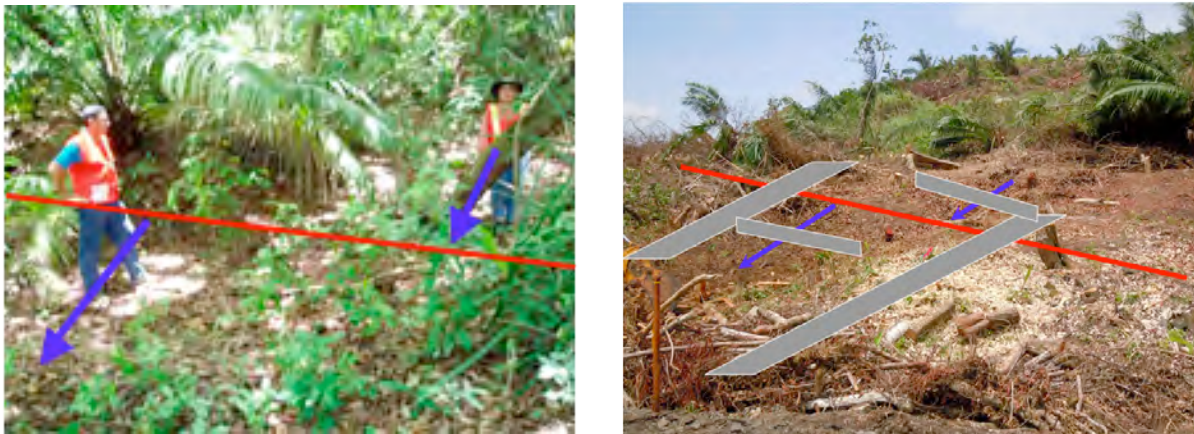
Fig. 4: (Left) Photo, looking south of the proposed trenching site before the vegetation was cleared. The Pedro Miguel fault was interpreted to trend sub-horizontally across the photo, between the two ACP geologists who are standing in the upper and lower channel courses, respectively, which appear to be displaced ~3 to 4 meters across the fault. On the left is the beheaded downstream segment of the channel, and on the right is the truncated upstream equivalent flowing into the fault. (Right) The same location with the vegetation removed, showing the planned trench locations perpendicular to, and parallel to, the Pedro Miguel fault, designed to reveal and accurately measure the offset of the small channel across the fault.

The intent of the investigation was to confirm the fault's location and identify piercing points that we could use to measure fault displacements across the site. This was done by excavating trenches on both sides of the offset channel (Fig. 5, left), and extending them perpendicularly across the fault (Fig. 5, right). The first trenches were to be located adjacent to, but outside the channel margins so as to locate the fault while preserving the channel form and the channel deposits for detailed reconstruction and measurements in subsequent trenches. Once the fault location was confirmed, fault-parallel trenches would be excavated across the channels on opposite sides of the fault, initially keeping them several meters from the fault (Fig. 4, right). These excavations would define the 3-D channel geometry away from the fault. After logging and surveying the channel margins and thalweg, both fault-parallel trenches would be progressively widened towards the fault by removing thin slices, with new logging and surveying of the channel forms after each slice. Eventually, the result would be a 3-D surveyed map of both sides of the channel as it interacts with the fault, and an accurate measurement of the channel's offset across the fault.
