RESILIENCE LESSONS LEARNED FROM SELECT RECENT EARTHQUAKES

R. C. Lo⁽¹⁾

Abstract

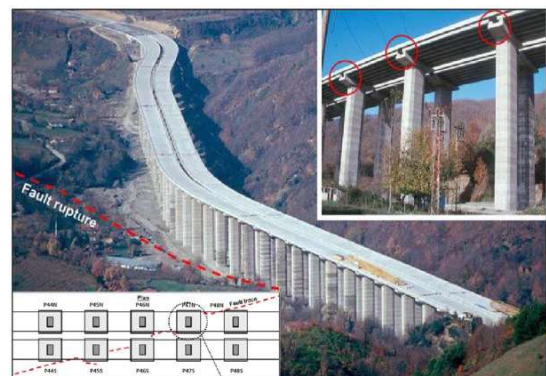
Fig. 2 - Bolu Viaduct during 1999 Düzce EQ (from Yang and Mavroedidis 2018,[4])

On August 17, 1999 a magnitude Mw 7.4 earthquake occurred in the Kocaeli and Sakarya provinces of Turkey, a densely populated industrial heartland of northwestern Turkey. Three months later, on November 12, at the eastern end of the August fault break the adjacent segment of the North Anatolian Fault system ruptured, producing the Mw 7.1 Düzce earthquake [2]. This pair of earthquakes resulted in heavy casualties and economic damages in the extended swath of affected area (see Table 1). To better understand the national fault activities, Turkey government engaged a multi-disciplinary and multi-lateral research project to monitor these faults from 2005 to 2010 (see Fig. 1, [3]). Ongoing monitoring beyond 2010 is expected to continue in similar programs based on available resources and perceived research objectives. Figure 2 shows Bolu viaduct damaged during both the Kocaeli and Düzce earthquakes. The lower left inset shows the local fault crossing the viaduct pier foundation plan, while the upper right inset indicates displaced super-structure [4].

Ulusay et al. (2018,[17]) discussed the behaviour of structures built on active fault zones using examples of the 1999 Kocaeli (Izmit) and Düzce earthquakes. Yang and Mavroeidis (2018,[4]) provided a review of bridges crossing fault rupture zones including those involved in the 1999 Kocaeli (Izmit) and Düzce earthquakes in Turkey and the 2008 Wenchuan earthquake in China.

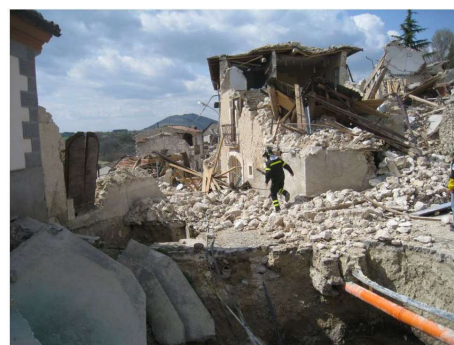
Fig. 4 - All structures in Castelnuovo on a hilltop were totally or partially collapsed (from GEER 2009,[5])

Unfortunately on April 6, 2009, a magnitude 6.3 earthquake hit L'Aquila and its vicinity followed by two large aftershocks in next 3 days, killing more than 300 people and injuring more than 1,500. The quake destroyed about 20,000 buildings and displaced 65,000 people. Figure 4 shows the damage scene at Castelnuovo, a hilltop town [5]. A contribution of 470 million Euros and other post-earthquake initiatives were made by the EU to assist local communities.

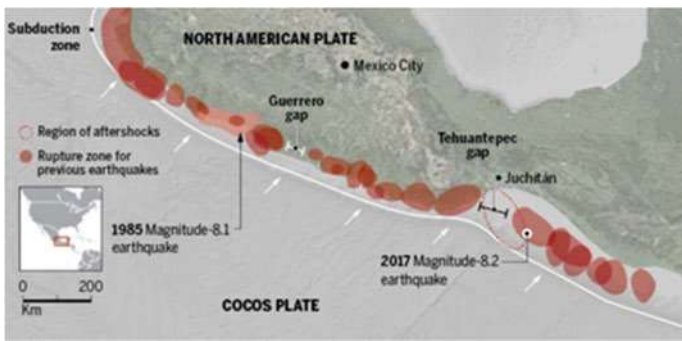
(a) Cocos Plate Subduction zone

As history would have it, the 2017 M_w 7.1 Puebla-Morelos intraplate event occurred on September 19, 2017, coincidental to the 32nd anniversary of the 1985 M_w 8.0 Michoacan interplate event (see Fig. 5a,[7]). The 2017 earthquake occurred as a result of normal faulting at a depth of approximately 50 km. While the problem of ongoing ground subsidence due to extraction of groundwater in the Mexico City is widely recognized for decades, the somewhat related problem of ongoing ground cracking and its intensification during seismic

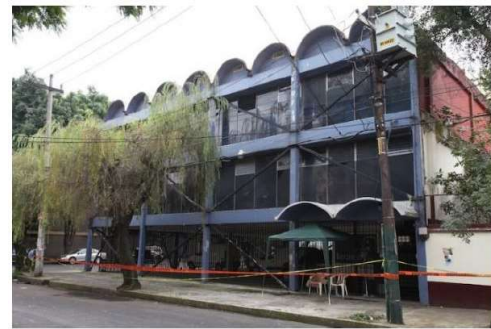
(b) Steel bracing of reinforced concrete commercial building

The building retrofit techniques observed in 2017 include: column strengthening and frame bracing. Successful seismic retrofits can be achieved when designed by competent structural engineers and constructed by experienced contractors. On the other hand, some buildings altered by owners without engaging competent engineers and contractors performed poorly in the earthquake.

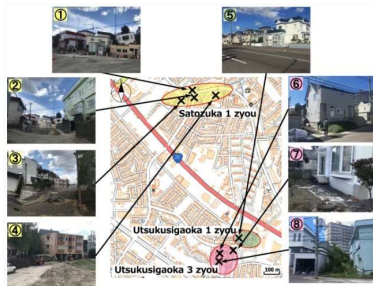
(a) Liquefaction induced house damages

Fig. 6 - Liquefaction affected areas in Kiyota Cho, Sapporo Hokkaido (from Serikawa et al. (2019)[10])

Serikawa et al.2019 [10] carried out an investigation to study the tilting of houses affected by liquefaction at Satozuka and Utsukushigaoka towns in Sapporo city. Figure 6a presents photos of houses affected by liquefaction in the two towns. Figure 6b shows the distribution of degree of tilting of the outer wall of these houses. The study indicates when the degree of tilting exceeded 0.6 degree, residents tended to move out from the house rather than continued to tolerate the deformed house condition.

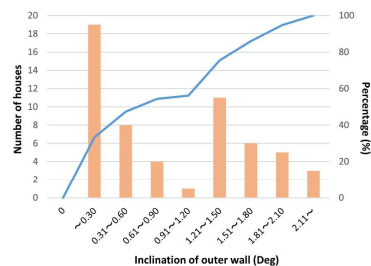
(b) Histograms of house inclinations

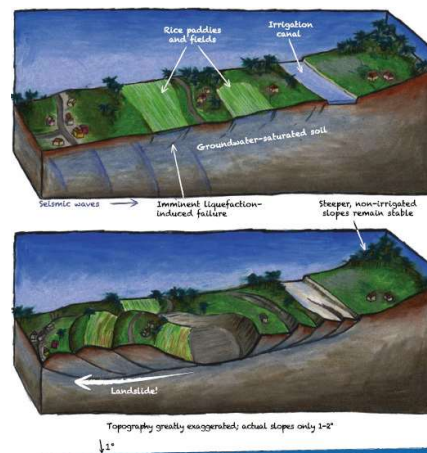
Fig. 8 - Landslides by liquefaction (from Keane 2019 [16])

Bradley et al. (2019, [15]) described another liquefaction hazard related to wet rice irrigation practice at Palu. Figure 8 illustrates this problem schematically (Keane 2019,[16]). The upper figure shows an up-slope irrigation canal and rice paddies and fields down slope. The aqueduct-supported cultivation, primarily of wet rice, raised the water table to near ground surface, saturating sandy alluvial soils. The lower figure depicts the aftermath of the earthquake-triggered liquefaction of the saturated ground at a gentle slope of $\sim 1^\circ$. Long-runout landslides and debris flows then swept through villages occupying the gentler slopes below.
