SEISMIC RETROFIT AND REPAIR OF REINFORCED CONCRETE BRIDGE WALL PIERS

C.P. Pantelides⁽¹⁾, B. Kunwar⁽²⁾, V. McEntee⁽³⁾

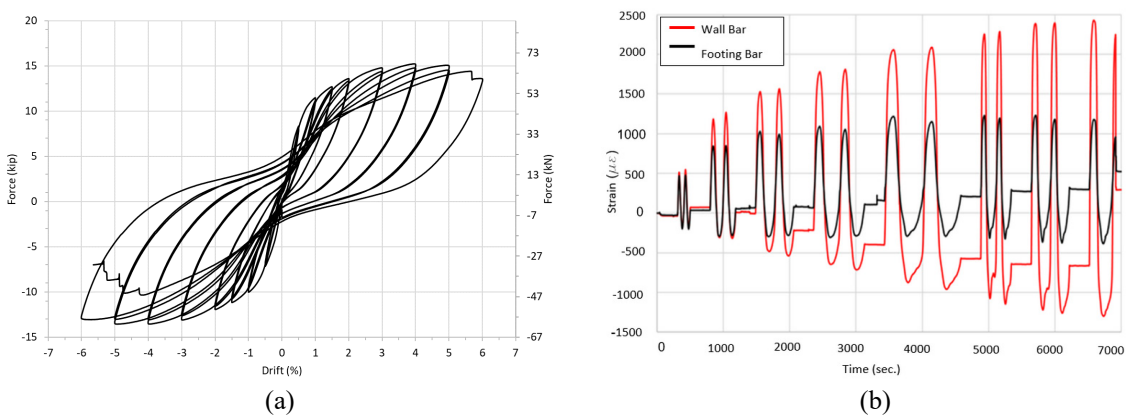
Fig. 2 – Performance of as-built wall pier: (a) hysteresis; (b) lap-splice wall and footing bar strains

The hysteresis for the control as-built wall pier can be seen in Fig. 2(a) where pinching is evident; lap splice failure developed gradually until the first cycle of the 6.0% drift ratio when a significant drop in lateral load was observed. The strain in the lap spliced bars is shown in Fig. 2(b); the lap splices did not develop the yield strain during the test, but actually the lap spliced bars in the wall reached the yield point. Moreover, the difference in strain between footing bars and bars in the wall pier is greater than 1000 microstrains, which indicates lap splice failure had occurred. At 2.0% drift ratio, cracks began to widen on both sides of the wall pier measuring 0.33 mm. During the 3.0% drift ratio, the plastic hinge had formed completely and cracks grew to a width of 0.76 mm. The lateral load began decreasing at the 4.0% drift ratio with significant damage shown in Fig. 3; at the 6.0% drift ratio the wall failed due to loss of the lap splice tension capacity. The as-built wall pier behaved poorly, hysteretic energy dissipation was low and the lateral load degraded significantly; the as-built wall pier would have performed poorly in a strong earthquake.

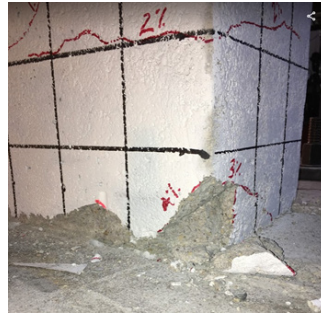
Fig. 3 – As-built wall pier spalling occurring at 4.0% drift ratio

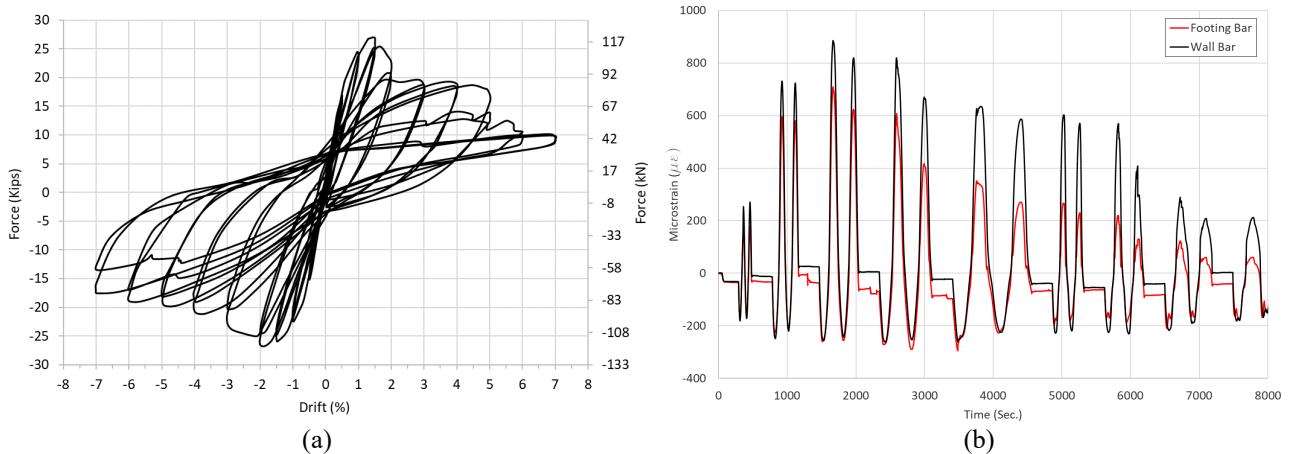
Fig. 7 – Performance of retrofitted wall pier with vertical CFRP anchors: (a) hysteresis; (b) lap-splice wall and footing bar strains

The hysteresis in Fig. 7(a) exhibited general stability throughout the entire test until the first cycle of 5.0% drift at which the maximum force dropped by 34%. A comparison between the footing bar strain and the wall bar strain in Fig. 7(b) shows the reduction in lap splice strain from the addition of the CFRP retrofit compared to Fig. 2(b) of the as-built wall pier. In the as-built wall pier test, the lap splices were increasingly strained throughout the test, reaching up to 1200 microstrain at 5.0% drift ratio. However, in the retrofit specimen, the lap splice strain ceased increasing after the 2.0% drift ratio and was at a maximum of 830 microstrain at this drift ratio. There was not a large difference in strain between footing bars and wall bars; in addition, none of the spliced bars yielded which implies that there was no lap splice failure. During the first cycle of the 2.0% drift ratio, two vertical CFRP anchors partially fractured on the west side of the wall, as shown in Fig. 8. At the 3.0% drift ratio, a 6.4 mm wide crack opened up on the east face of the wall and portions of the concrete began to spall at the base of the footing. After the 3.0% ratio there was no more debonding of the CFRP, and damage for the remainder of the test occurred in the footing. At 4.0% drift ratio the footing crack increased to 25 mm and at the 5.0% drift ratio, during the pull cycle, the lateral load dropped when two vertical anchors fractured, and steel rebar was exposed in the footing due to concrete

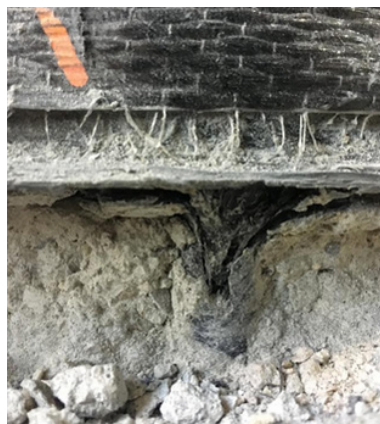
Fig. 8 – Partial anchor fracture for retrofitted wall pier with vertical CFRP anchors
