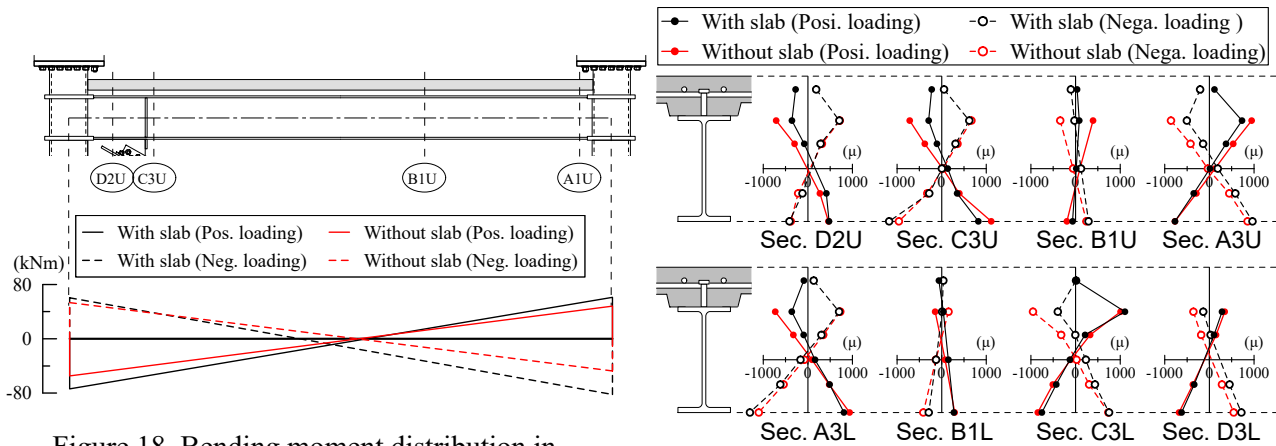
Figure 18 Bending moment distribution in upper beam at  $\theta = \pm 1/200$
