EFFECTS OF MULTI-DIRECTIONAL SEISMIC INPUT ON THE DYNAMIC BEHAVIOR OF URM STRUCTURES: AN EXPERIMENTAL STUDY

Abstract

Keywords: shake-table tests; unreinforced masonry; vertical acceleration; out-of-plane rocking; non-structural damage

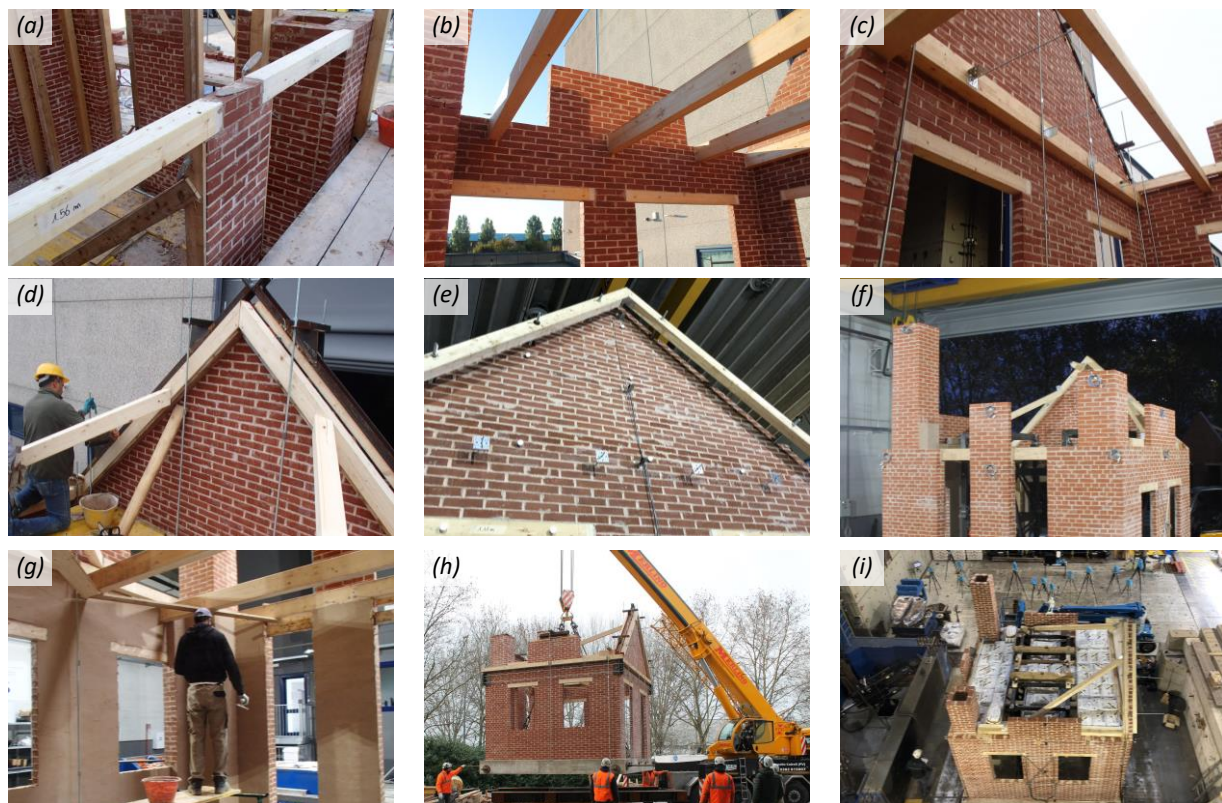
Fig. 2 – Construction details of the building specimens: (a) timber lintels at West façade; (b) floor diaphragm during construction; (c) wall-to-diaphragm connections at North façade (initially deactivated); (d) truss and struts at North gable; (e) end-plate outside the North gable (initially at distance); (f) chimneys and parapets (South-East view); (g) rendering of building interior; (h) transportation of building specimens; (i) additional masses on the floor diaphragm (top East view).

Three out of the four perimeter walls, North, East, and West façades, consisted of a single 100-mm-wide leaf, built with the standard stretcher bond. The South facade was made of a double 208-mm-thick wythe, using the Dutch cross brickwork bond. Large asymmetric openings were present at all façades, resulting in varying wall areas in both building directions, with the intent to magnify differential wall displacements (Fig. 1d). Timber lintels were placed above all openings: they were 110-mm-deep timber beams, extending into the masonry 100 mm on each side of the openings for support (Fig. 2a).

The floor consisted of 30-mm-thick timber floorboards nailed to 100-mm-wide and 180-mm-deep timber joists by means of two nails at each intersection, resulting in a flexible diaphragm (Fig. 2b). The floor joists were supported by the East, West, and South walls, while there were no wall-to-diaphragm connections at the North building façade. At the end of the construction works, 8-mm-diameter steel anchors were installed at the gable-floor joints, as shown in Fig. 2c (also visible in Fig. 2e). These anchors were not connected to the timber floor initially, but they were placed with the possibility to be nailed subsequently, in case of the early development of an out-of-plane mechanism of the façade.

A timber truss was installed back to back with the gable wall in a way that allowed only a one-side rocking response of the latter. Struts were additionally provided to support the truss rafters and transfer to the floor frame loads coming from the impact of the gable wall on the truss (Fig. 2d). A timber plate was installed outside the gable, forming an end-plate that prevented the collapse of the gable due to out-of-plane overturning during the experiments. Initially, the plate was placed at a distance that allowed relative displacements between gable and roof truss up to 170 mm; it was suspended by the roof truss through 20-mm-diameter steel bars (Fig. 2e).

Eight 500×500 mm² openings were foreseen on the floor sheathing to avoid interference with the columns of a steel-framed structure installed in the interior of the buildings (visible in Fig. 2i). The steel structure served as a reference frame for the measurement of relative displacements and as a safety system protecting the shake table against impact due to structural collapse during the tests. Each specimen was constructed on a reinforced concrete foundation beam, which was tightly bolted to the shake table. The foundation weighed 10.6 t, and it was rigid enough to allow the transportation of the structures from the construction site onto the shake table without causing damage to the masonry walls (Fig. 2h).

The masonry walls had a mass of 11.3 t, estimated with a mean density of 1950 kg/m³. Floor diaphragm and roof truss provided a mass of 0.3 t. An additional mass of 1.1 t was placed on the floor, using 44 25-kg-heavy bags of mortar (Fig. 2i), evenly distributed over the diaphragm to account for superimposed dead and live loads (equivalent to approximately 67 kg/m²). Two extra loads, equal to 450 kg each, were placed at the East and West borders of the floor to simulate the self-weight of the missing roof, which would have been transferred to the longitudinal walls of the structure through trusses supported on the East and West edges of the floor diaphragm. The total mass of the prototype building was 13.6 t.
