## EXPERIMENTAL STUDY OF DAMAGED REINFORCED CONCRETE WALLS REPAIRED USING SIMPLE TECHNIQUES

G. Muñoz-Arriagada<sup>(1)</sup>, R. Henry<sup>(2)</sup>, K. Elwood<sup>(3)</sup>

### Abstract

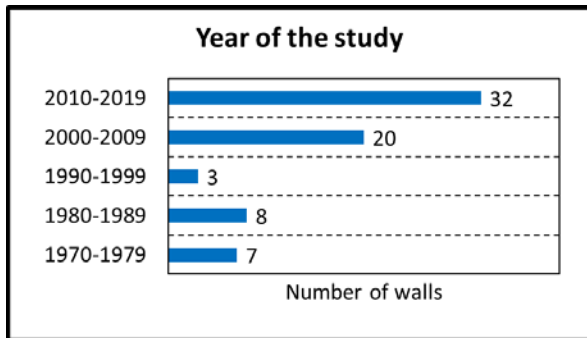
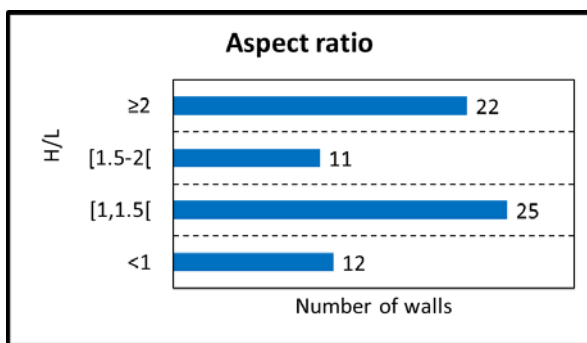
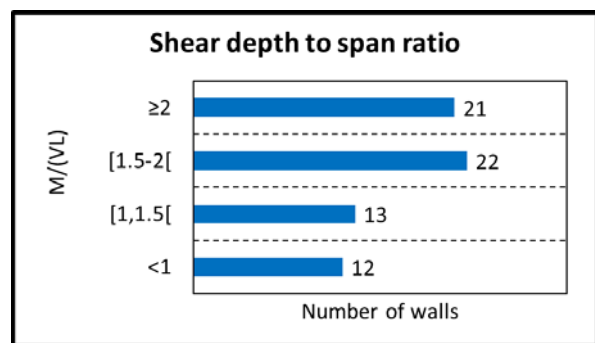
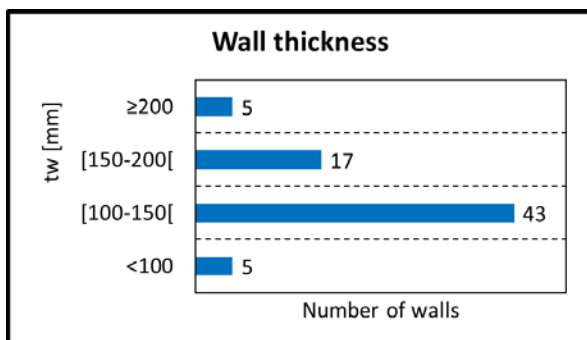
Figure 1: Characteristics of the repaired walls found in literature.

A total of 70 previously tested repaired RC walls were found from 27 different studies, dating back to 1975. Fig. 1 shows the main characteristics of the walls, where the most common cross-section is rectangular, representing 49% of the total tests. The number of barbell shape and “H” shape walls correlates well with the number of walls with high shear stress (more than 4 [MPa]). Wall thickness equal to or greater than 150 [mm] represents just 31% of the total, which aligns with the scale factors lesser than 50% in most of the cases. The axial force ratio, defined as the ratio of the vertical axial load over the compressive strength of the section, are typically 10% of below, which represents low to medium axial forces demands for New Zealand buildings.

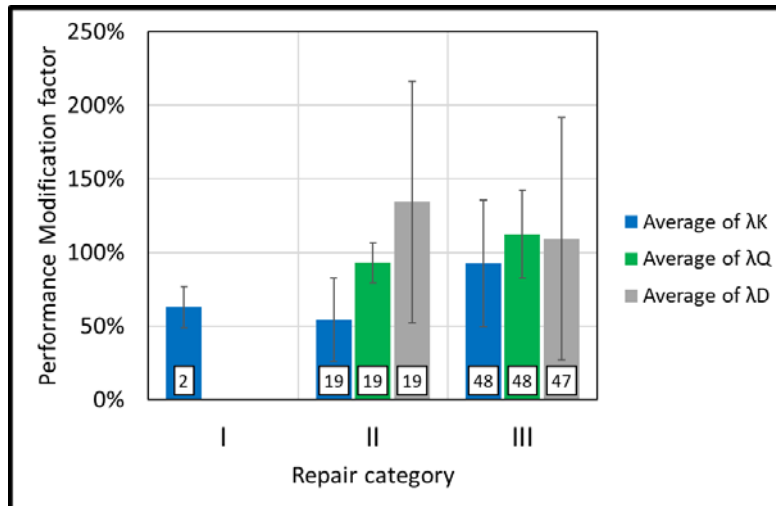
Figure 5: (a) Average of  $\lambda_K^*$ ,  $\lambda_Q^*$ , and  $\lambda_D^*$  using the entire database versus repair category, (b) Average of  $\lambda_K^*$ ,  $\lambda_Q^*$ , and  $\lambda_D^*$  for categories I and II versus cross section.

The averaged PMFs for stiffness, strength, and displacement capacity are presented in Fig. 5 (a). The number at the base of each column represent the number of walls considered in that average, and the error bars represent one standard deviation in each direction of the sample. In all categories, the average stiffness recovery was more than 50% (63%, 54%, and 92% in categories, I, II, and III, respectively), but generally less than a full recovery. Only 19 repaired walls achieved a stiffness higher than their benchmark walls, all grouped in category III. For repair category I, only  $\lambda_K^*$  was calculated since the walls tested were not suitable to calculate  $\lambda_Q^*$ , and  $\lambda_D^*$  (the third wall is not presented because there are inconsistencies in the load-displacement curve provided). The 93% and 112% average strength recovery for categories II and III, respectively, show that full strength recovery is not hard to achieve. In categories II and III, the displacement capacity was greater than 100% (134% for categories II, and 109% for category III), but the calculation of these values are influenced by cases where only one of the walls in the set failed. If these cases are removed from the analysis, the average displacement capacity recovery was 113% for category II and 115% for category III. Both cases still have

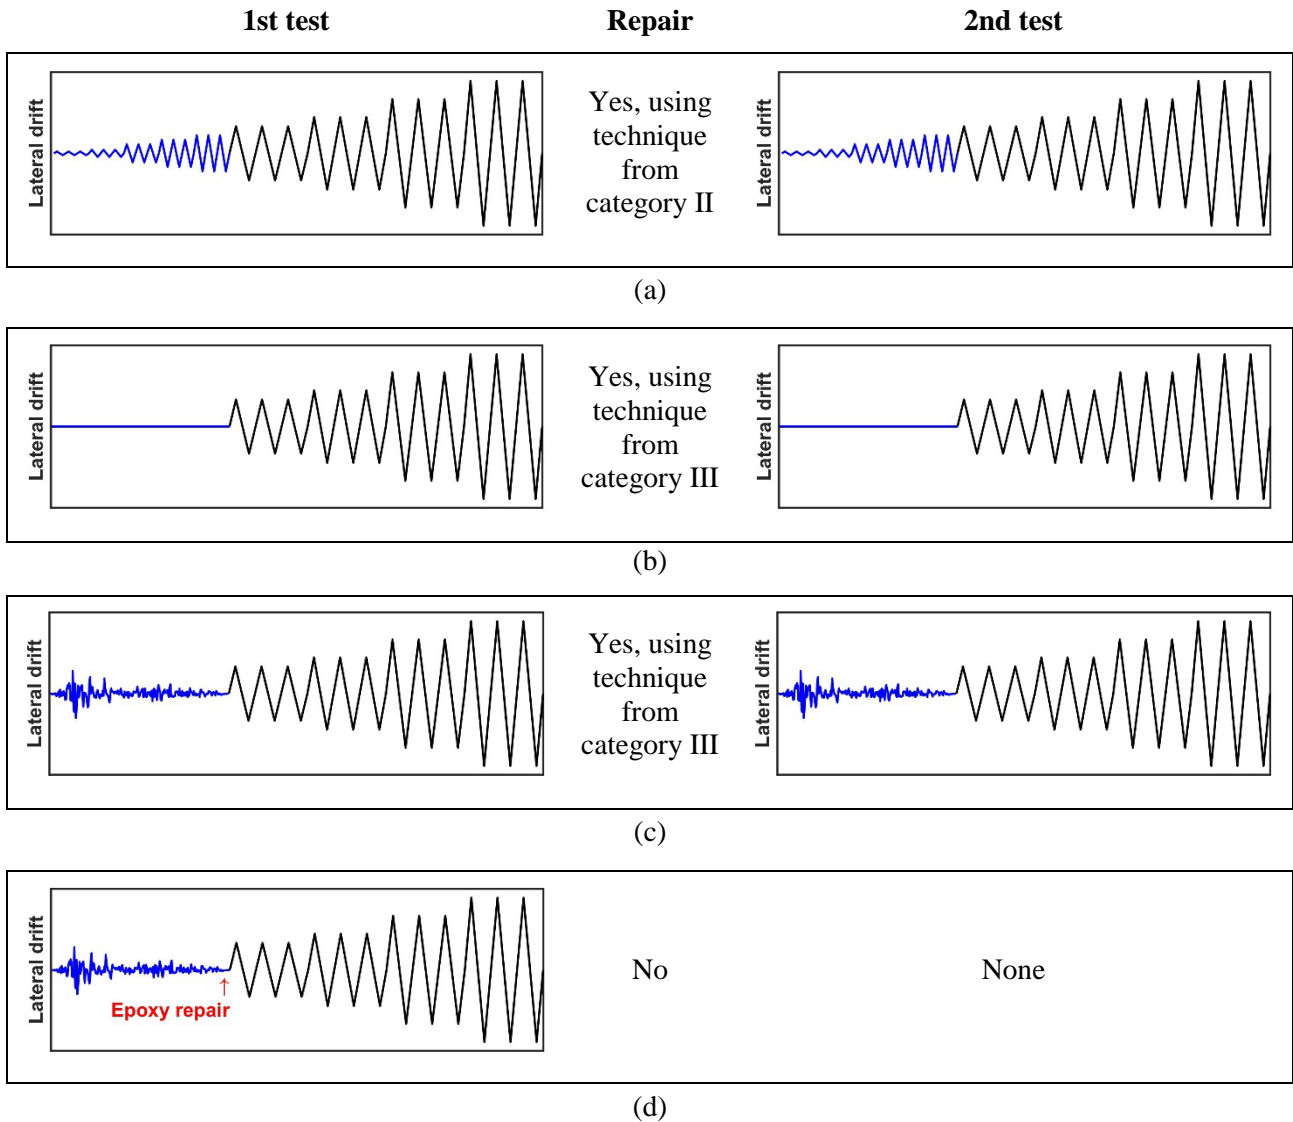
Figure 7: Scheme of the loading protocols (a) CYC, (b) UNDAM, (c) DAM and, (d) REP.

Four identical test walls were constructed to study the influence of the loading protocols and the repair technique on the wall response, as summarised in Table 2. The first wall (CYC) will be subjected to a standard reverse cyclic loading protocol. In order to achieve the target level of moderate damage before the repair, a drift value between the drift at which spalling and buckling of the longitudinal boundary reinforcement steel occurred will be used as the target peak drift for the earthquake demand in the other specimens. After failure, the wall will be repaired using a technique from category II of Table 1 and retested. The second wall (UNDAM) will be subjected to a similar loading protocol as CYC, but the drifts below the target damage drift removed. The third wall (DAM) will be subjected to a simulated earthquake displacement demand extracted from a numerical model and scaled to achieve the target damage drift. After this, the wall will be tested cyclically until failure. Then the wall will be repaired using a repair technique in category III in Table 1 and retested. The fourth wall (REP) will be subjected to the same loading protocol of the third wall, but epoxy injection and epoxy mortar will be used as a repair technique between the earthquake demand and the cyclic displacement. Fig. 7 shows a scheme of the loading protocol of each specimen.

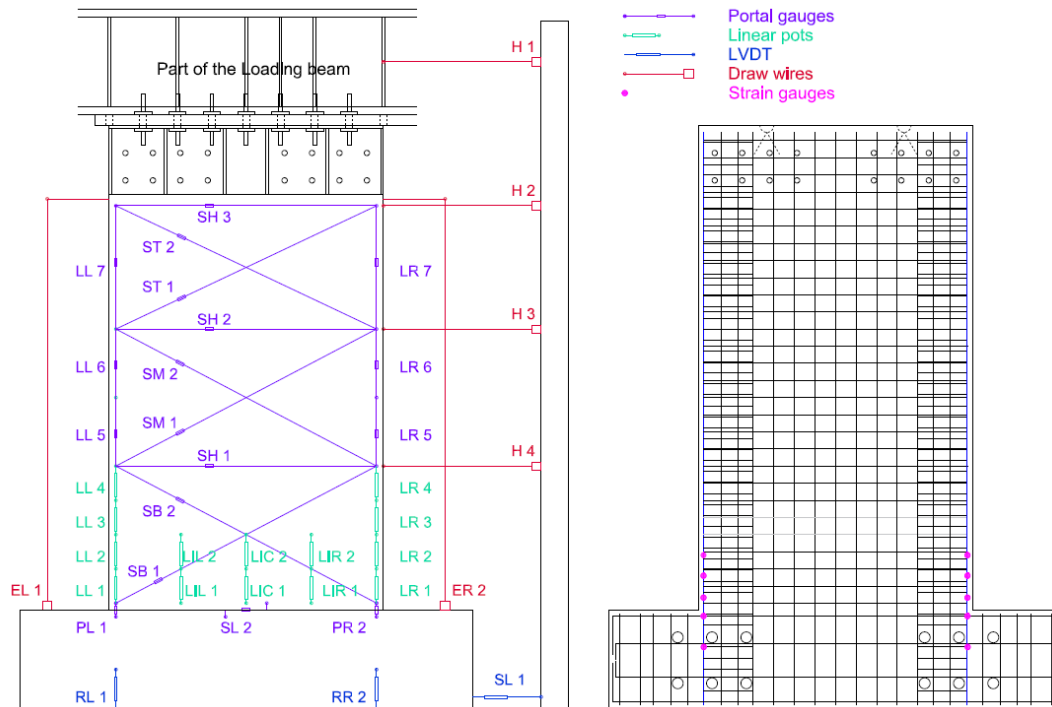
Figure 9: Instrumentation.

The instrumentation for the test walls is shown in Fig. 9. The global displacement measurements will consist of 4 draw wires and 1 vertical Linear Variable Differential Transformer (LVDT) at different heights, 2 vertical Linear Variable Differential Transformer (LVDT) to measure body rotation at foundation level and, 1 LVDT to measure sliding. In addition, 2 horizontal displacement transducers (called Portal Gauge, or PGs) will be used to measure strain penetration at wall-foundation interface, 1 horizontal PG to measure shear sliding at the wall base, and 2 draw wires to capture axial elongation. Local response measurements will consist of vertical sets of PGs and linear pots to capture longitudinal deformation at wall edges, and diagonal couples of PGs to capture shear distortions. The strain in the reinforcing bars will be recorded using 8 strain gauges in the outer longitudinal boundary reinforcement. Finally, a Digital Image Correlation analysis will be carried on in the other face of the wall.
