Experimental evaluation of reinforced concrete wall repaired with increased thickness

J. Moscoso⁽¹⁾, M. Hube⁽²⁾, H. Santa María⁽³⁾, P. Espinoza⁽⁴⁾

Keywords: shear wall, repaired wall, damage, rocking

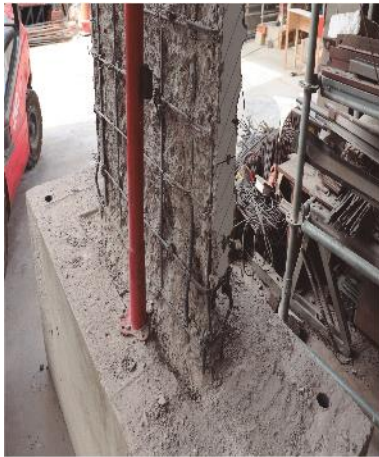
Demolition of concrete

Fig. 5 – Repair Procedures for RW1 and RW2.

An overview of the repair procedures for RW1 and RW2, that was similar, is shown in Fig. 5. The repair process began removing all of the concrete of the boundary and a thickness of 4 cm of the concrete, on each side, on the center of the specimen. This removing was done over a height of 1.75 m for W1 and 1.0 m for W2 above the base of the specimen; this distance was selected based on the extent of the observed damage and in order not to generate damage in unrepaired areas of the specimen. Concrete was removed using jackhammer equipment. After completion of demolition, the boundary longitudinal reinforcement were cut at the height of 300 mm above the base of the specimen, the new segments of longitudinal reinforcement were installed using anchors mechanic. The additional vertical reinforcement were placed anchoring the new bars at the base of the specimen. The anchoring was done with a drilling hammer, the new bars of the boundary (6 of 10mm) were anchored 150 mm and the new vertical distributed reinforcement (8 of 8mm) was anchored 12 cm. Furthermore, the epoxy was used to anchor the new reinforcement at the base. Once placed the new vertical reinforcement, was placed the transverse reinforcement in the boundary (stirrups with seismic hooks) and the horizontal distributed reinforcement. The spacing of the horizontal reinforcement was design according to AC318-14 (Chapter 18) [9]. Additional to vertical and horizontal reinforcement, mechanical interlock (two horizontal bars crossing the cross-section) was used, to resist shrinkage between new and old concrete. Reinstatement of repair concrete completed the repair process.

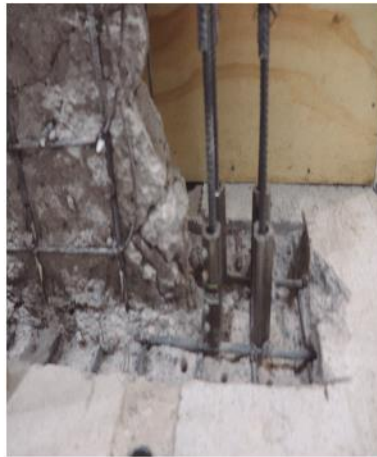
Use of anchors mechanic

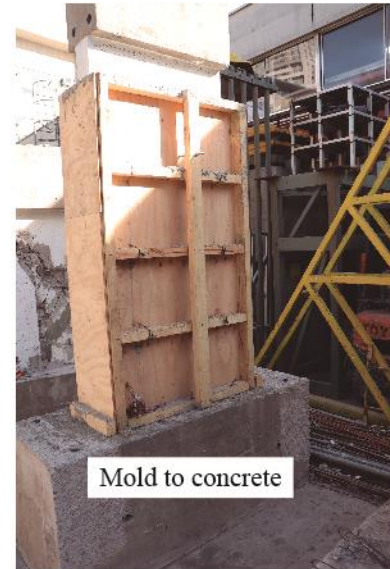
Mold to concrete

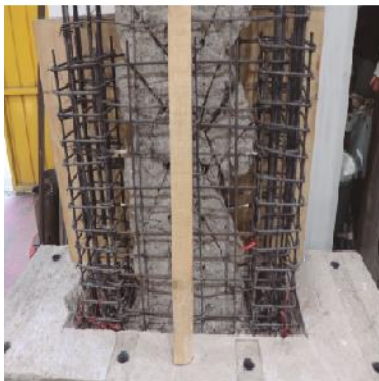
Reinstatement of new reinforcement

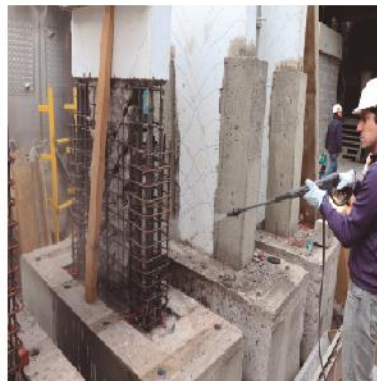
Surface cleaning

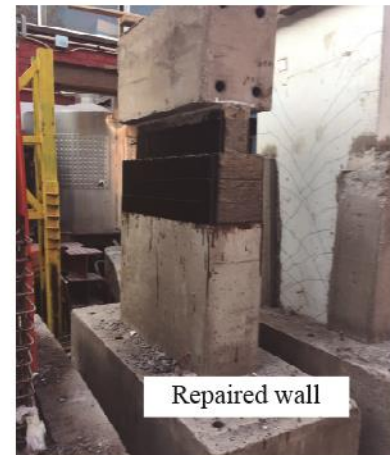
Repaired wall

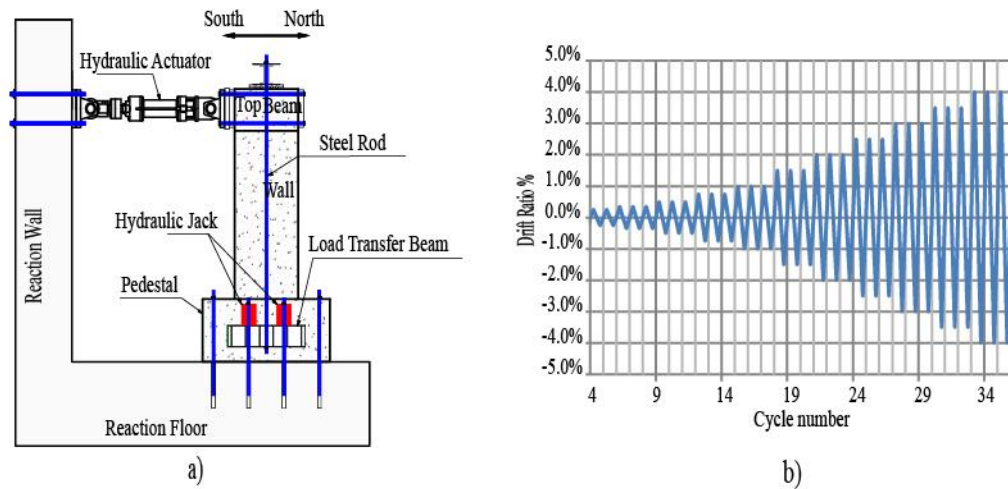
Fig. 6 – a) Test setup, b) Loading protocol.

The test setup is shown in Fig. 6a. An axial load of approximately $10\%A_g f'_c$ was applied at the bottom of the specimen by hydraulic jacks mounted on steel beam that load transfer by post-tensioning rod to top of specimen. Cyclic lateral displacements were applied to the specimens by a hydraulic actuator mounted horizontally to a reaction specimen. An out-of-plane restraint system was used to restrict out-of-plane movement at the top beam of the specimens. The loading protocol used was developed by [10] in accordance with ACI 374.2R-13 [8]. Fig. 6b shows the loading protocol. This protocol was similar for two specimens with three displacement-controlled cycles at each drift level.

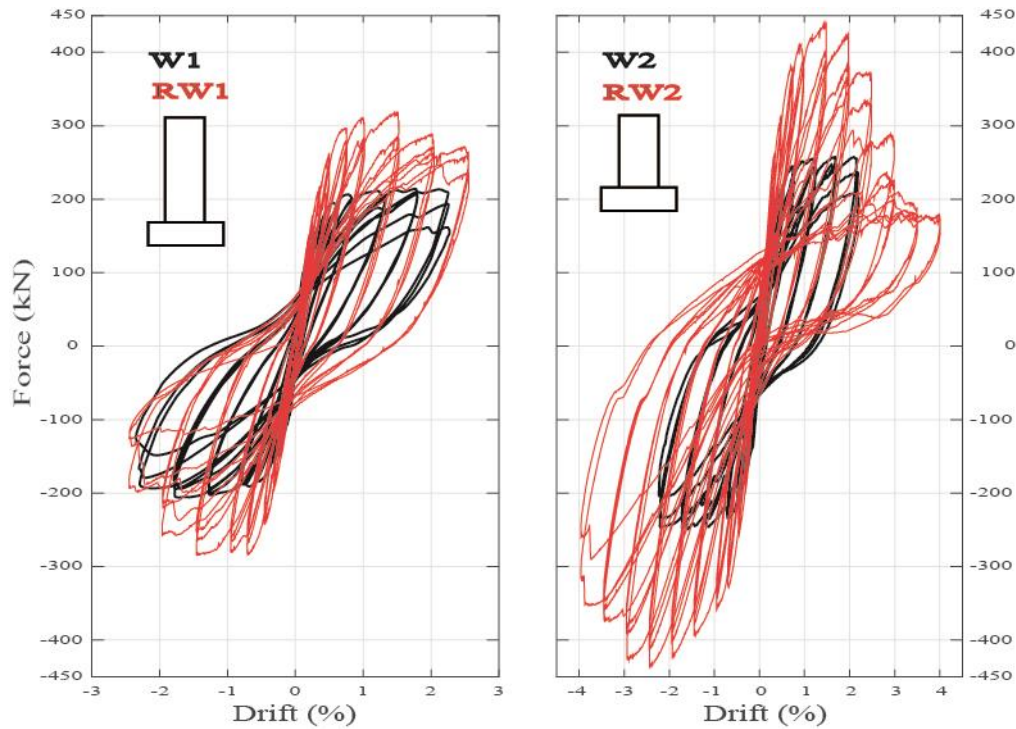
Fig. 8 – Measured load-drift responses

The load-deformation responses for the repaired specimens, RW1 and RW2, and the original specimens, W1 and W2, are shown in Fig. 8. The elastic stiffness, maximum strength, deformation and total dissipated energy of the repaired specimens was higher than that of the unrepaired specimens. For RW1 the stiffness was 48.5% higher than W1, while for RW2 the stiffness was 38.9% higher than W2. Similar trend occurred in maximum resistance where for RW1 the strength was 49.1% higher than W1, the increase was also seen for RW2 with 68.8% above W2. While, for the deformation the increase was RW1 13.2% higher than W1 and in RW2 was 76.2% higher than W2. The maximum increases occurred in the total dissipated energy, where the increase was 59.8% between RW1 and W1, while for RW2 the increase was 180.1% compared to W2.
